Eversource 345-kV Structure Replacement Projects (2021-2022)

Planning Advisory Committee Meeting

January 21st, 2021

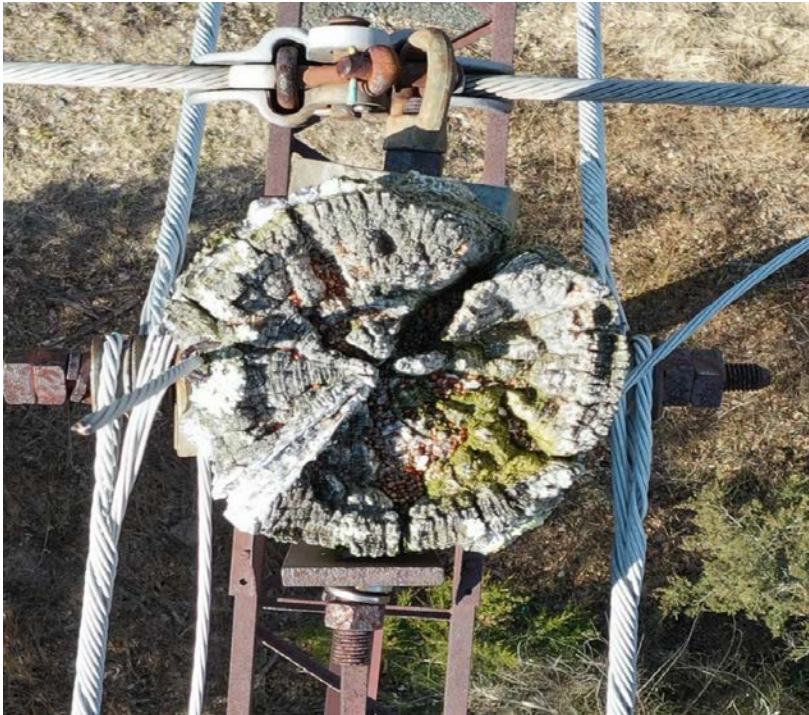
Pole Top Rot –
Line 387

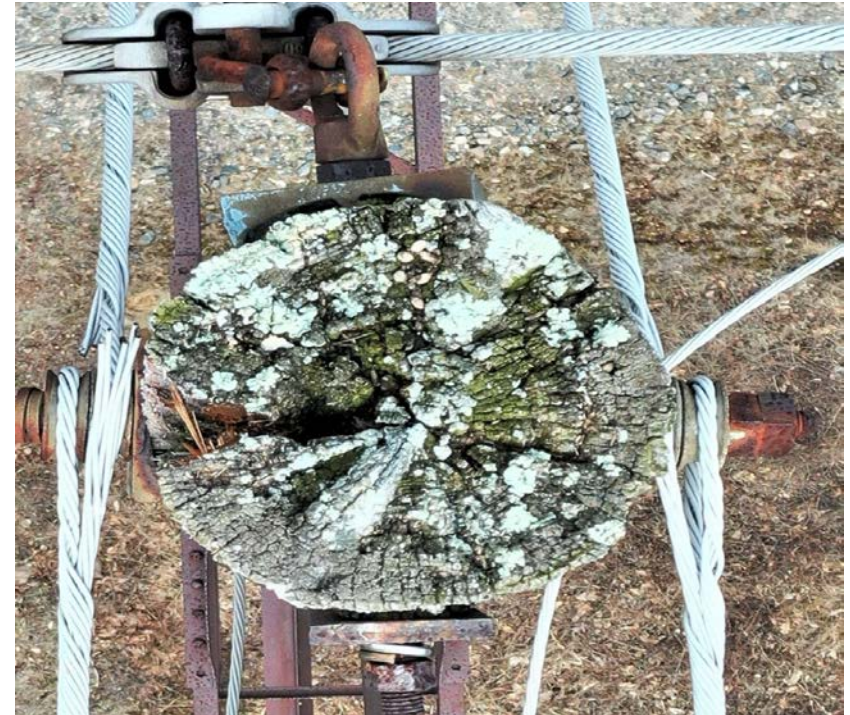
Pole Top Rot –
Line 387

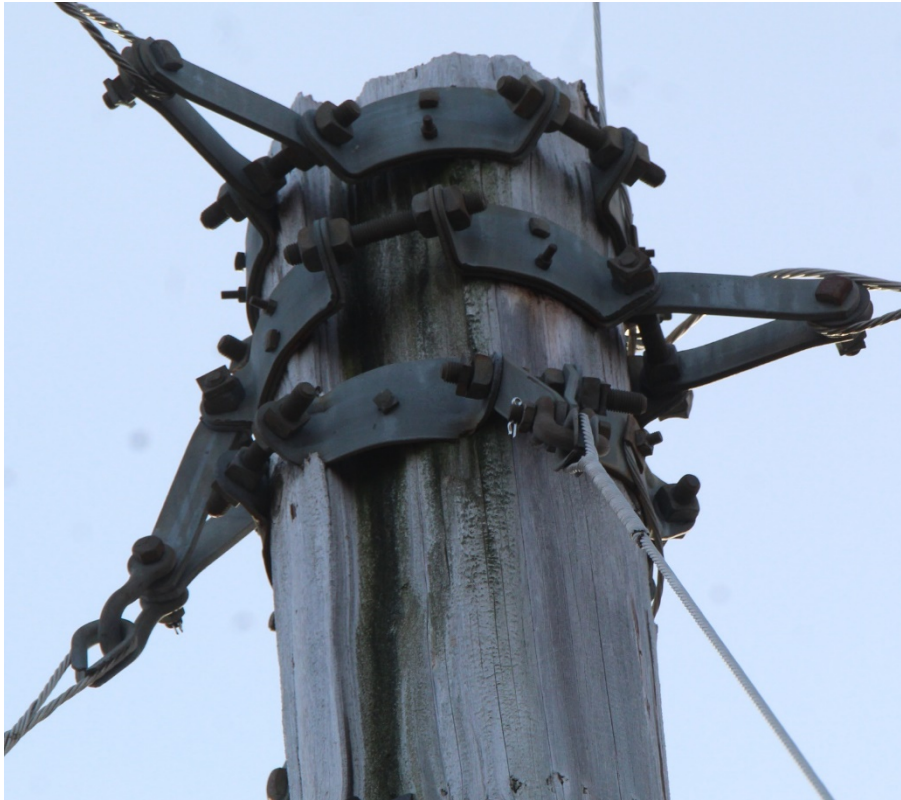
Pole Splits –
Line 310

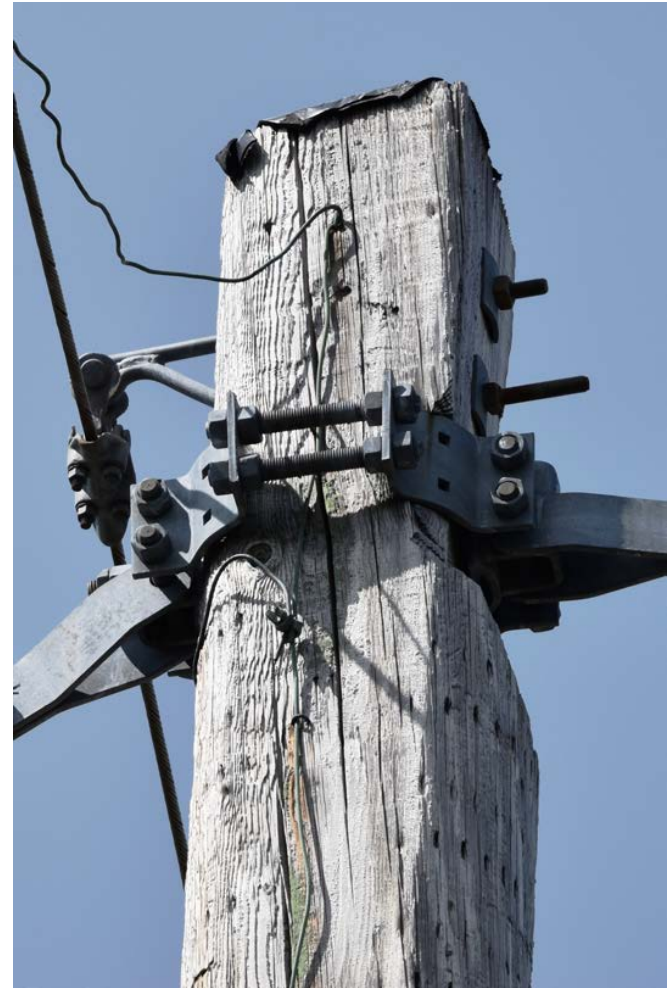
Pole Splits –
Line 319

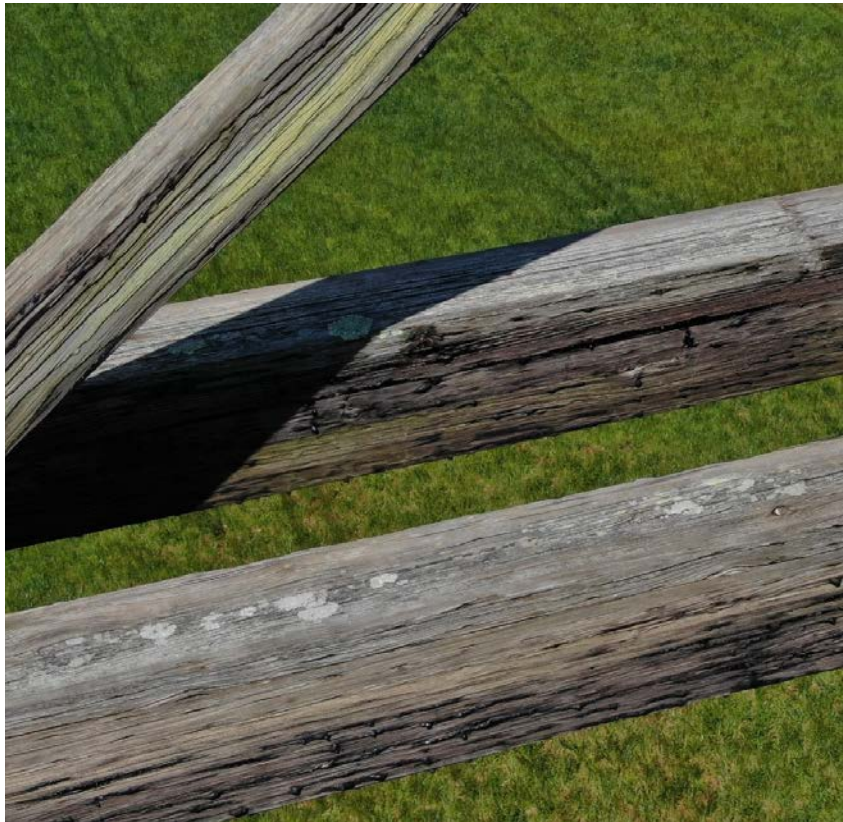
Cross Arm Damage – Line 3754

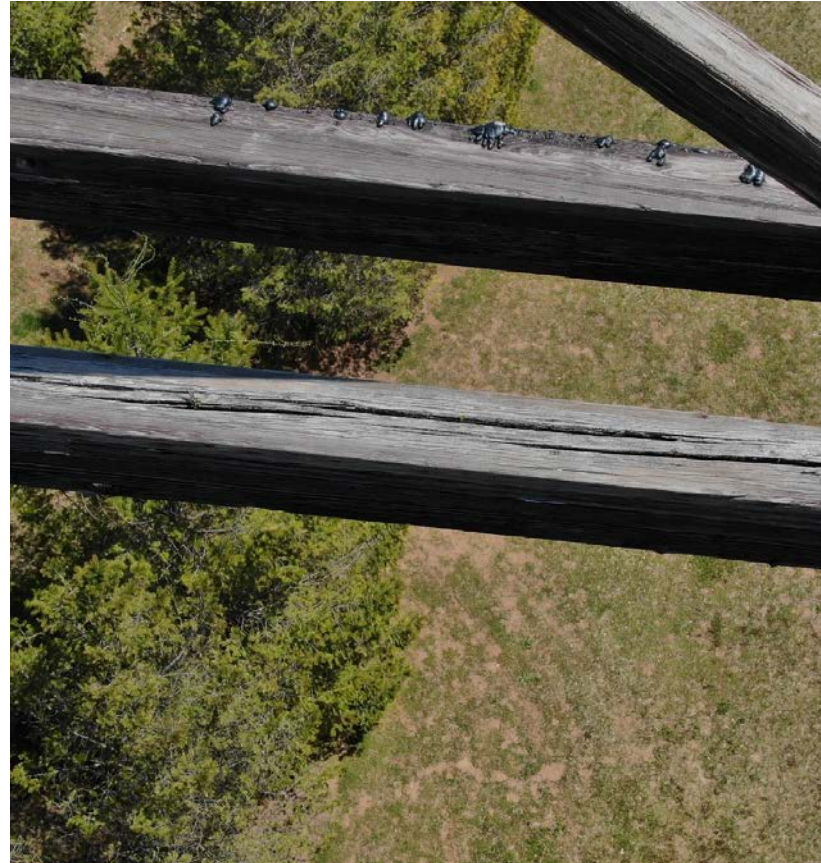
Cross Arm Damage –
Line 3754

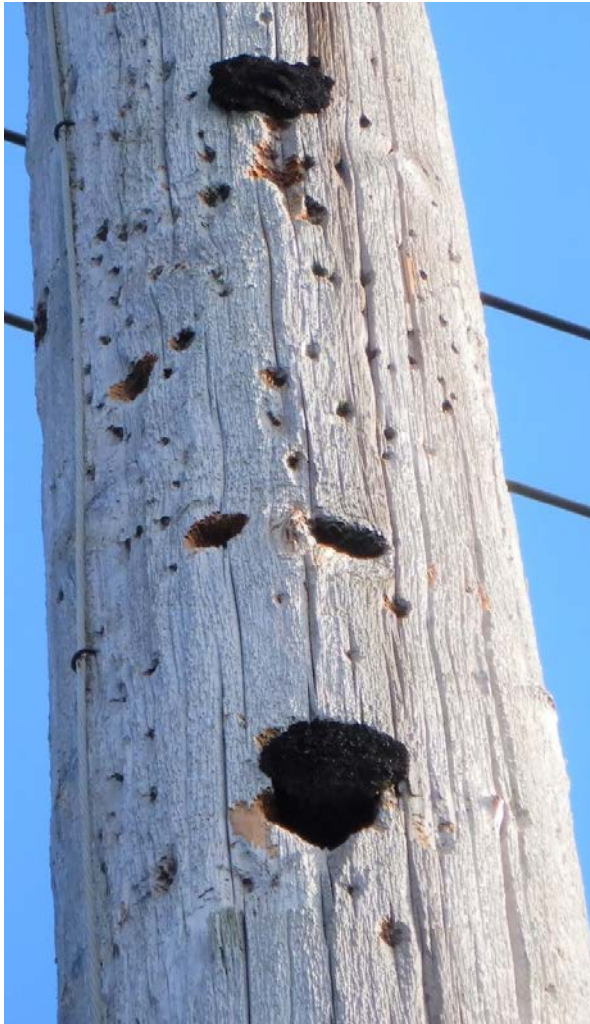
Woodpecker Damage –
Line 387

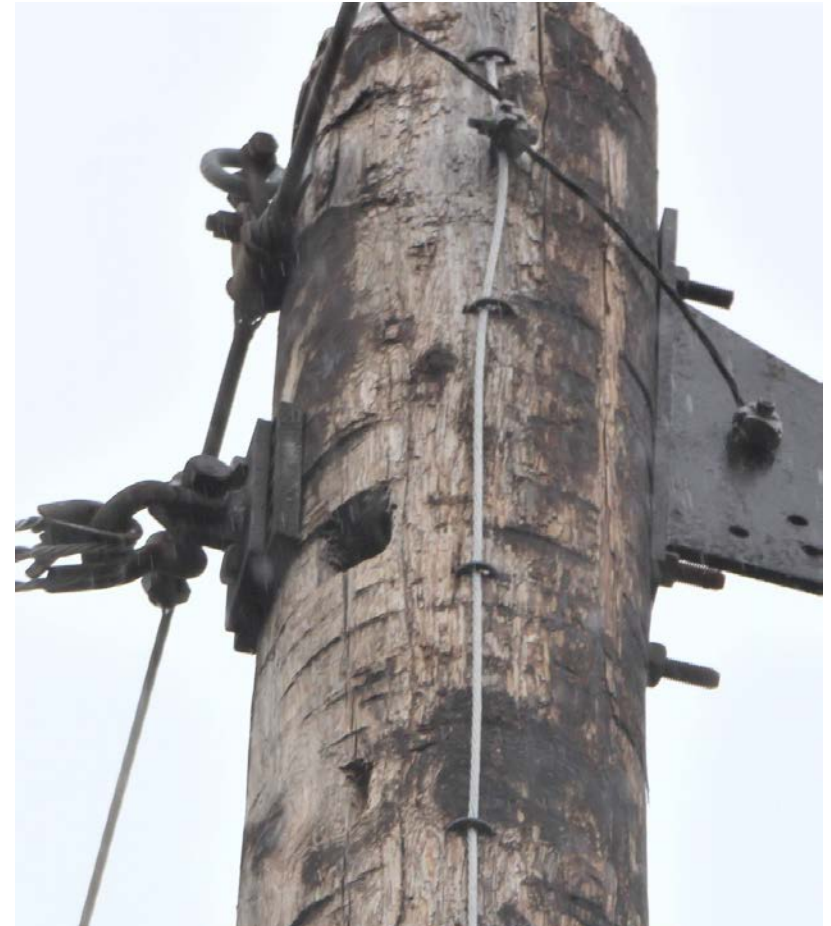
Woodpecker Damage –
Line 3041

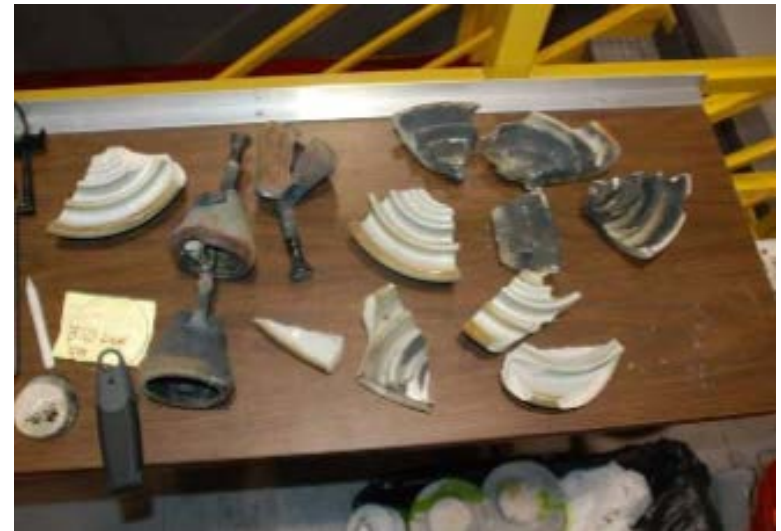
- PINCO insulators must be replaced to ensure continued reliability
 - PINCO insulators have not been installed on Eversource system since the late 1980s
 - May 2017 PINCO insulator failure on 310 line prompted additional testing
 - EPRI testing revealed that PINCO insulators were defective and failed below mechanical and electrical ratings
- Replacements of PINCO insulators, where applicable, will be coordinated with structure replacements

Fragments of Failed PINCO Insulator –
Line 310
