NHDES FIELD INSPECTION REPORT

Land Resources Management Program, Water Division

■ FILE NUMBER: 2022-02462
■ INSPECTION DATE: February 28, 2023
OWNER/APPLICANT NAME: Eversource Energy
■ SITE LOCATION: Eversource Row, Derry, between Pingree Hill Rd and Ledgewood Dr
■ NHDES INSPECTION PERSONNEL: Jeff D. Blecharczyk;
■ OTHER PARTIES IN ATTENDANCE: Conor Madison (GZA); Ashley Friend (Eversource) and Vince Edwards (Eversource
■ INSPECTION TYPE: $oxtimes$ Compliance $oxtimes$ Permitting $oxtimes$ Initial $oxtimes$ Follow-Up $oxtimes$ Restoration Plan Monitoring
■ IMPACTED RESOURCE: □ Protected Shoreland □ Lake/Pond □ River/Stream ☒ Upland ☒ Wetland
■ POSTED PERMITS: ☐ AOT ☐ Shoreland ☐ Subsurface ☐ Wetlands ☒ None
■ ATTACHMENTS: ⊠ Color Photographs □ Aerial Photographs □ Site Sketch □ Other
■ WEATHER CONDITIONS: overcast, lite snow fall
PURPOSE: The purpose of the site inspection was in response to concerns about construction practices
BACKGROUND:

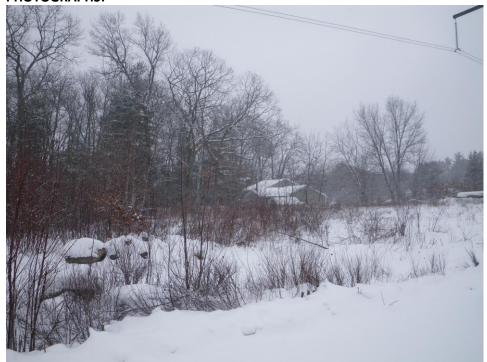
Photo 1 Looking southerly, pole 314 to the right. Ledgewood Dr in background

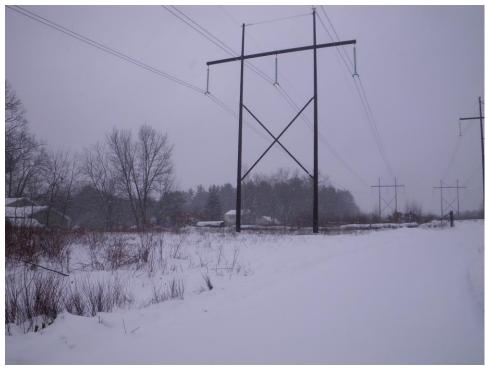
Photo 2 looking south southwest at pole 314, Ledgewood Dr in in the background.

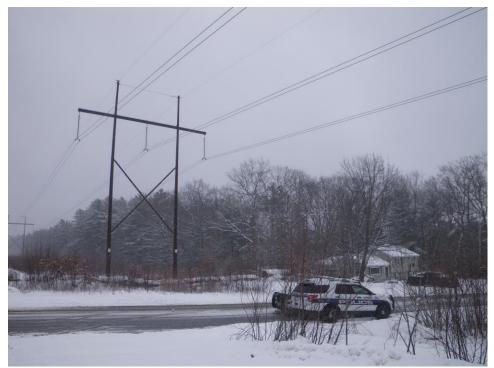
Photo 3 Looking across Ledgewood Dr, northeasterly from pole 320; pole 314 present in photo.

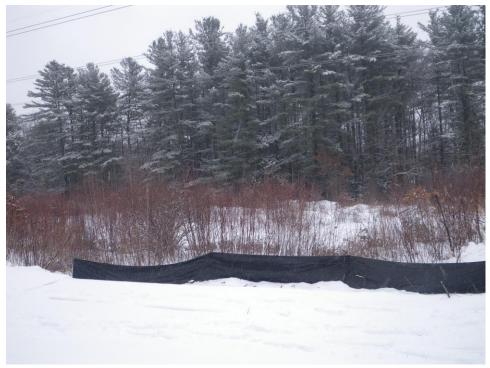
Photo 4 from pole location 319 along line 373; looking east, south east across the wetland drainage

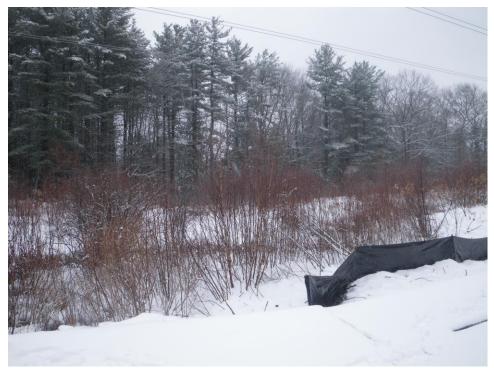
Photo 5 from pole location 319 along line 373; looking southerly across the wetland drainage towards properties off Rocky Circle.
