# **Eversource 115-kV Wood Pole and Shield Wire Replacements 2020-2023 – Revision 1**

Planning Advisory Committee Meeting

December 19, 2019

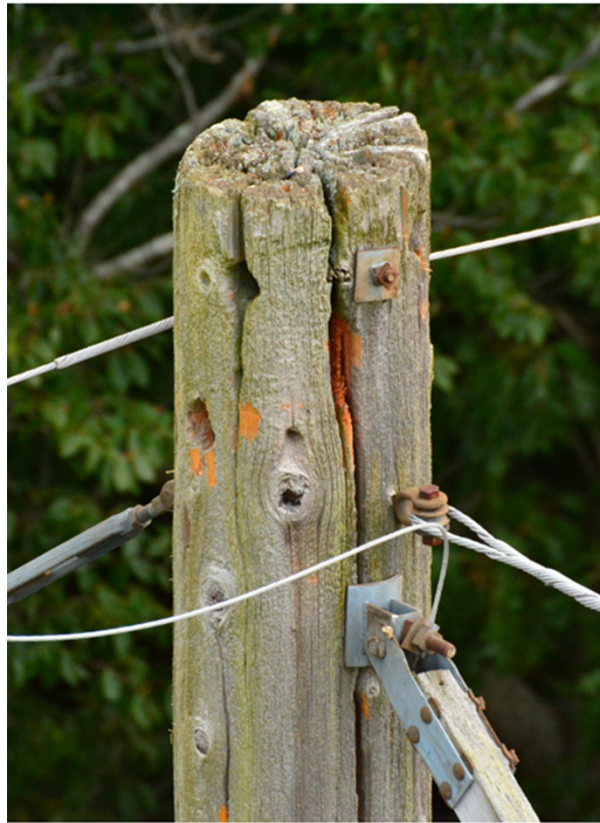
Line 1080  
Str 6351  
Pole Crack & Woodpecker Holes

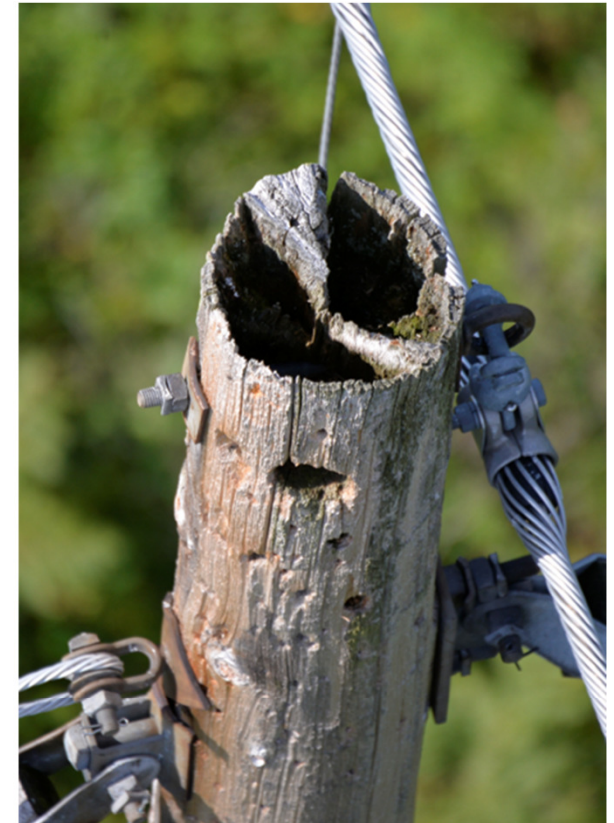
Line 1161  
Str 40079  
Deep Pole Top Rot

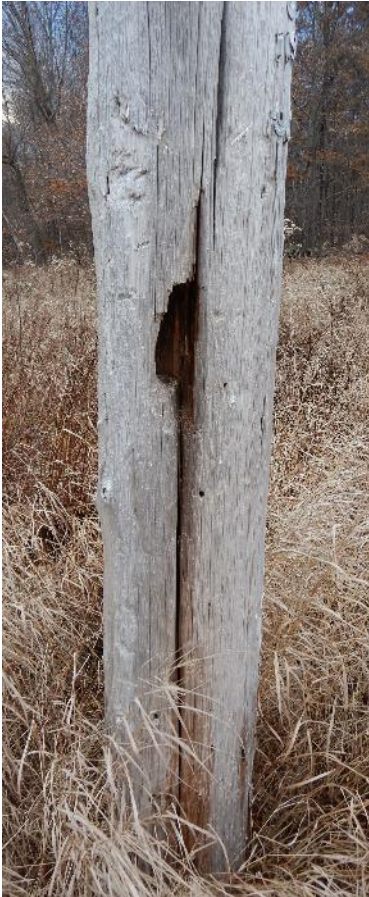
Line K174 Str 119  
Pole Base Splitting

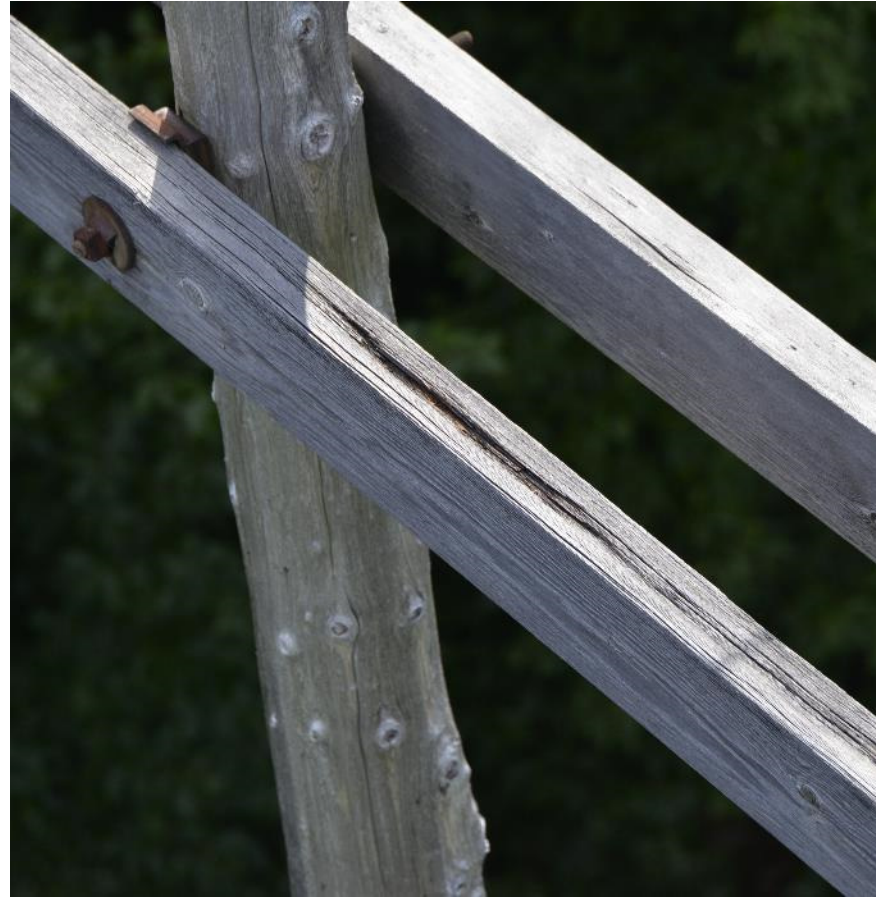
Line 1421 Str 32008  
Cross Arm Splitting

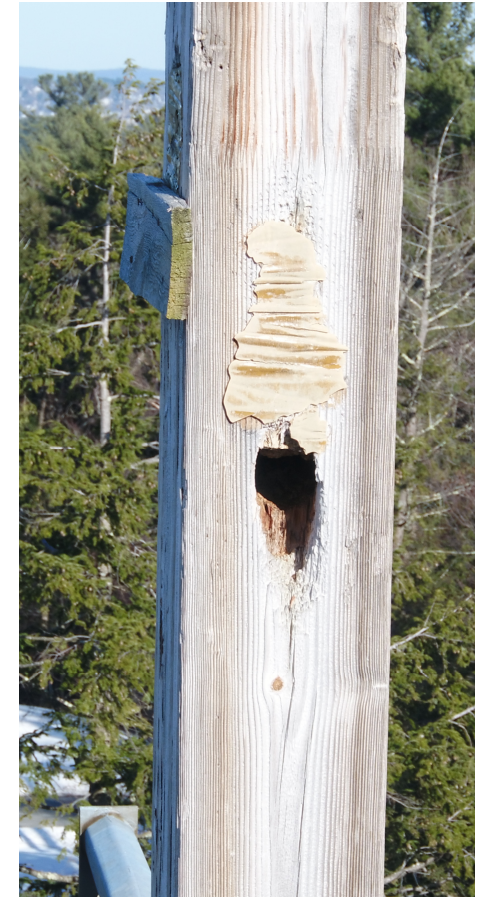
Line K105 Str 95  
Deep Woodpecker Hole

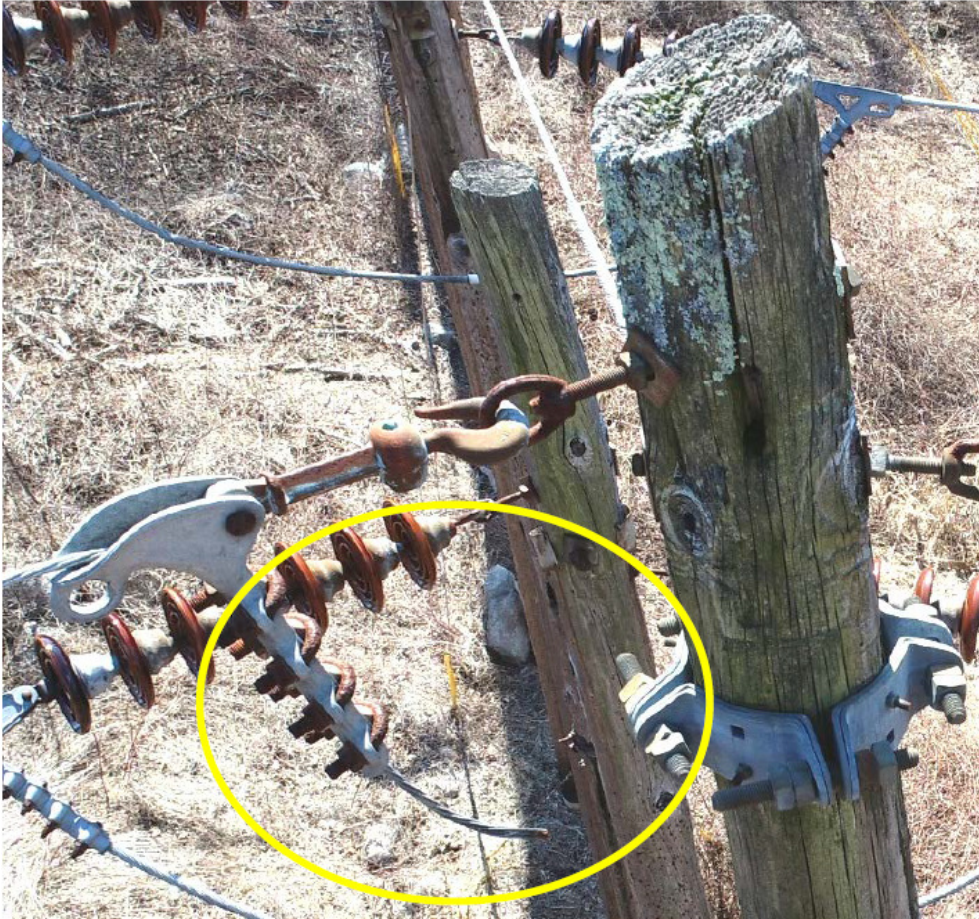
Line 1410  
Broken Static Wire

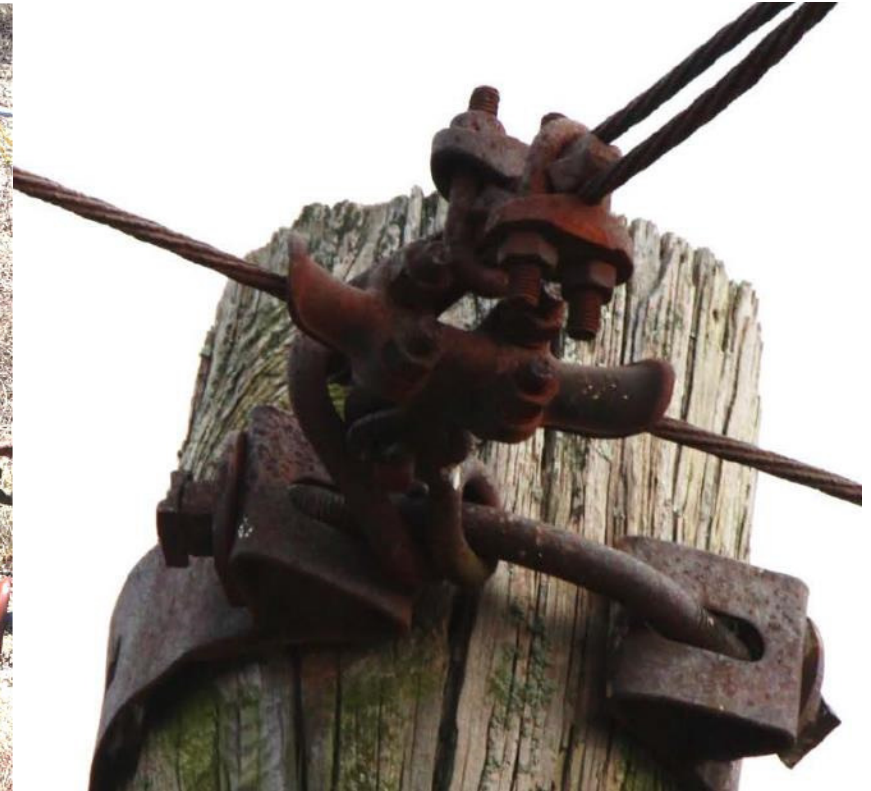
Line 1756  
Rusting and Pitting on  
Shield wire & Hardware
