Eversource 115-kV Wood Pole and Shield Wire Replacements 2020-2023 – Revision 1

Planning Advisory Committee Meeting

December 19, 2019

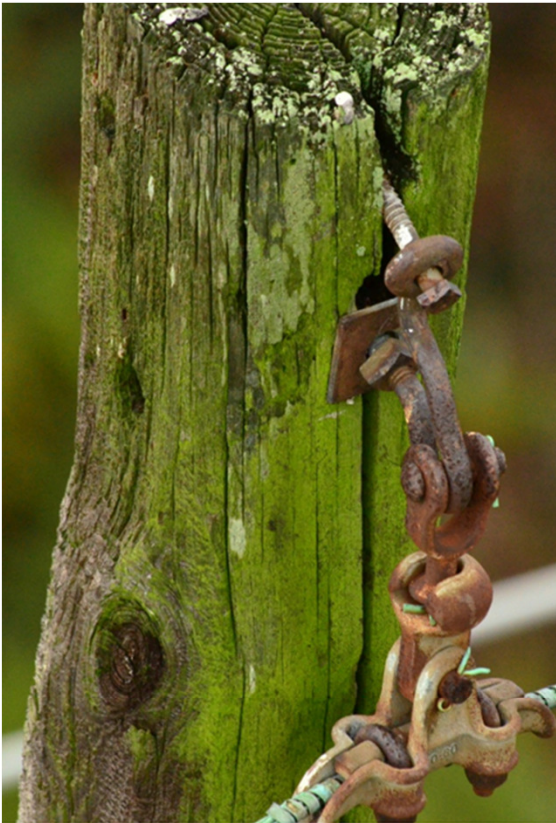
Line 1000
Str 7619
Pole Crack

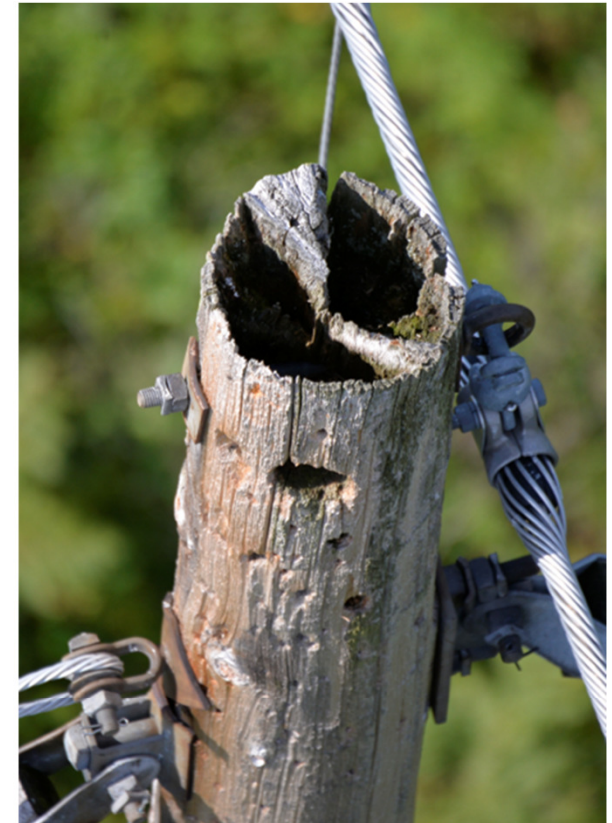
Line 1161
Str 40079
Deep Pole Top Rot

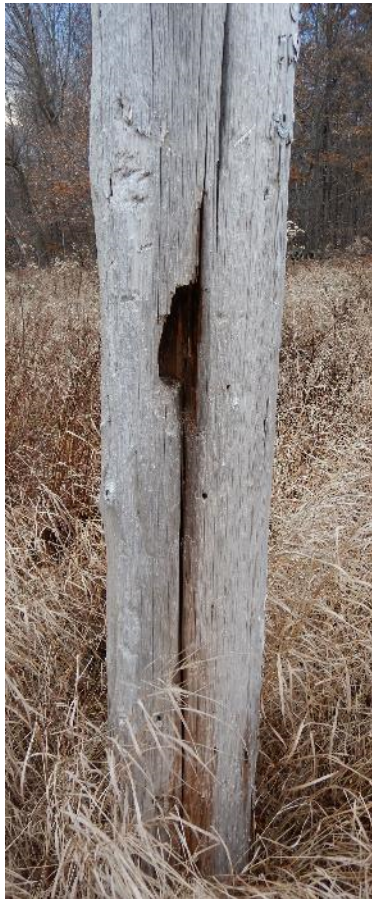
Line K174 Str 119
Pole Base Splitting

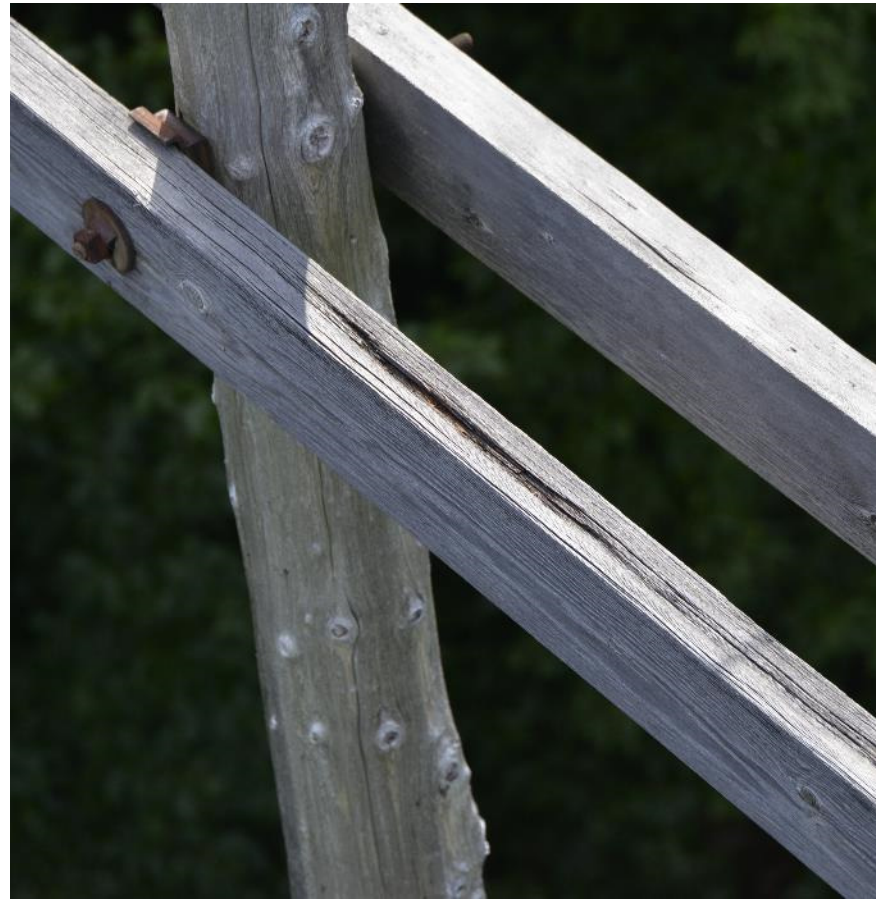
Line 1421 Str 32008
Cross Arm Splitting

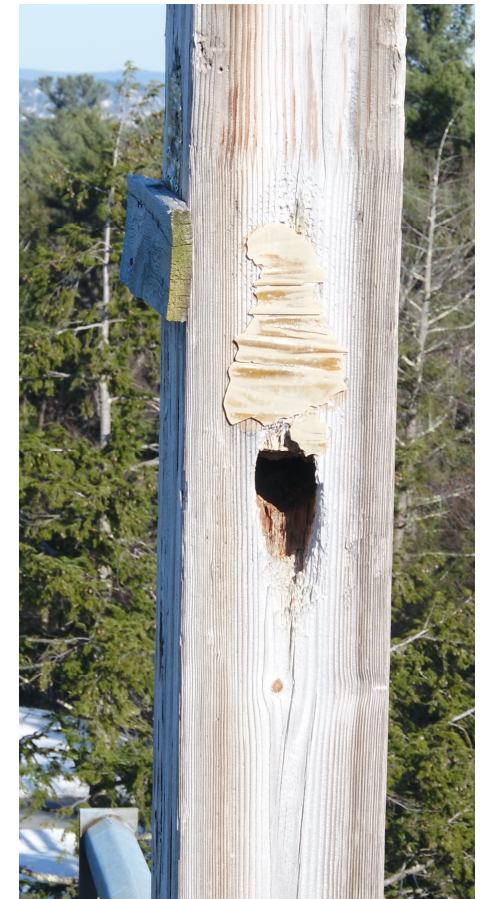
Line K105 Str 95
Deep Woodpecker Hole

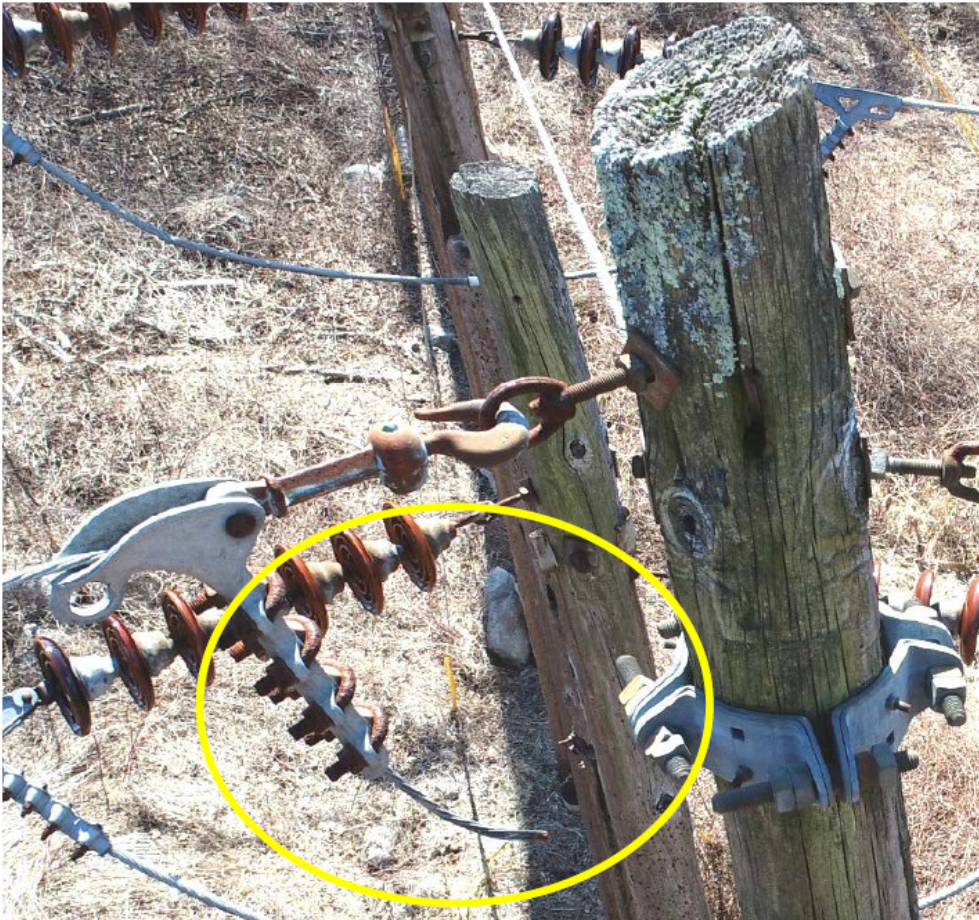
Line 1410
Broken Static Wire

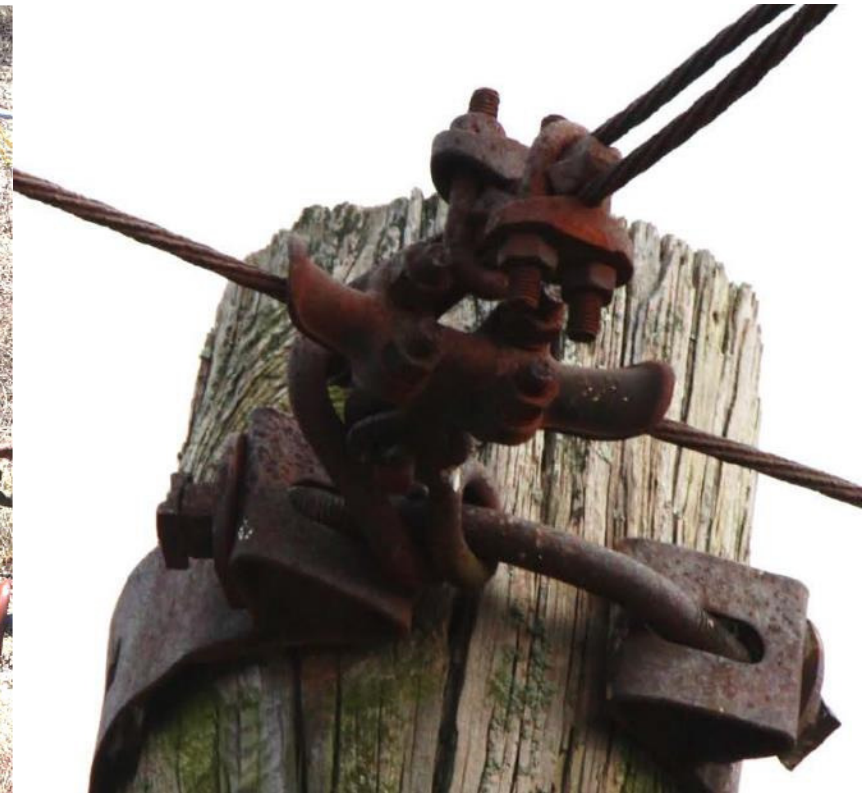
Line 1756
Rusting and Pitting on
Shield wire & Hardware
