Eversource 115-kV and 230-kV Wood Pole and Shield Wire Replacements 2021-2022

Planning Advisory Committee Meeting

June 16th, 2021

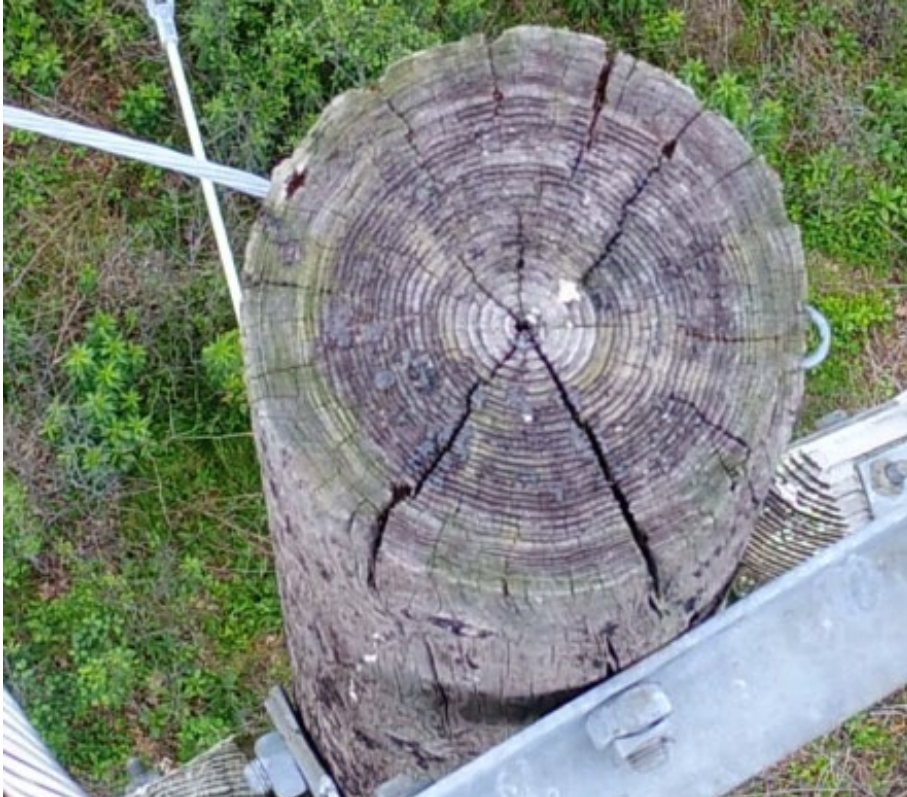
Pole Top Split –
Line 456-522,
Structure #2

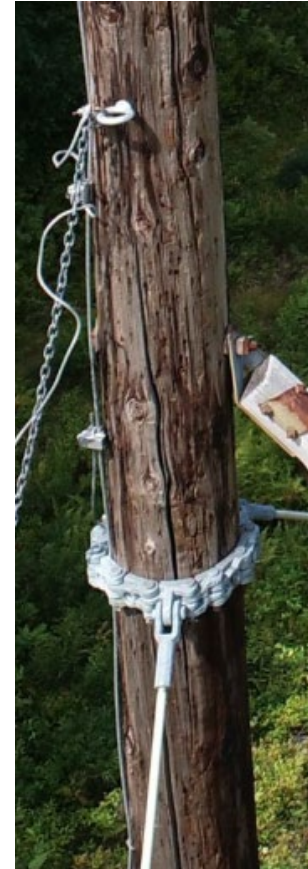
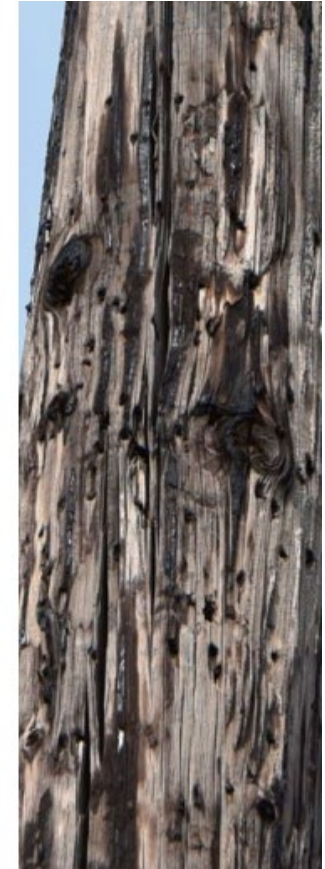
Pole Breaks and Woodpecker Damage –
Line 456-522,
Structure #54

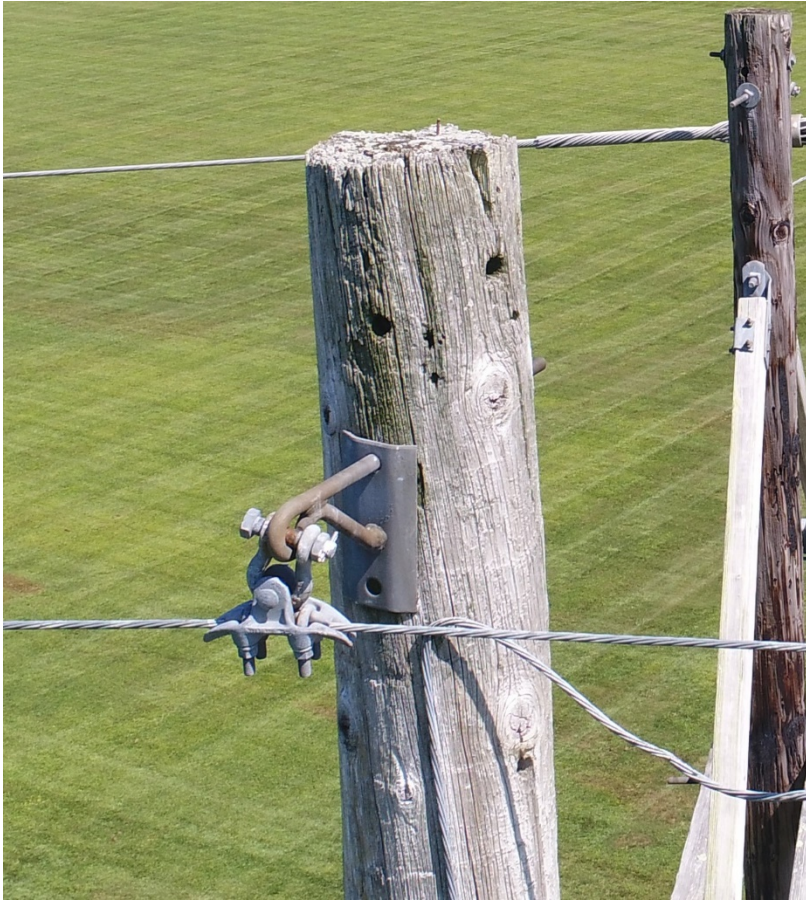
Woodpecker Damage –
Line 240-510,
Structure #185

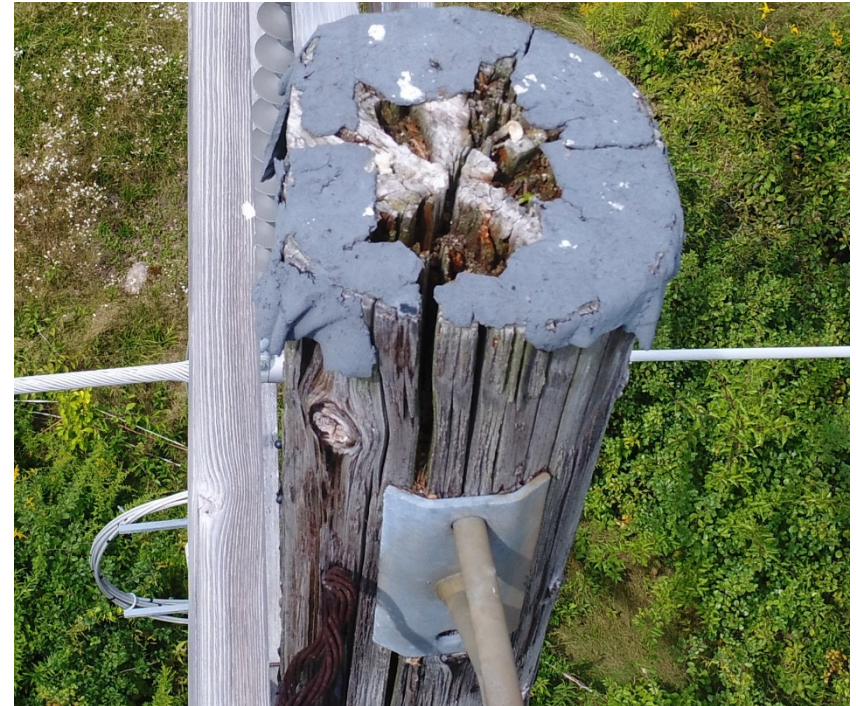
Pole Top Rot –
Line 240-510,
Structure #197

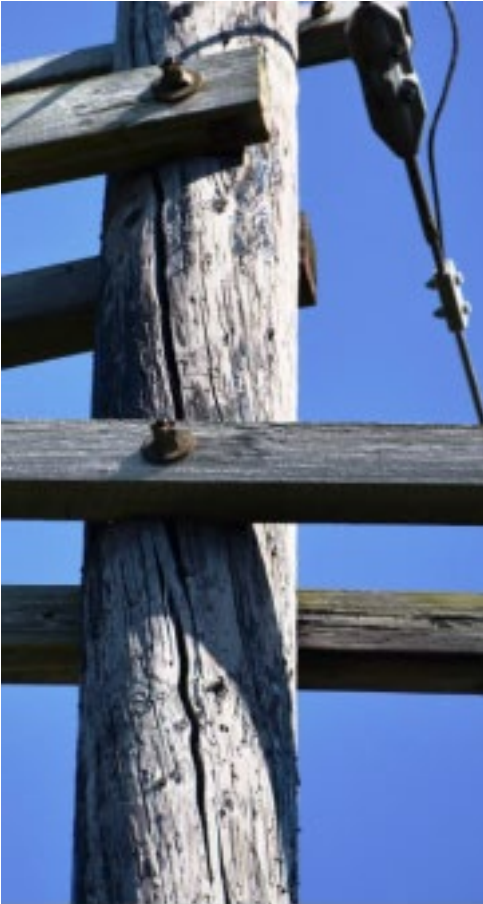
Pole Splits –
Line 342-603,
Structure #83

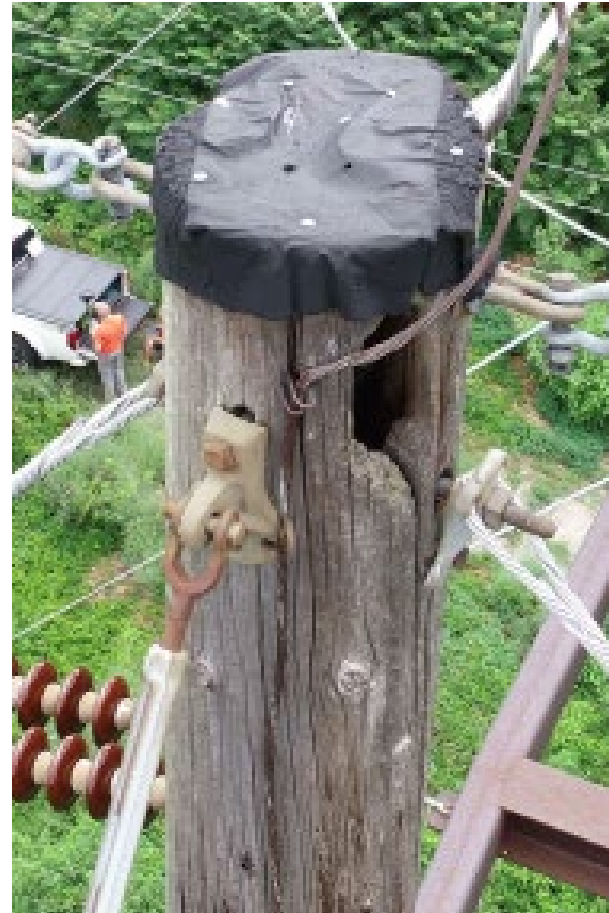
Woodpecker Damage –
Line 342-603,
Structure #101

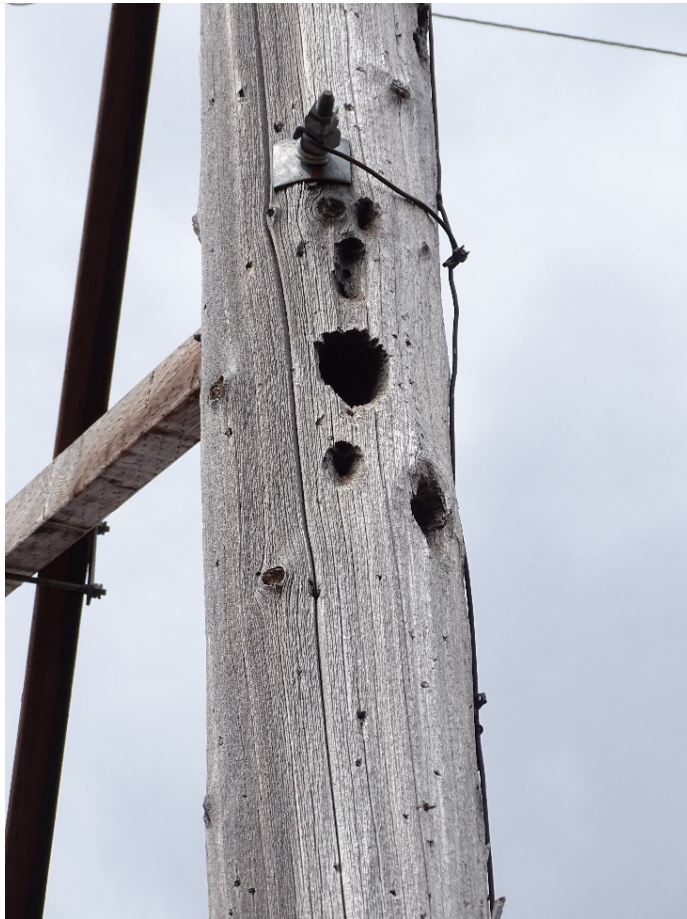
Woodpecker Damage –
Line D121,
Structure #46

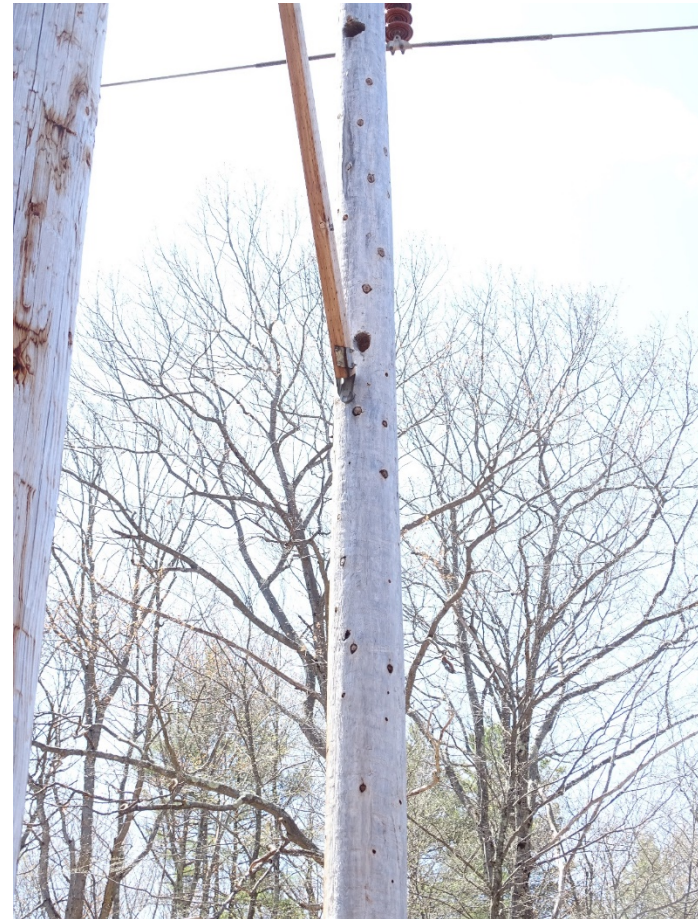
Woodpecker Damage –
Line D121,
Structure #77

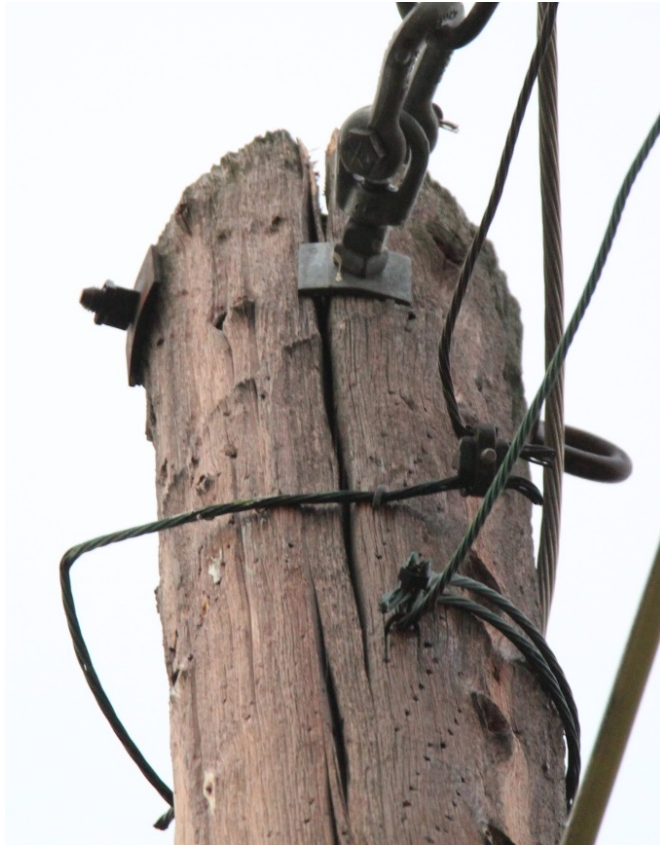
Split Pole Top, Cracks, Decay –
Line 1751,
Structure #3-331

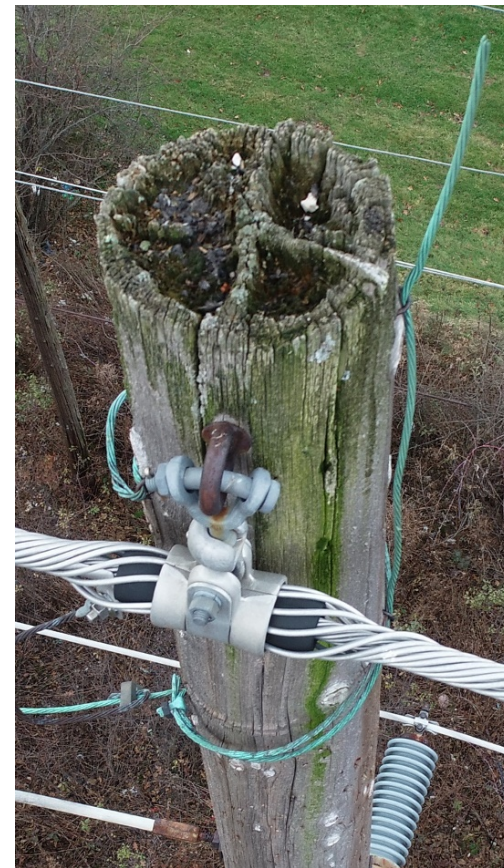
Split Pole Top, Cracks, Decay –
Line 1751,
Structure #3-363
