Eversource 115-kV Structure Replacement Projects

Planning Advisory Committee Meeting

October 17, 2018

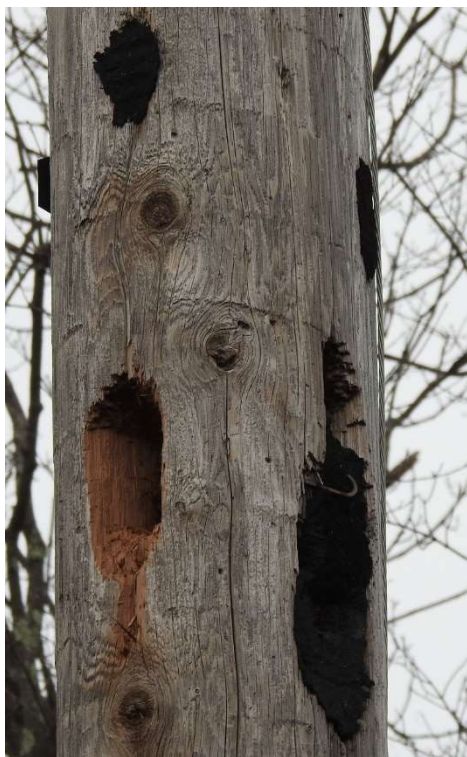
CT – 1726 Line Str. # 8056:

Pole Degradation – Woodpeckers/Age

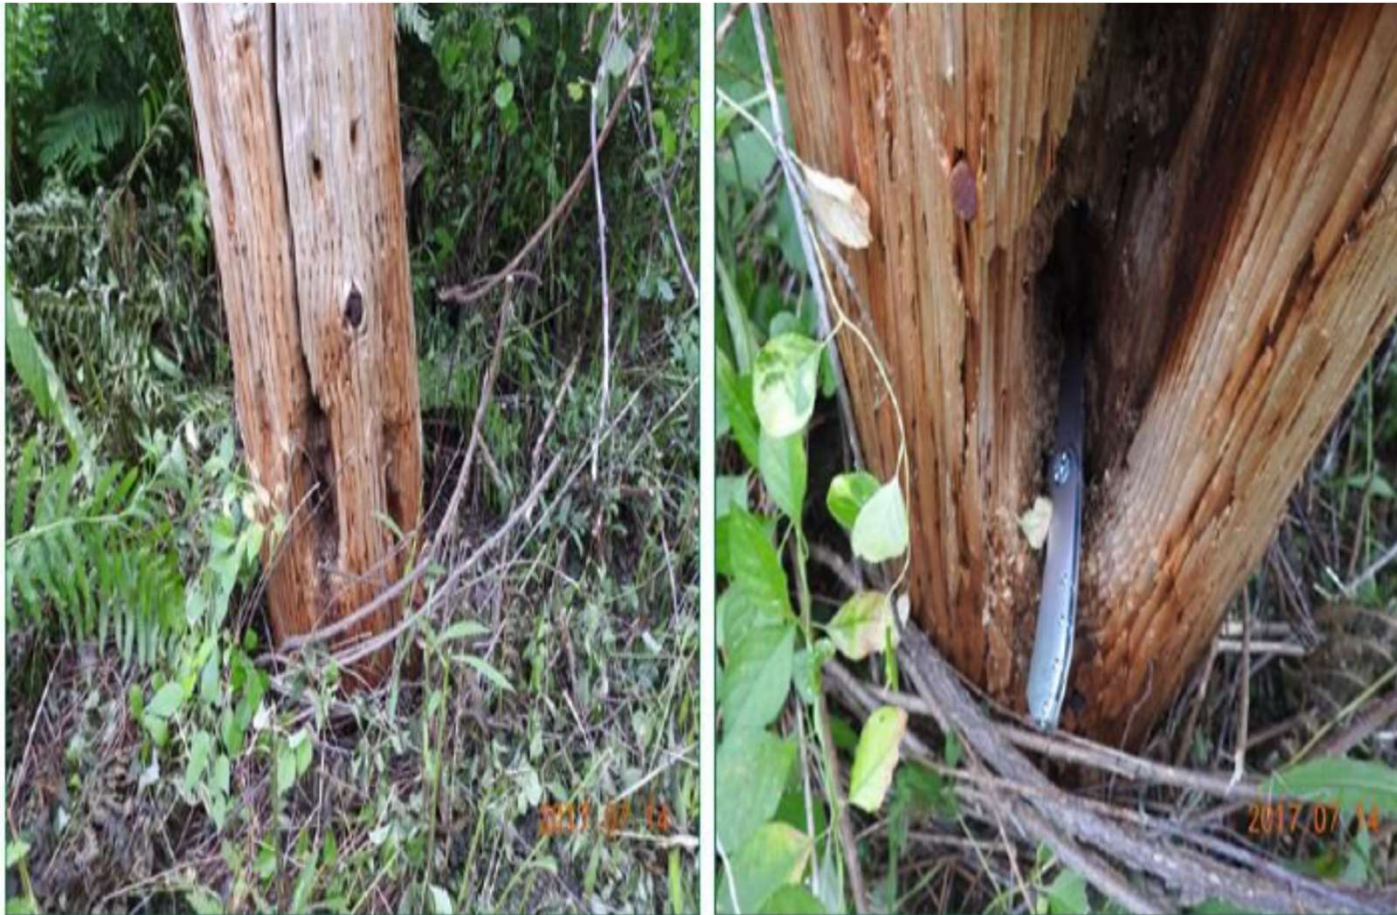
NH K174 – Str 182

Pole Degradation – Woodpeckers/Age

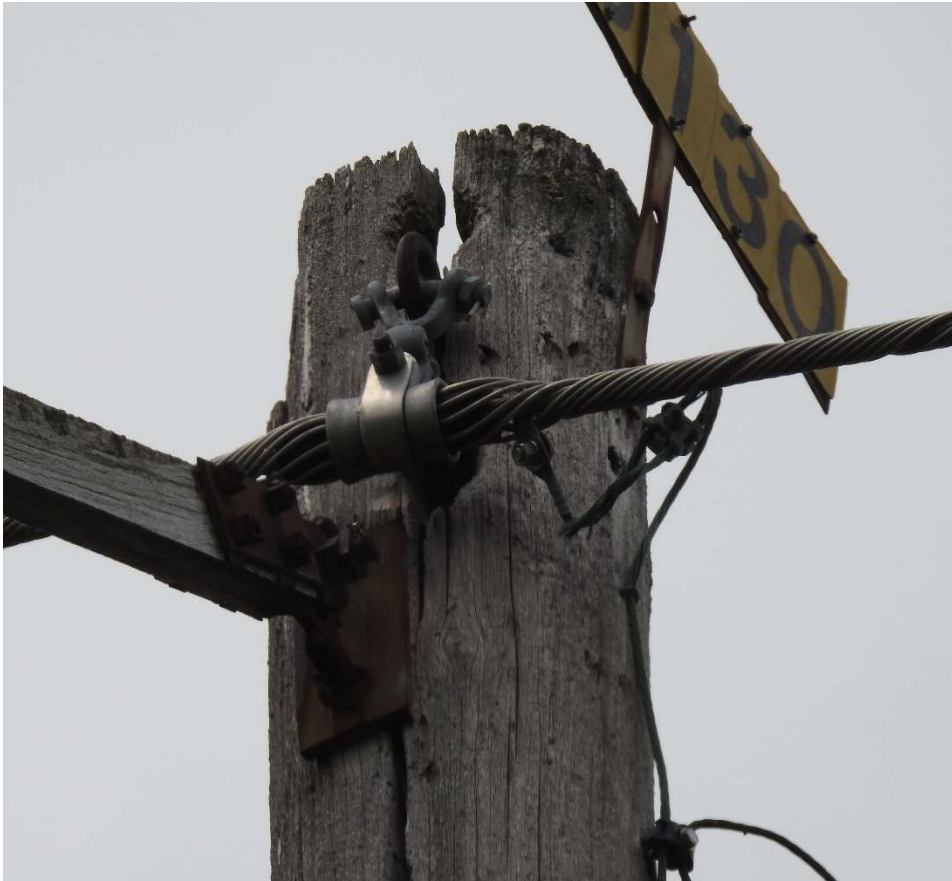
CT 1448 Line Str 10130

Pole Top Rot

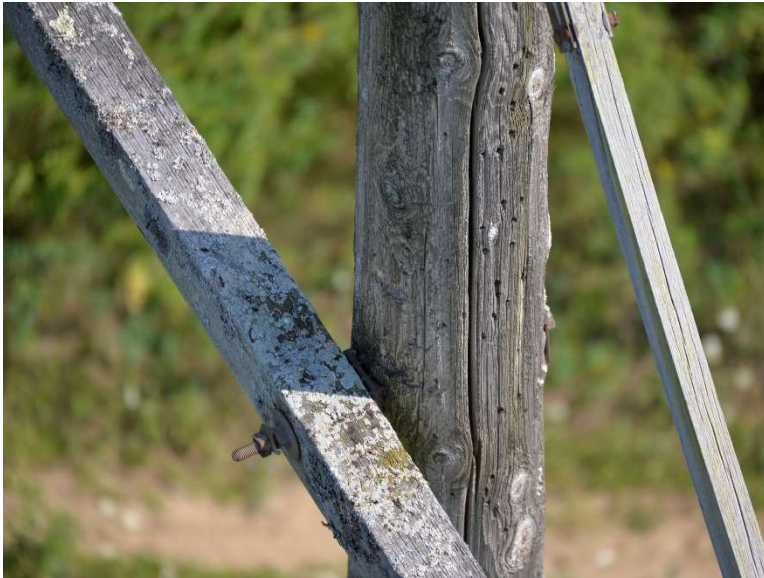
MA F132 – Str 15008

Damaged Structural Members

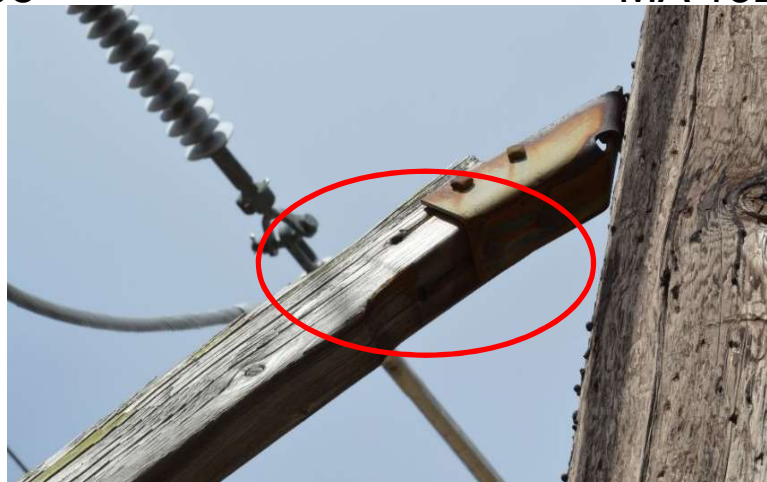
MA 65-508 Line: Brace failure
