Eversource Laminated Structure Replacement Projects

Planning Advisory Committee Meeting

December, 2017

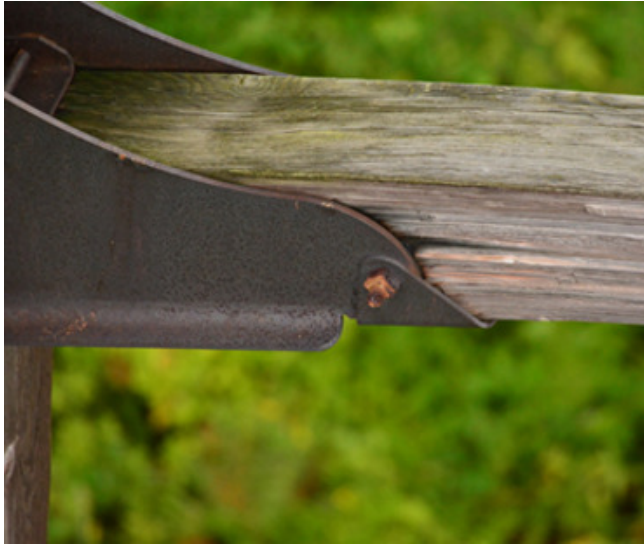
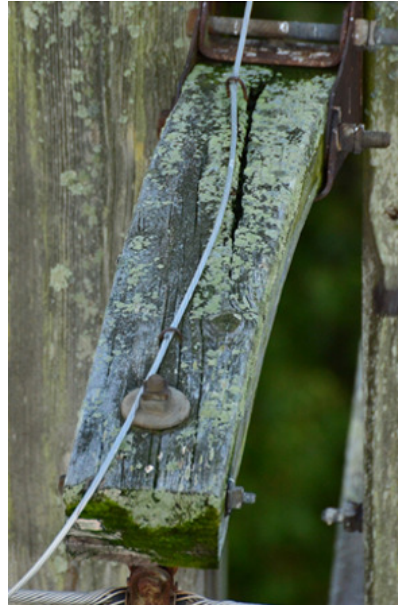
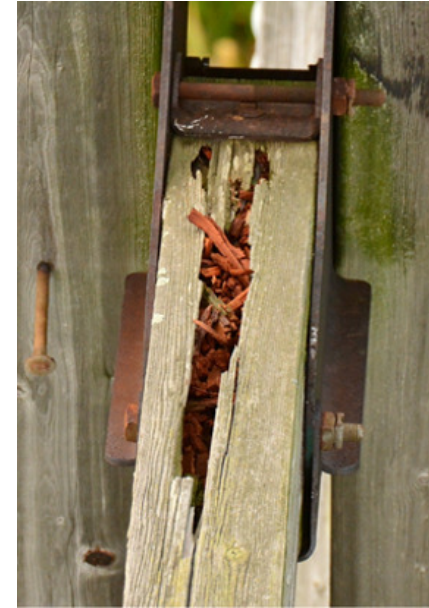
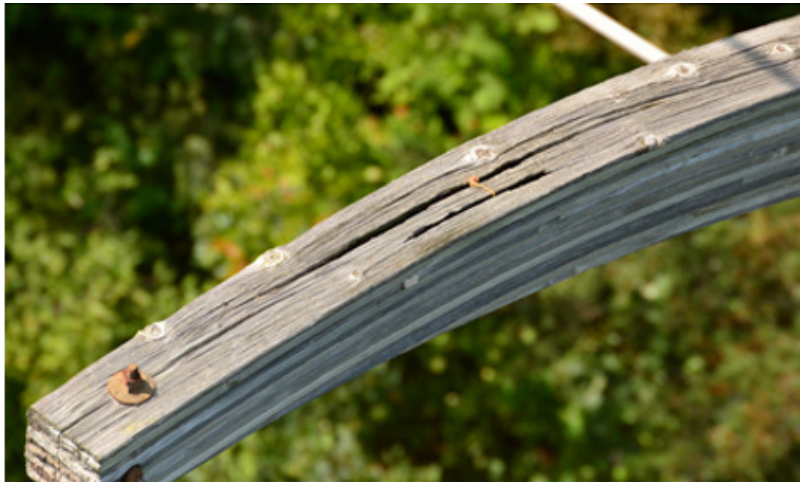
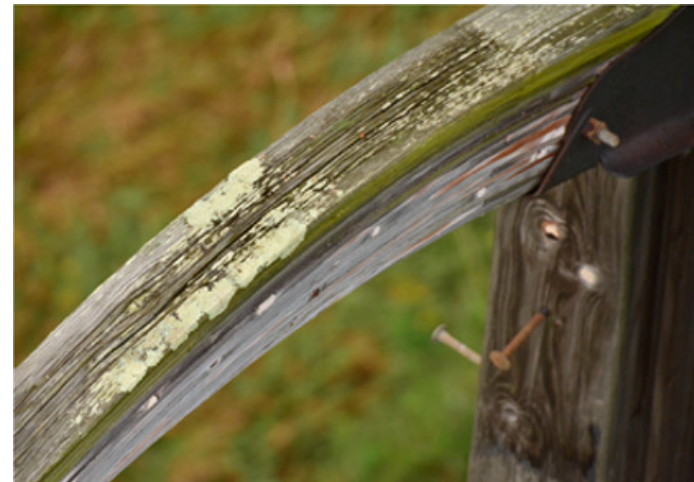
Condition Summary Davit Arm Deterioration

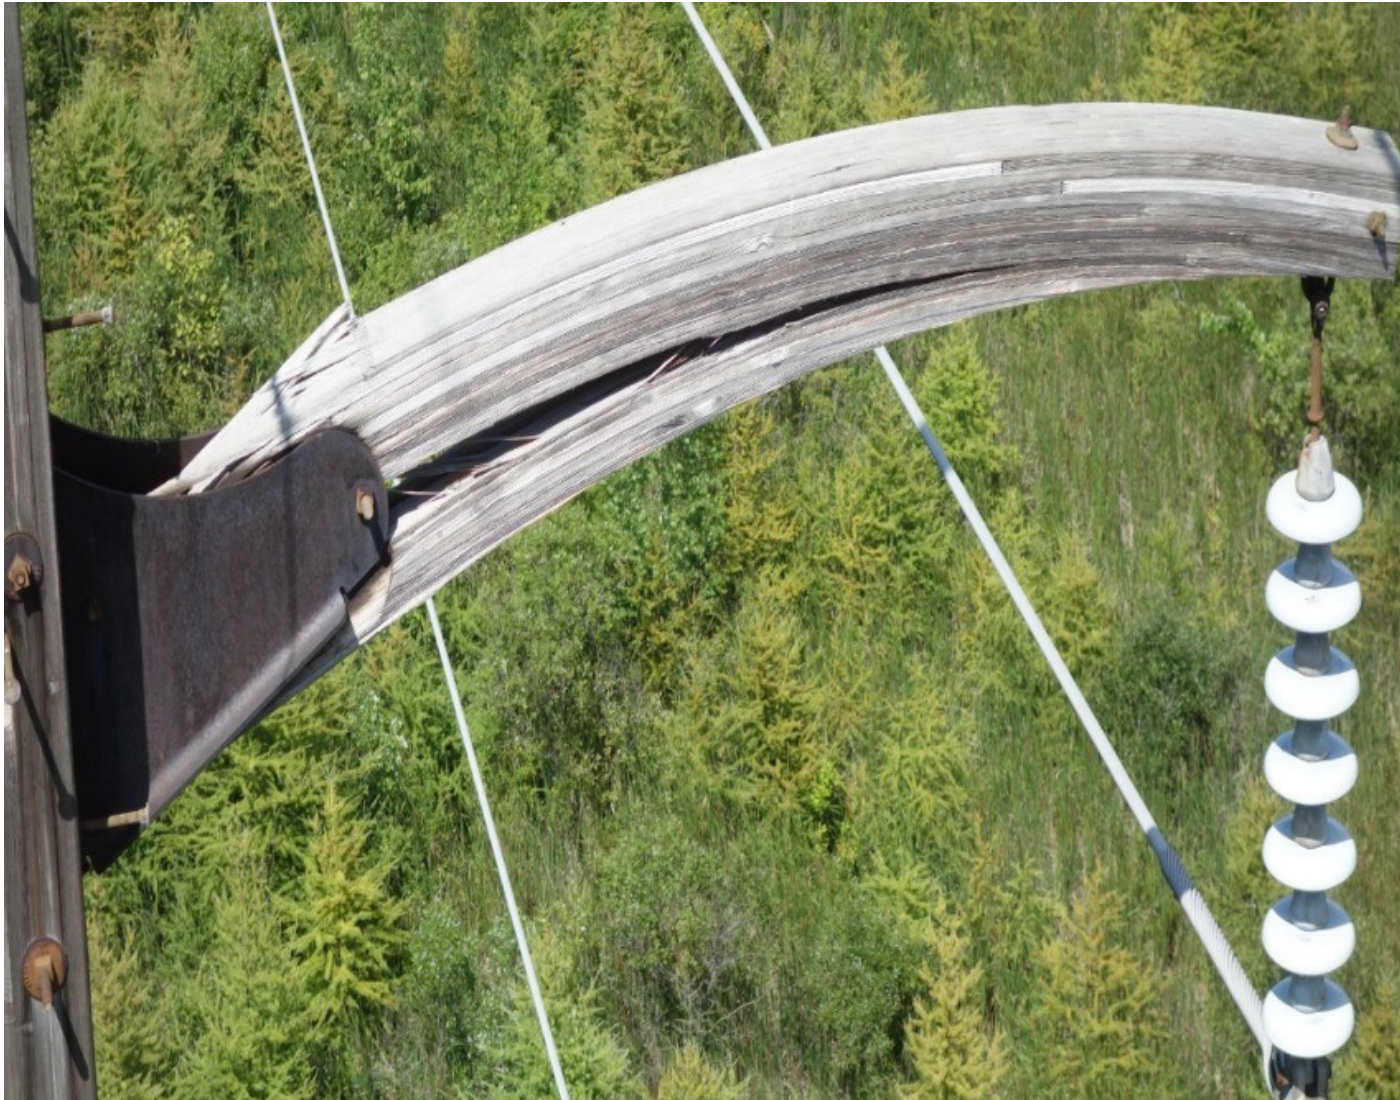
1211/1161 Line “close call” – Sept. 2016

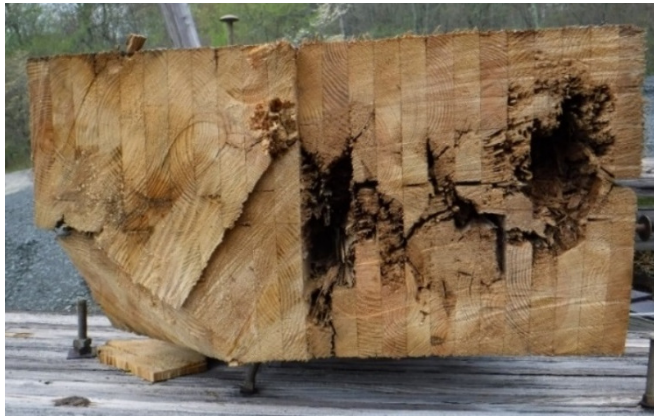
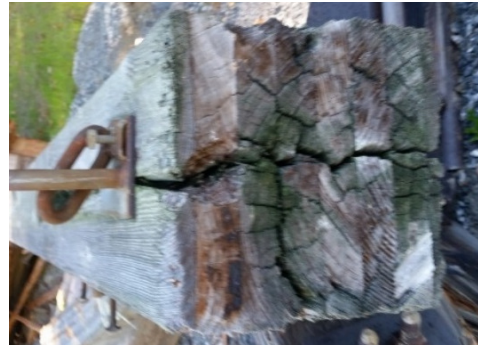
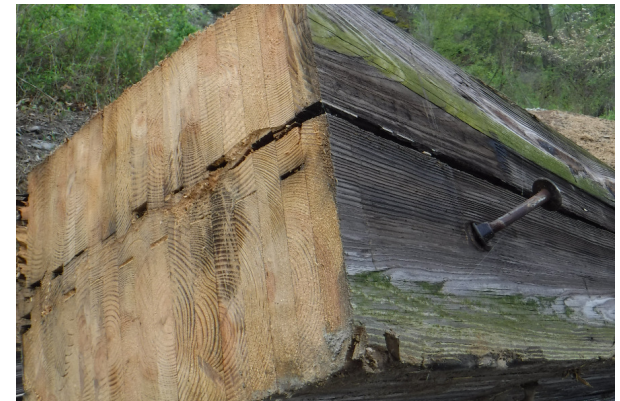
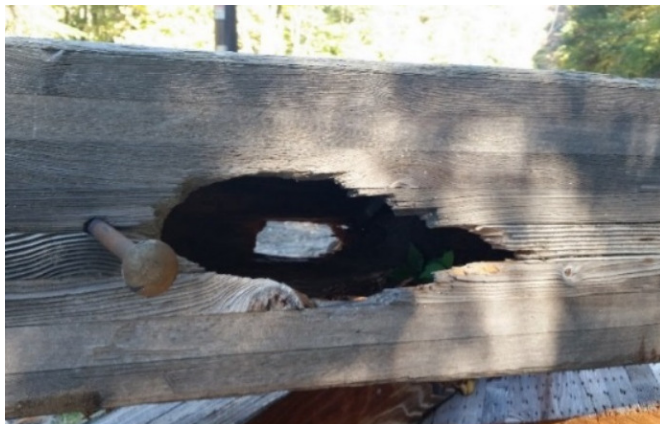
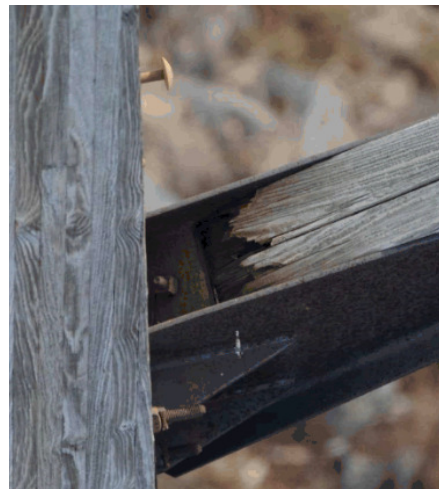
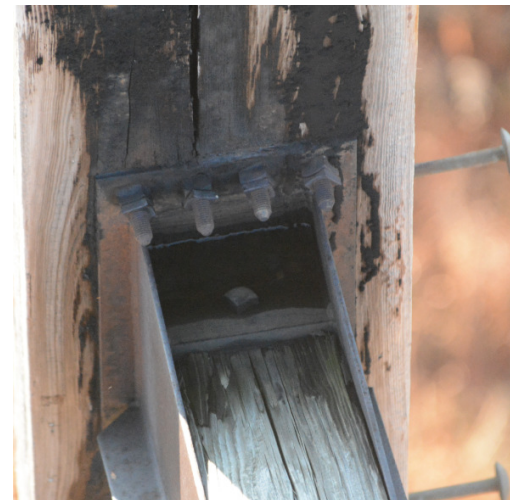
Typical Wood Degradation

(ground line or aerial inspections will miss extent of internal deterioration)

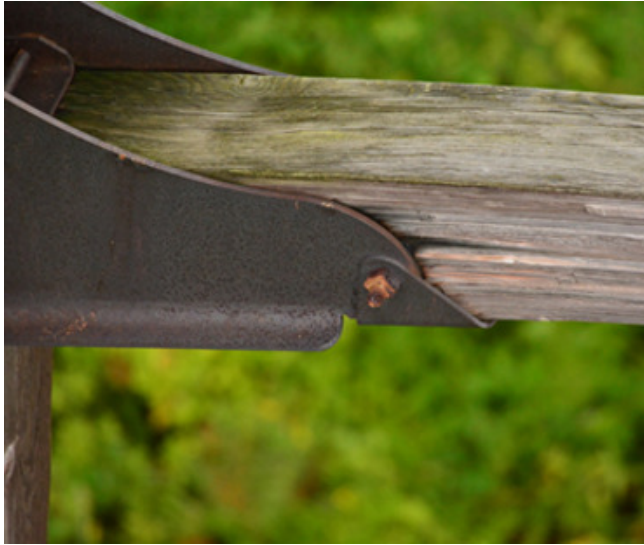
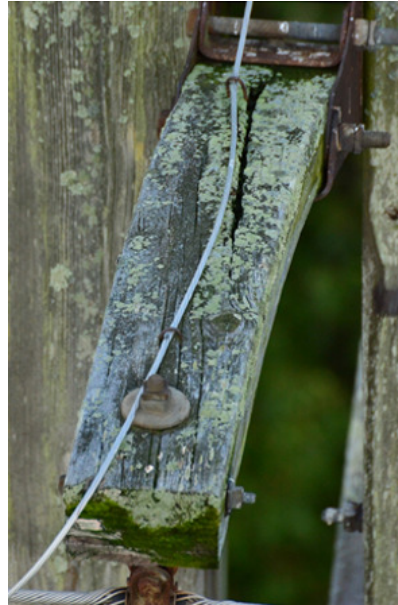
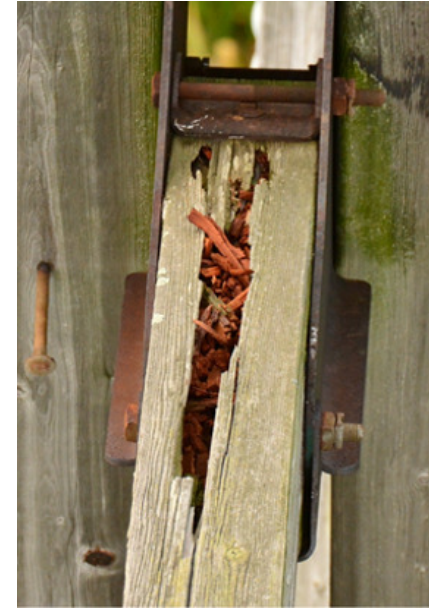
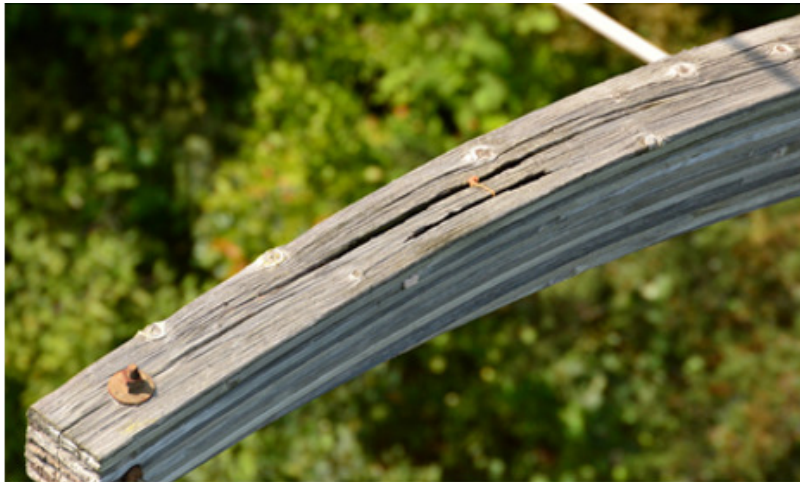
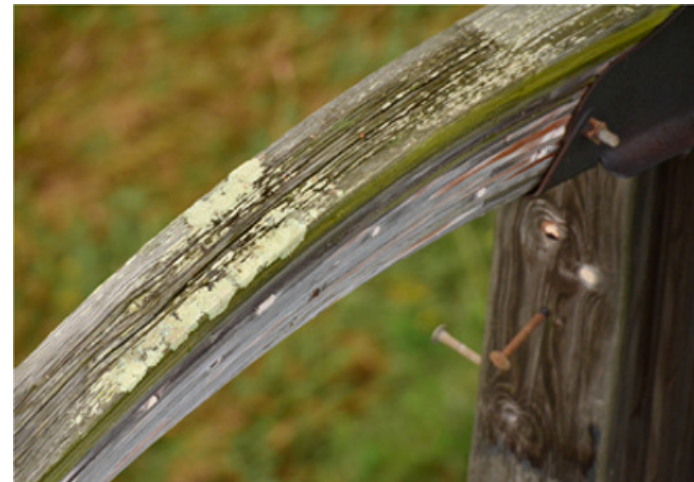
Condition Summary Davit Arm Deterioration

- Replace all wood structures
- Re-use existing conductor and shield wire
- Majority of structures to be replaced with Direct Embedded Engineered Steel Poles and Light Duty Tubular Steel Poles
- Cost = \$52.5 Million

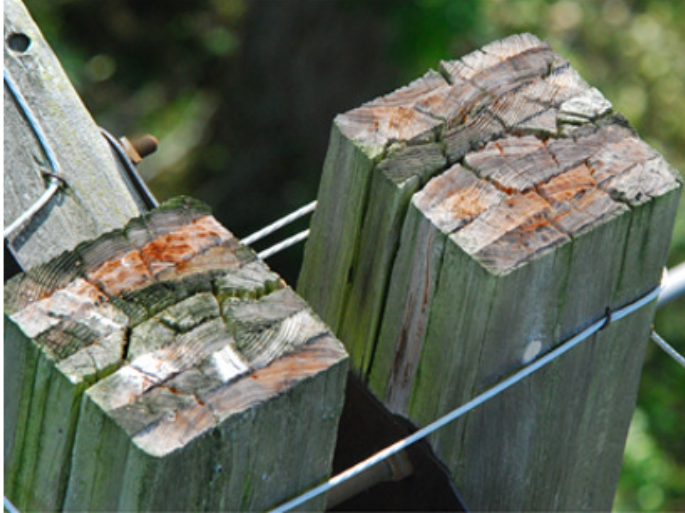
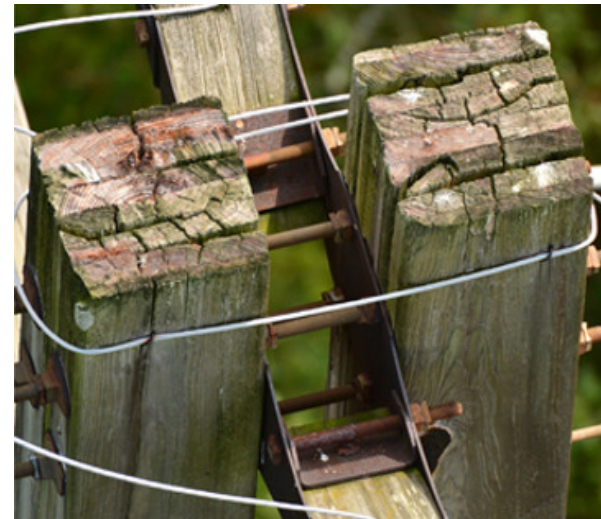
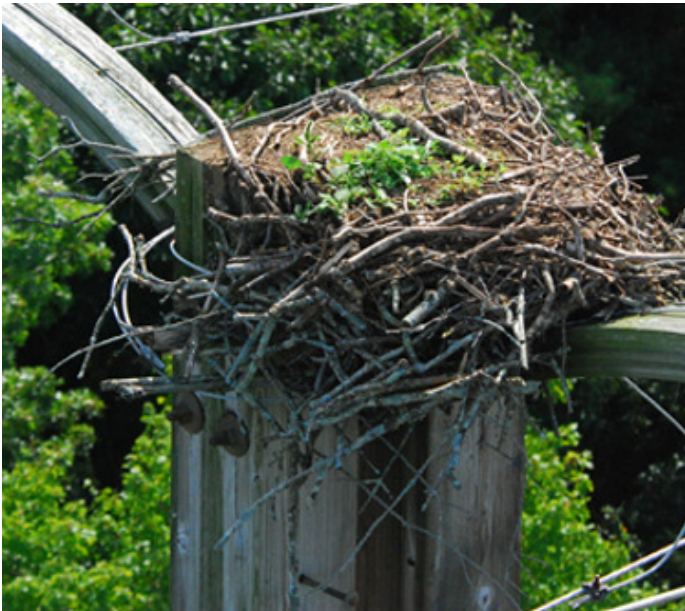
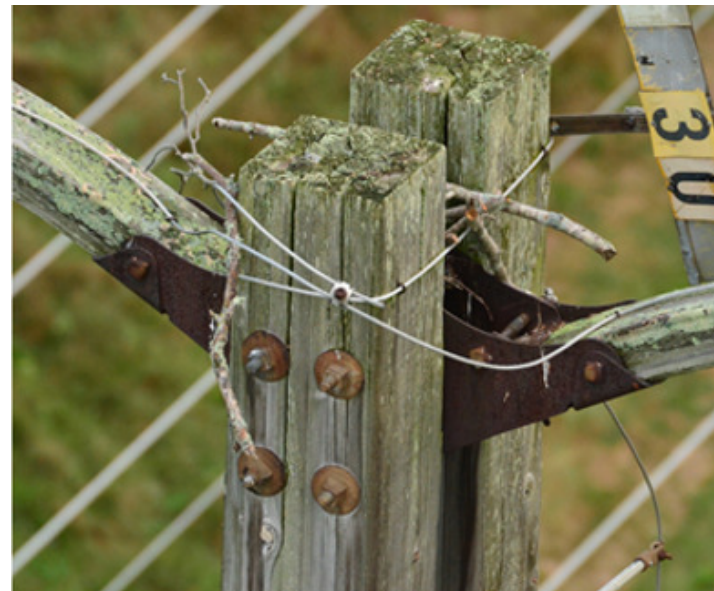
Condition Summary

Pole Deterioration

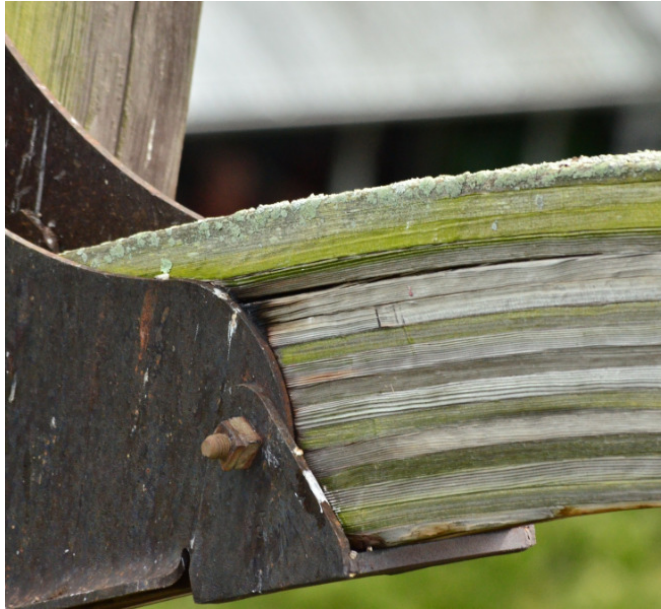
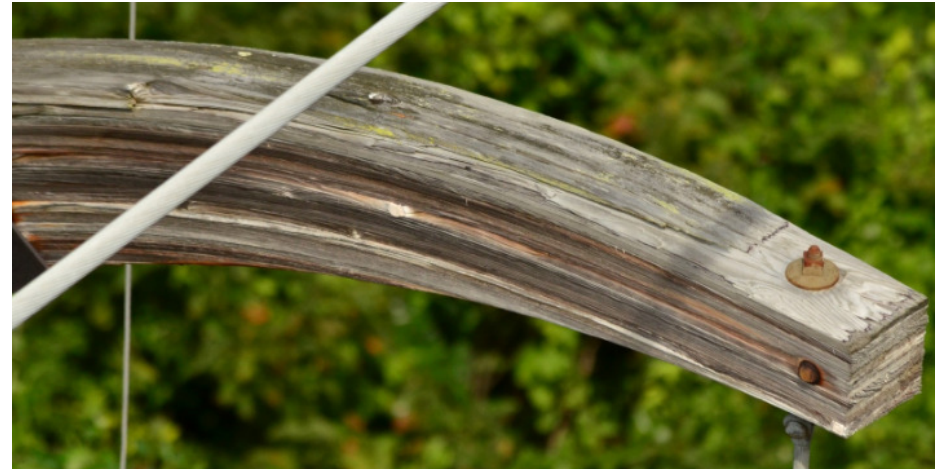
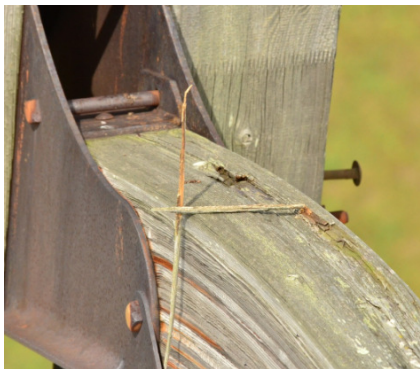
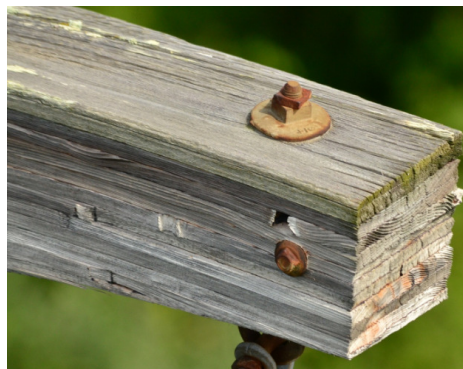
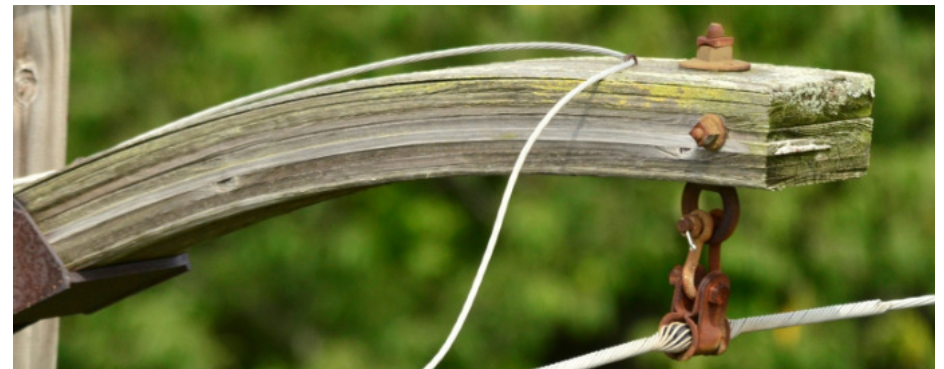
Condition Summary

Davit Arm Deterioration

- Replace all wood structures
- Re-use existing Conductor and Shield Wire/OPGW
- Majority of structures to be replaced with Direct Embedded Engineered Steel Poles and Light Duty Tubular Steel Poles.
- Cost = \$17.8 Million

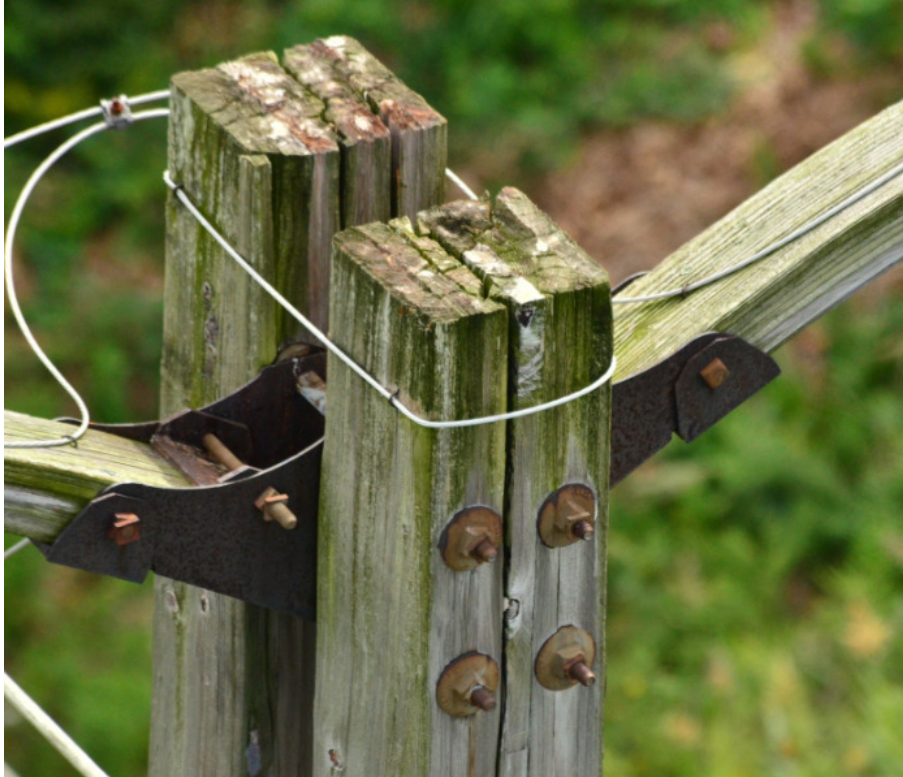
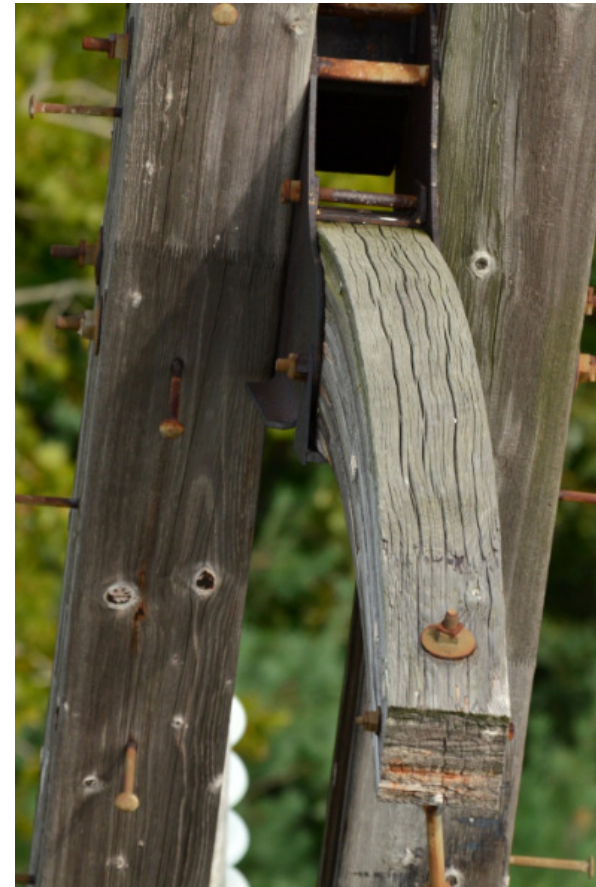
Condition Summary

Pole Deterioration

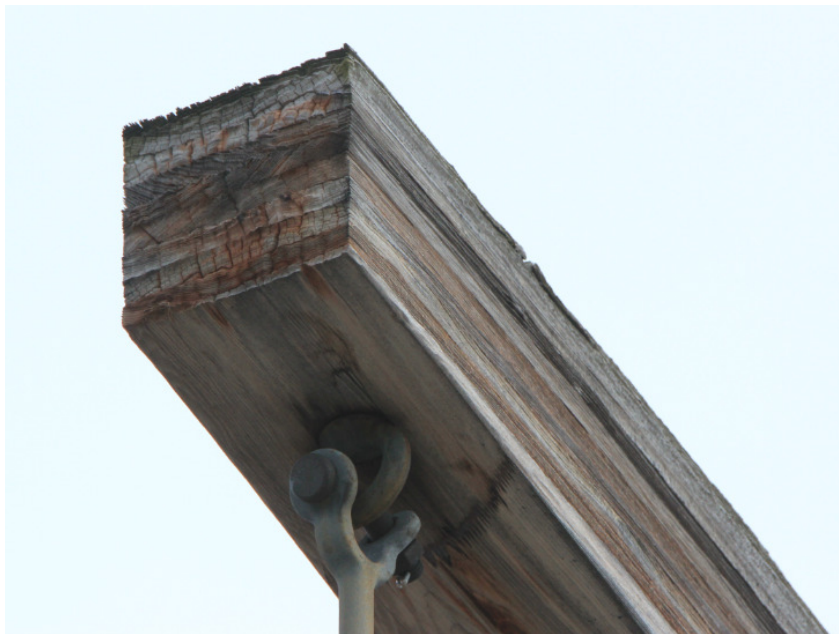
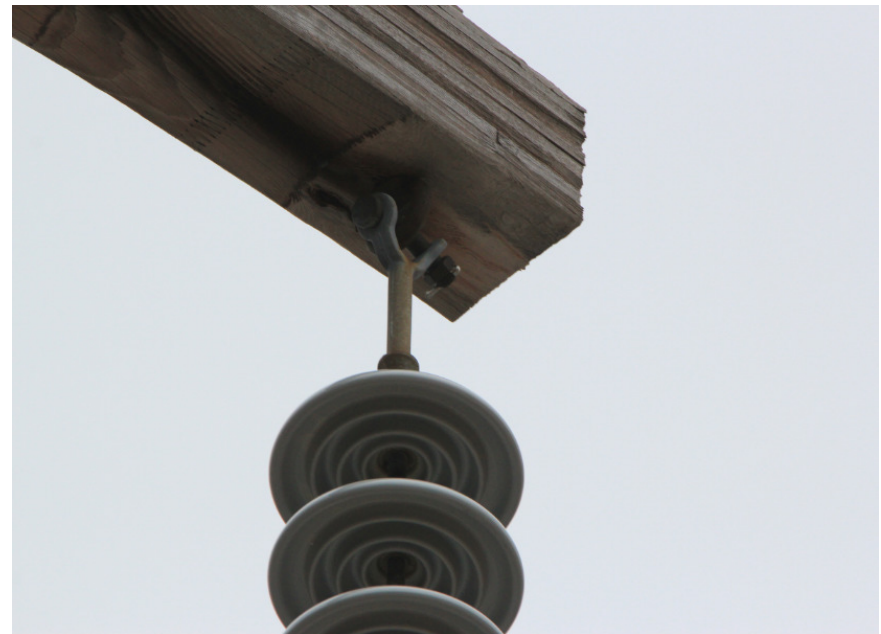
Condition Summary

Davit Arm Deterioration

- Replace all wood structures
- Re-use existing Conductor and Shield Wire
- Majority of structures to be replaced with Direct Embedded Light Duty Tubular Steel Poles.
- Cost = \$10.9 Million

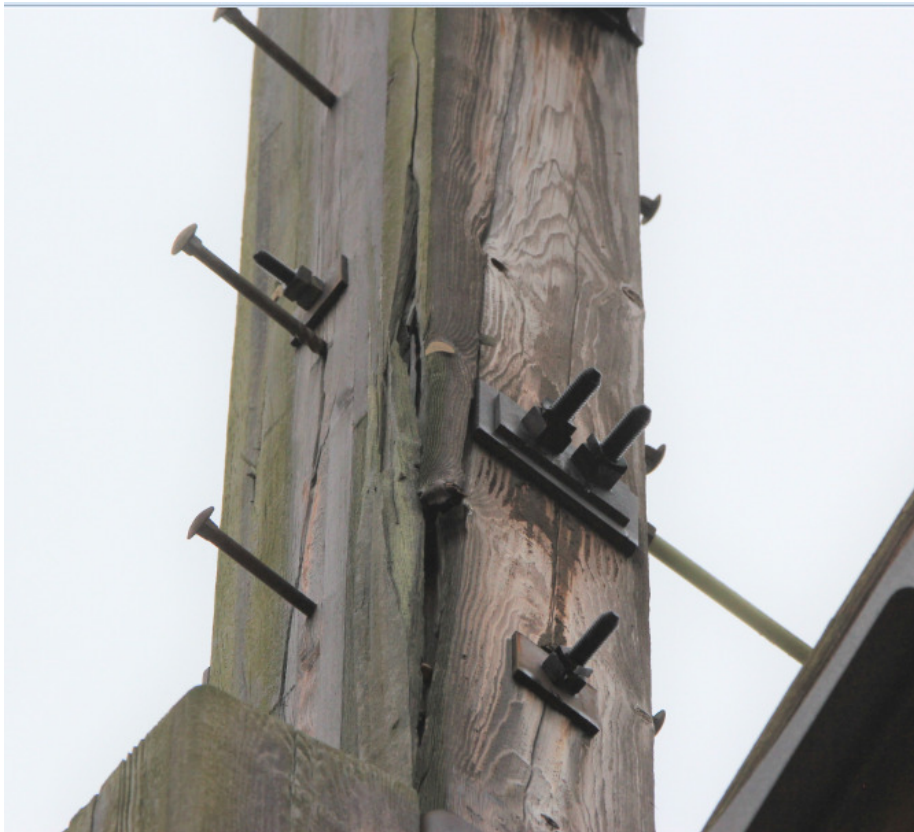
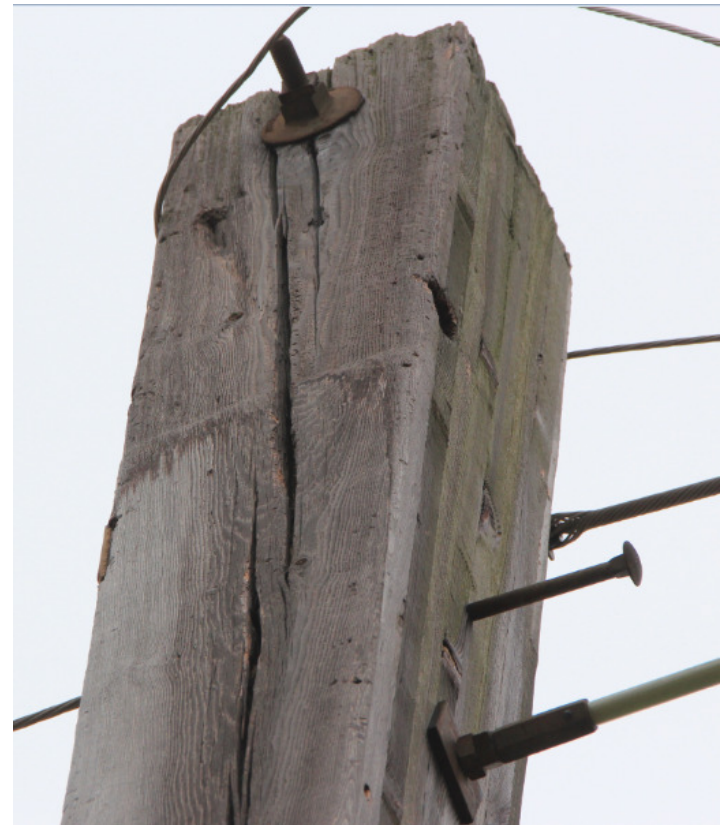
Condition Summary

Pole Deterioration

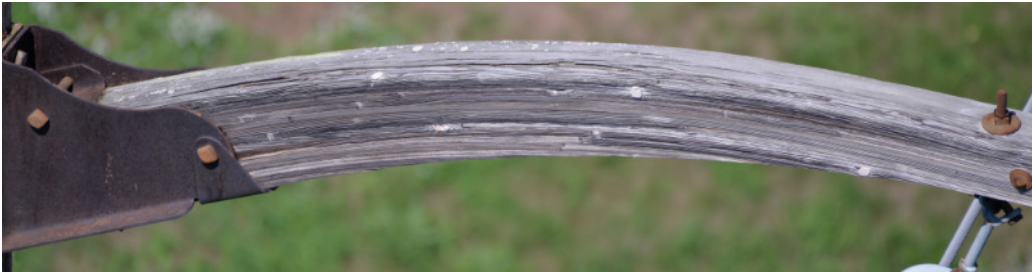
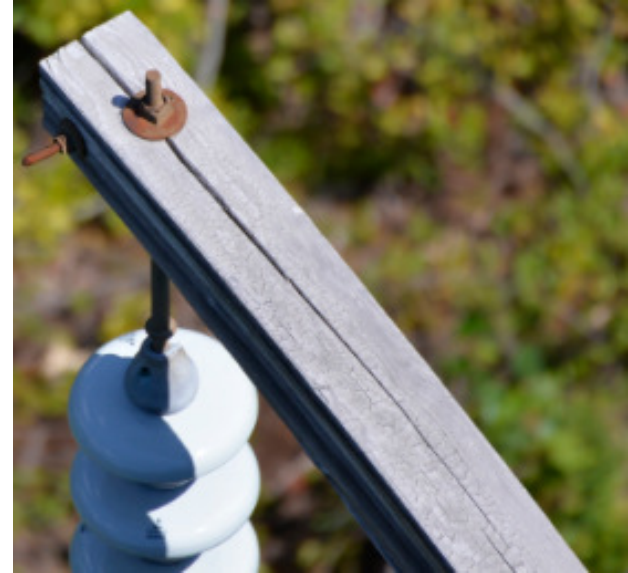
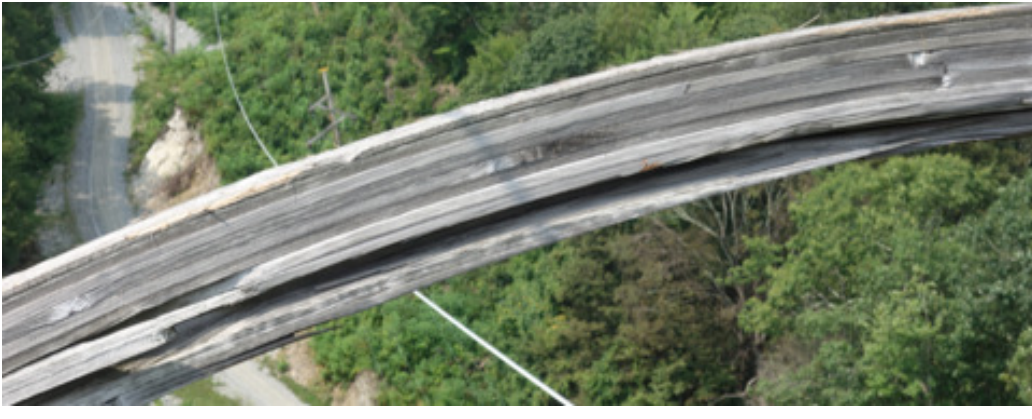
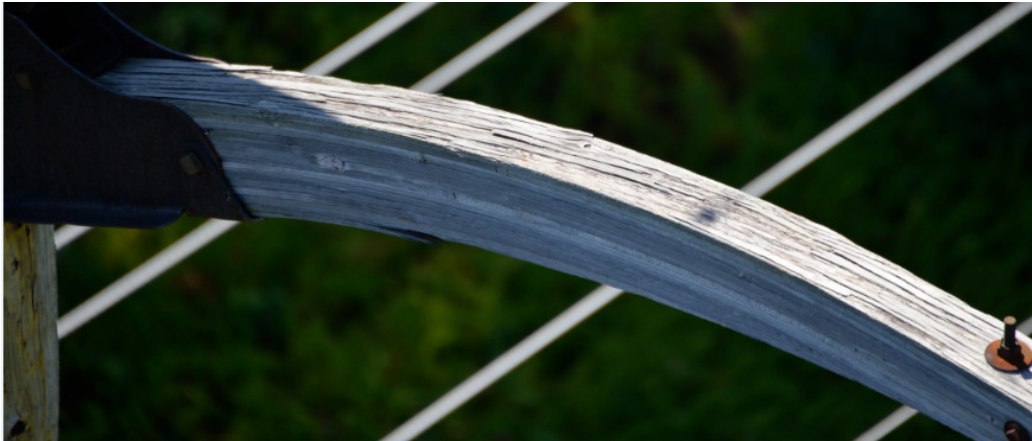
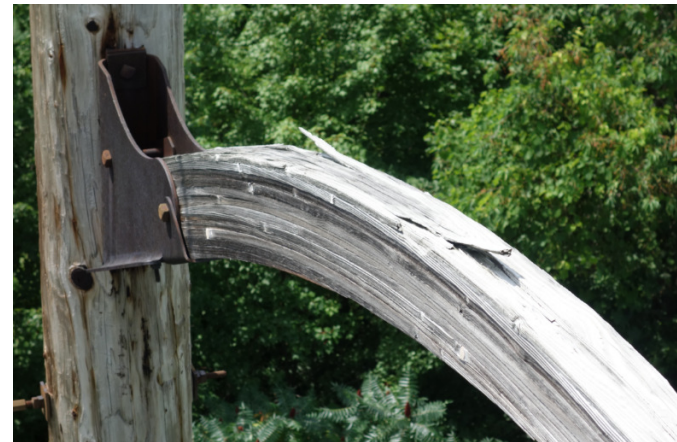
Condition Summary Davit Arm Deterioration

- Replace all wood structures
- Re-use existing Conductor and Shield Wire
- Majority of structures to be replaced with Direct Embedded Light Duty Tubular Steel Poles.
- Cost = \$14.5 Million

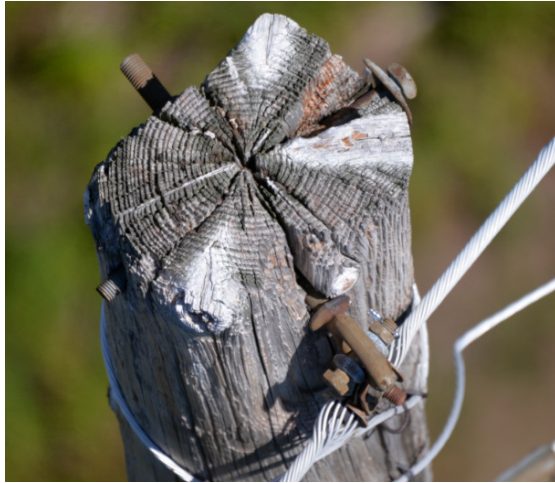
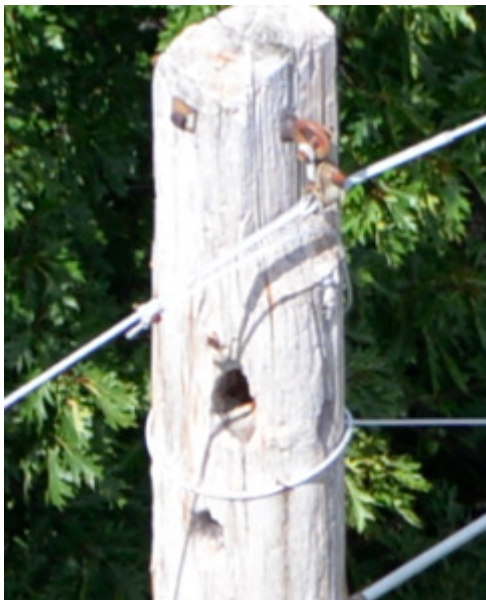
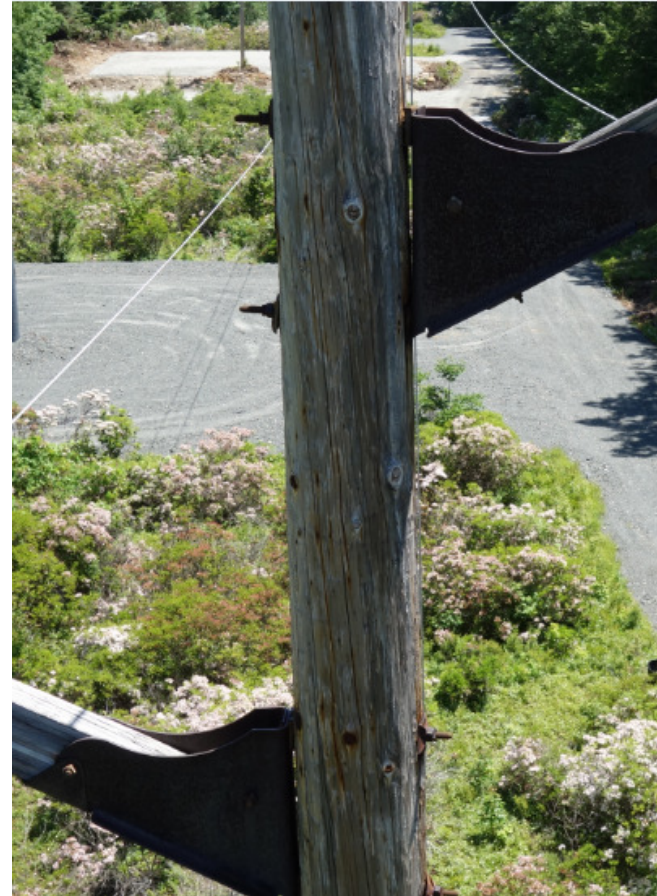
Condition Summary

Pole Deterioration

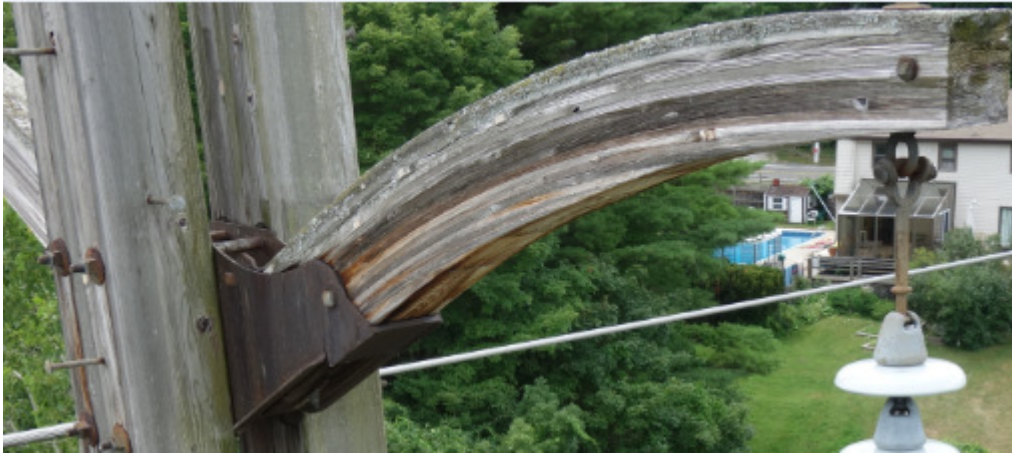
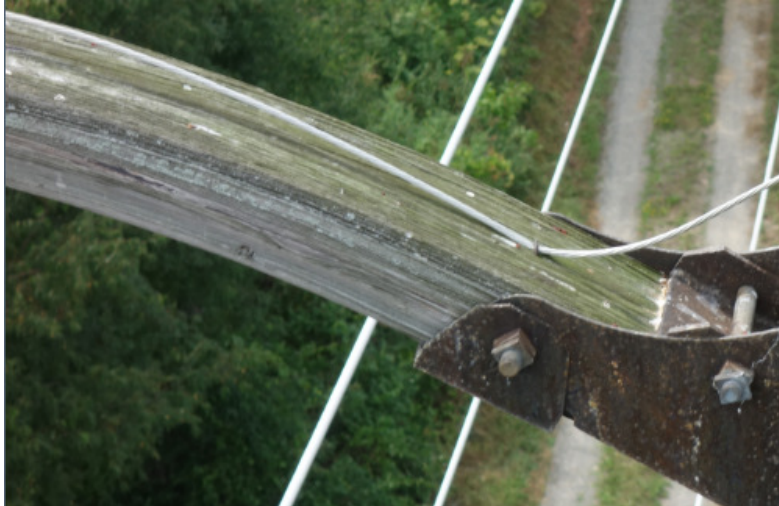
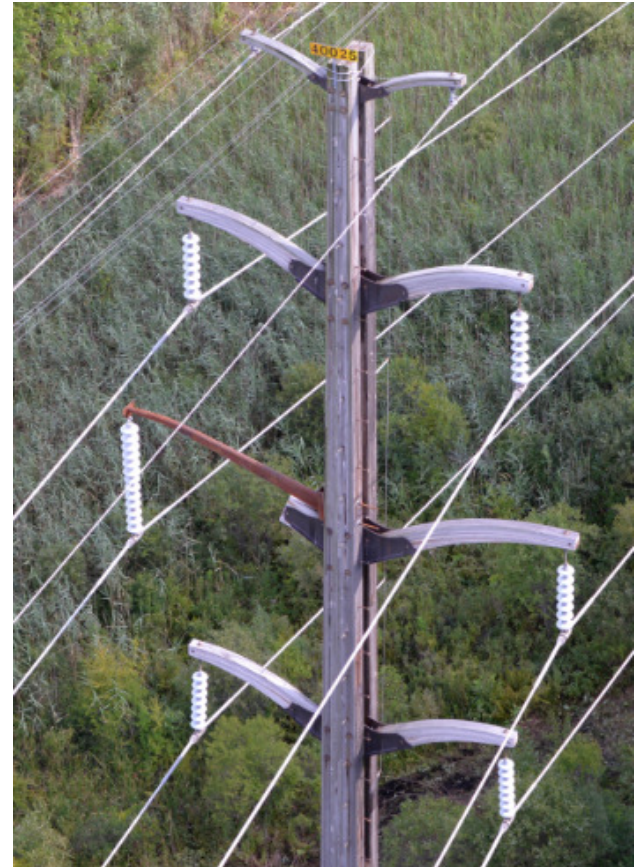
Condition Summary Davit Arm Deterioration

- Replace all wood structures
- Re-use existing Conductor and Shield Wire
- Majority of structures to be replaced with Direct Embedded Engineered Steel Poles and Light Duty Tubular Steel Poles.
- Cost = \$12.5 Million

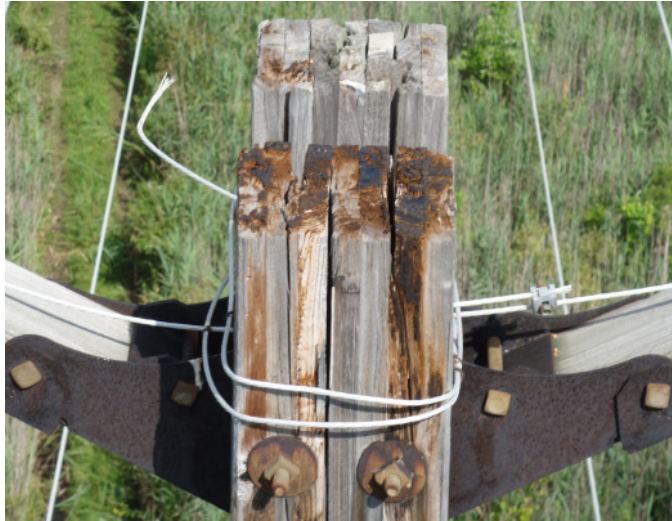
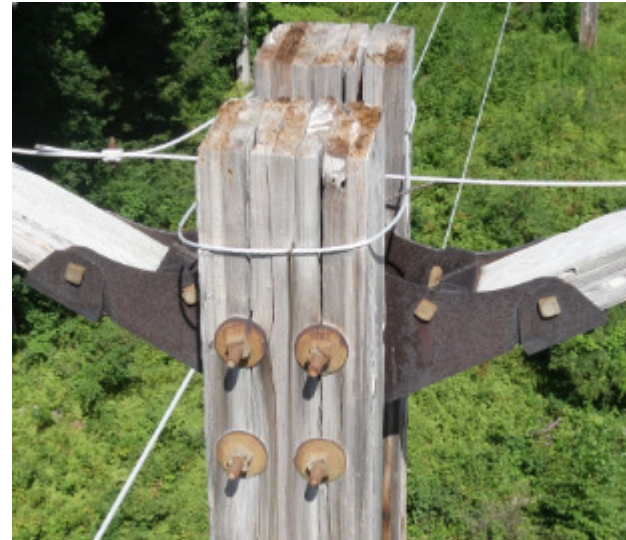
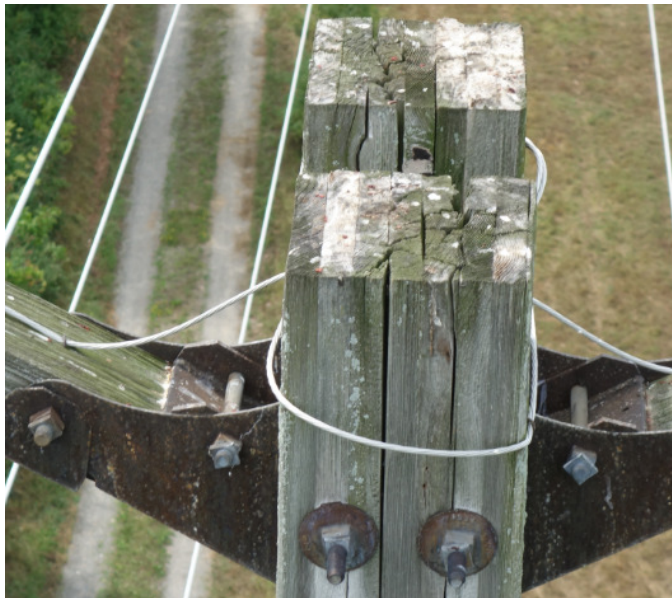
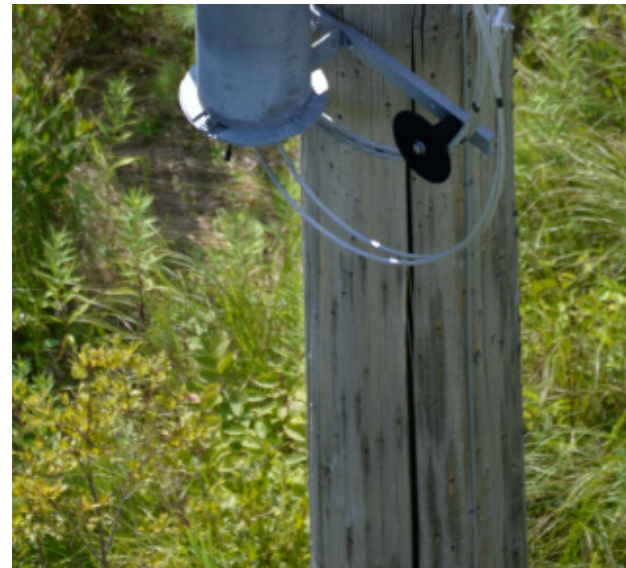
Condition Summary

Pole Deterioration
