Eversource Laminated Wood Structure Replacement Program Phase II – Revision 1

Planning Advisory Committee Meeting

October 20th, 2021

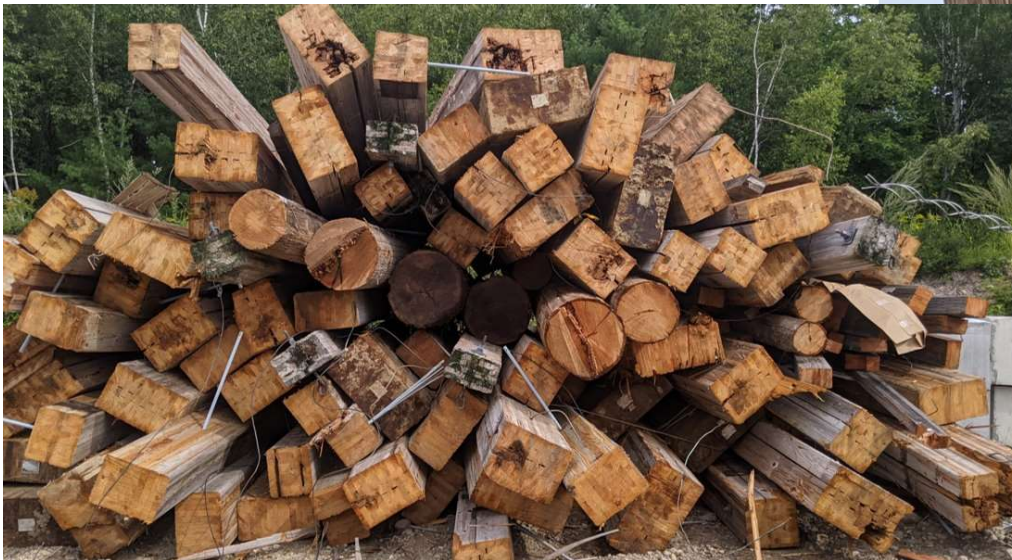
Above: G128 Line –
Slide Cracking, Rot and Insect Damage

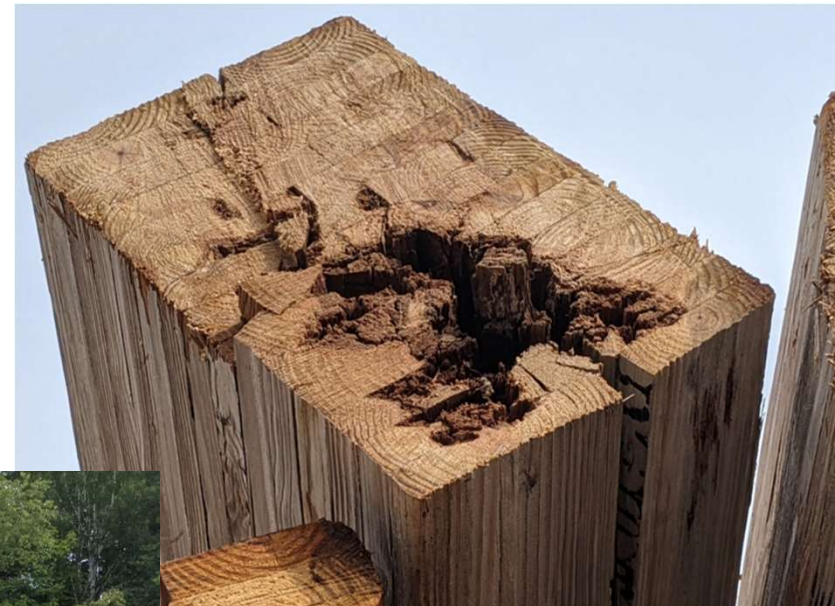
Left: G128 Line –
Highly Degraded Laminated Wood
Structures with Cracks, Internal Rot, and
Insect Damage

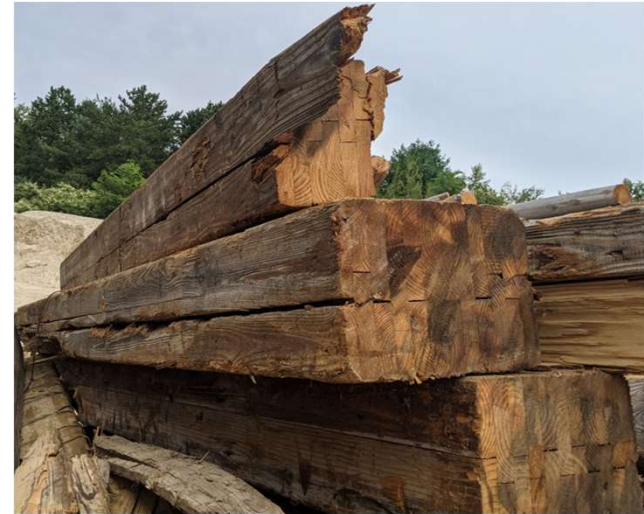
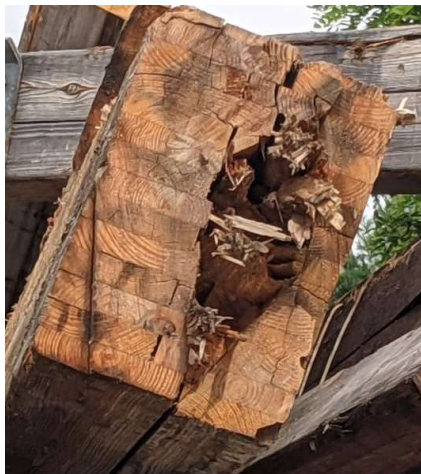
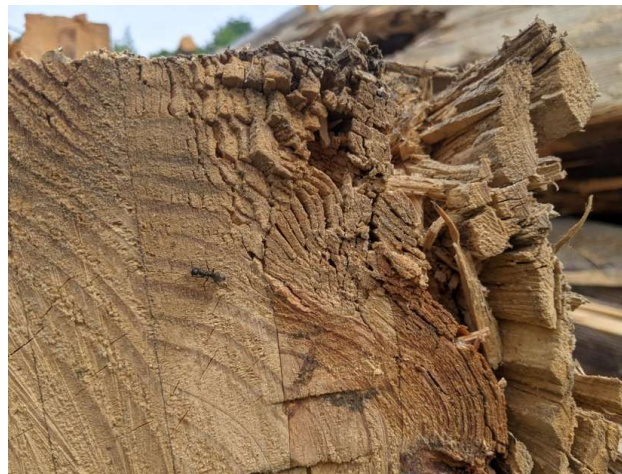
L175 Line –
Degraded Laminated Wood
Structures, Internal Rot, Side
Cracking, Insect Damage

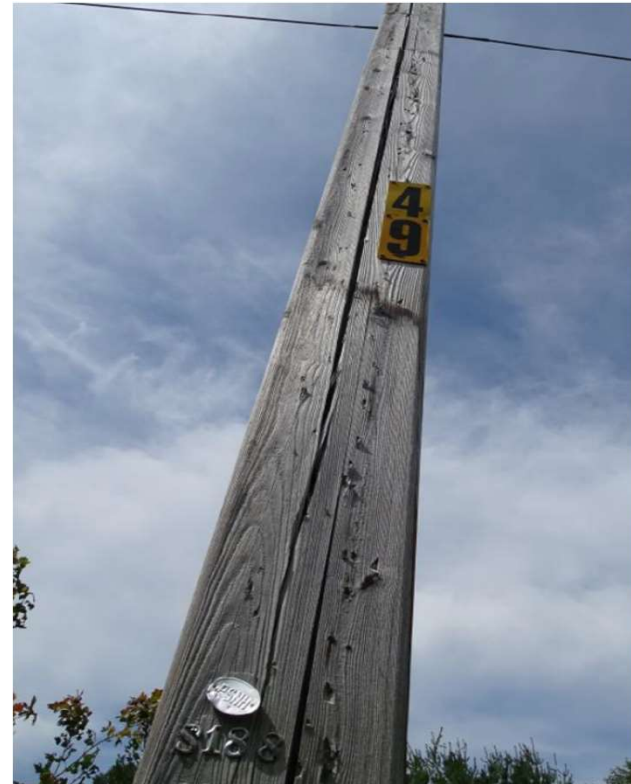
- Side cracking or top rot on the poles may be indicative of far worse damage inside the structures as indicated by the cross-sections of the dismantled L175 and G128 structures
- Laminate wood structures across Eversource's footprint are beginning to show signs of cracking and degradation at the tops of poles (more photos of LWS inspections in Appendix I)

Side Crack –
S188 Line, Structure #49

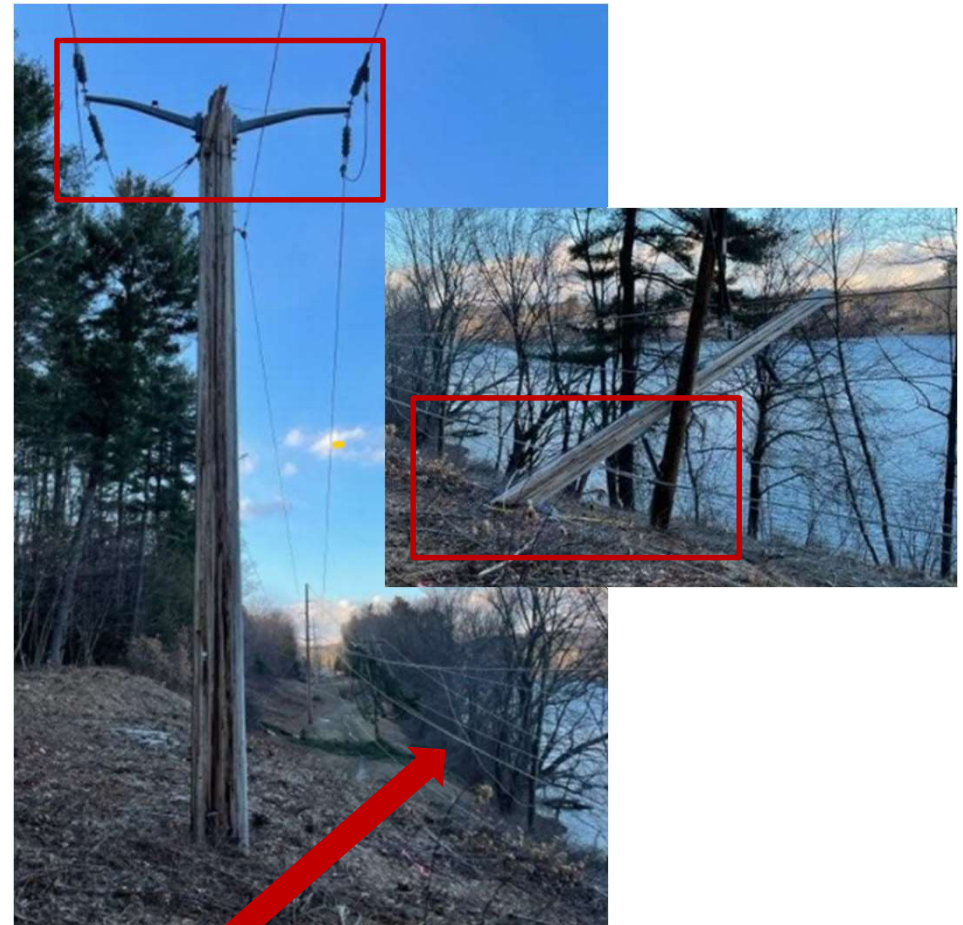
- In March of 2021, the V191 experienced a laminate wood structure failure
- The laminate structure snapped due to an internal failure above the distribution line connection on the pole
- The red boxes indicate where the structure was severed
- The structure showed only minor external signs of damage, but inside had degraded to the point of failure

V191 Line Structure 47 –
115-kV Wires on the Ground due to
Laminated Wood Structure Failure

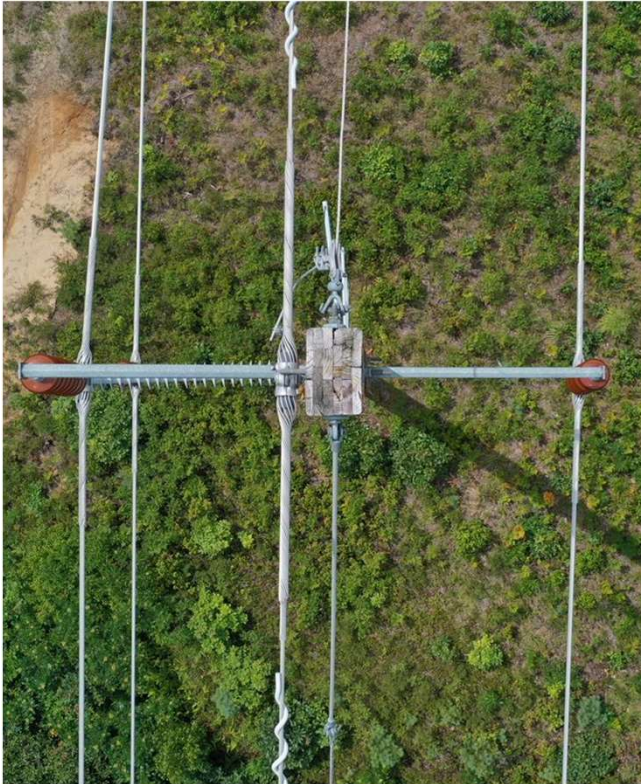
Pole Top Cracking –
A152 Line, Structure #46

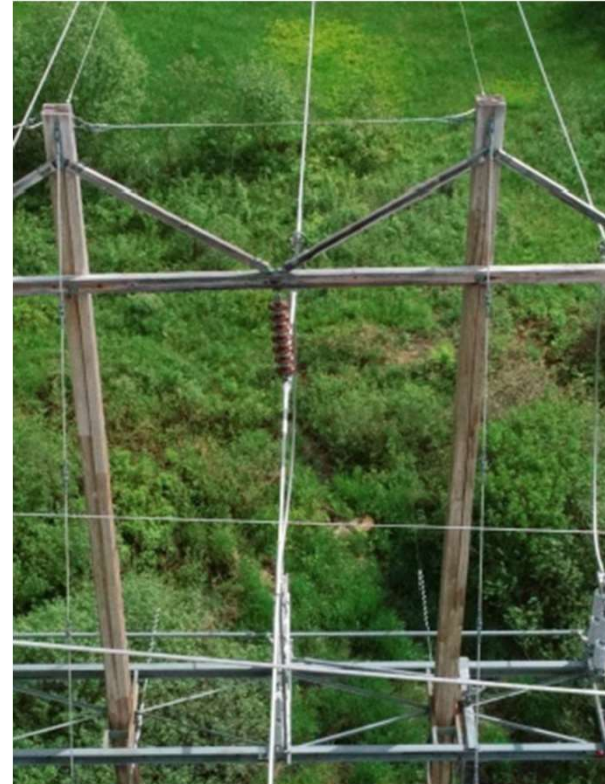
Cracking Laminate Structure –
A152 Line, Structure #70

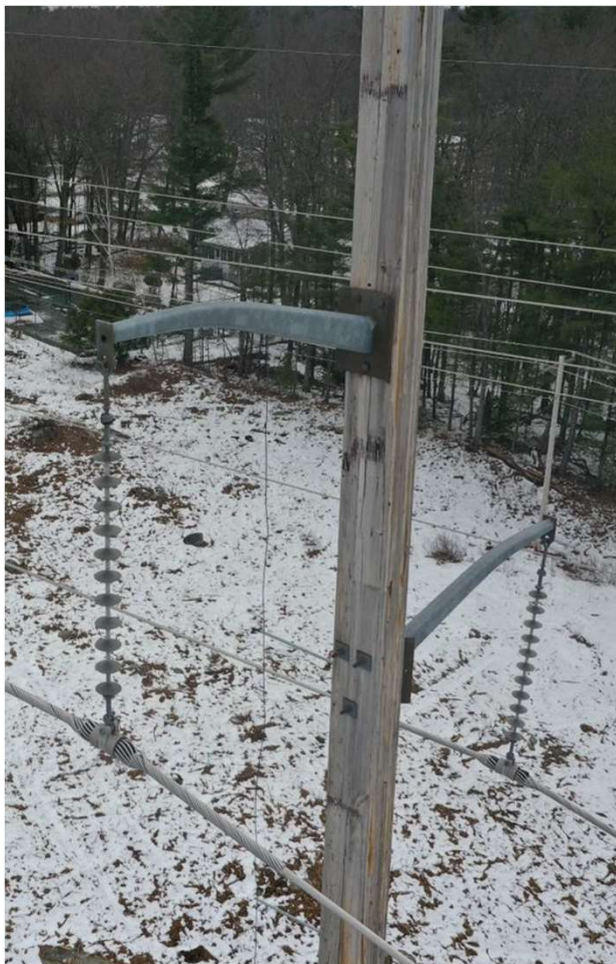
Side Cracks –
R187 Line, Structure #21

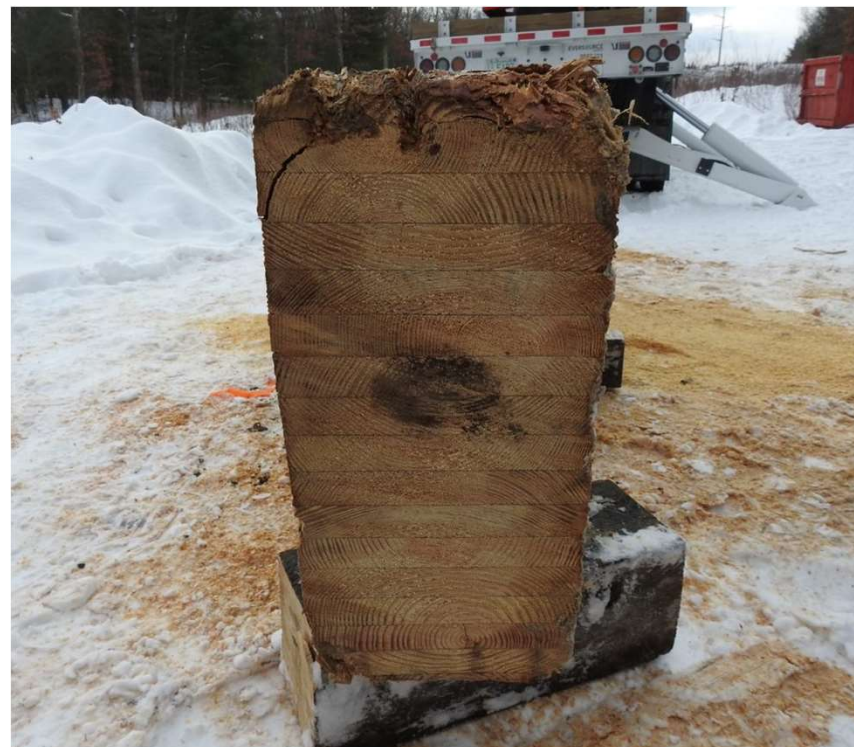
Rotting Cross Section –
R187 Line, Structure #7

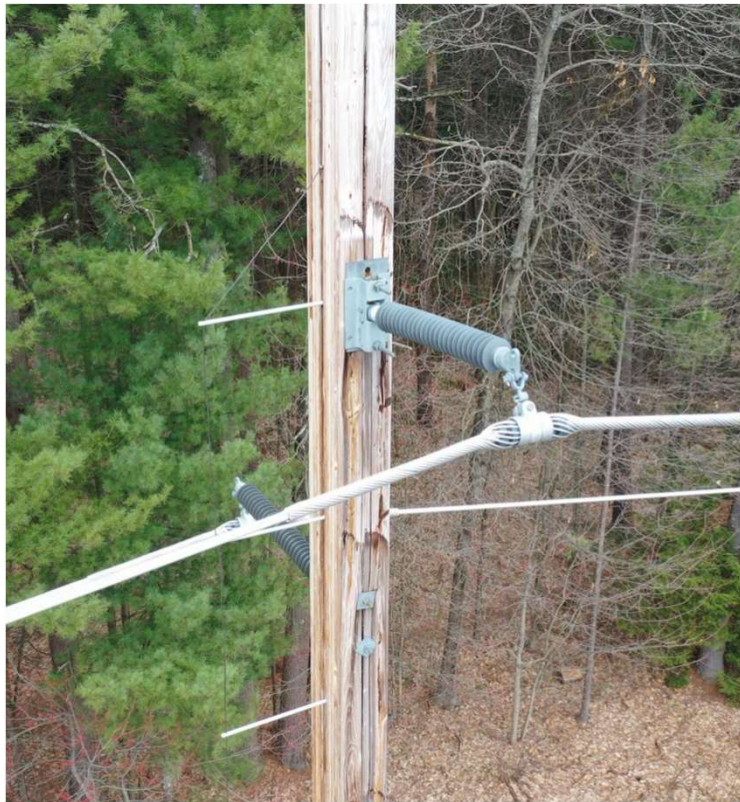
Cracking Laminate Structure –
V191 Line, Structure #47

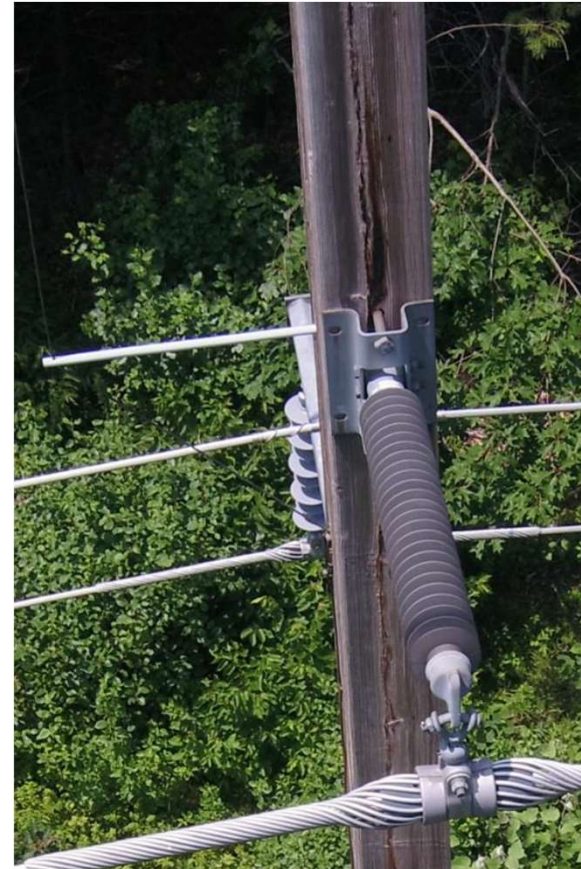
Side Crack –
V191 Line, Structure #13

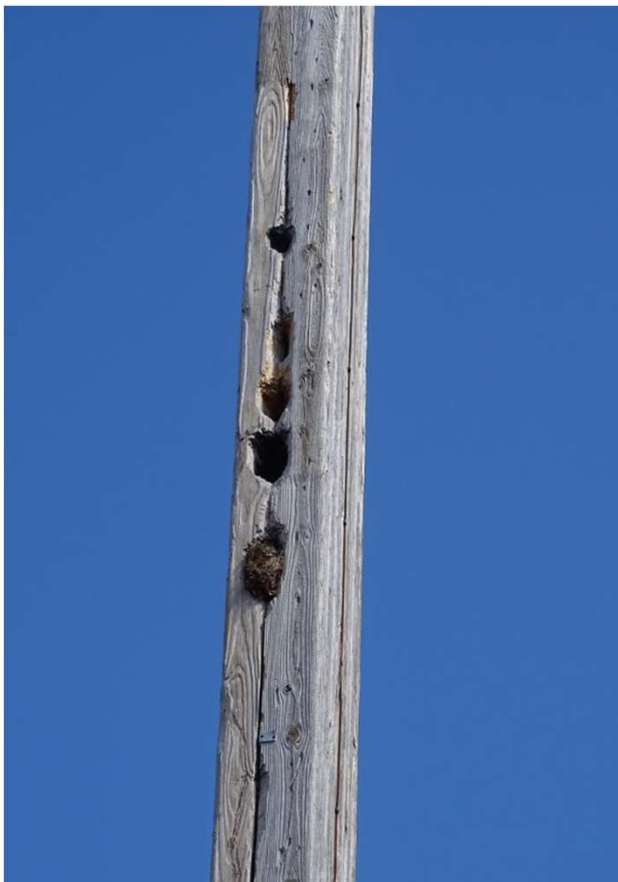
Woodpecker Damage and Cracking –
S188 Line, Structure #52

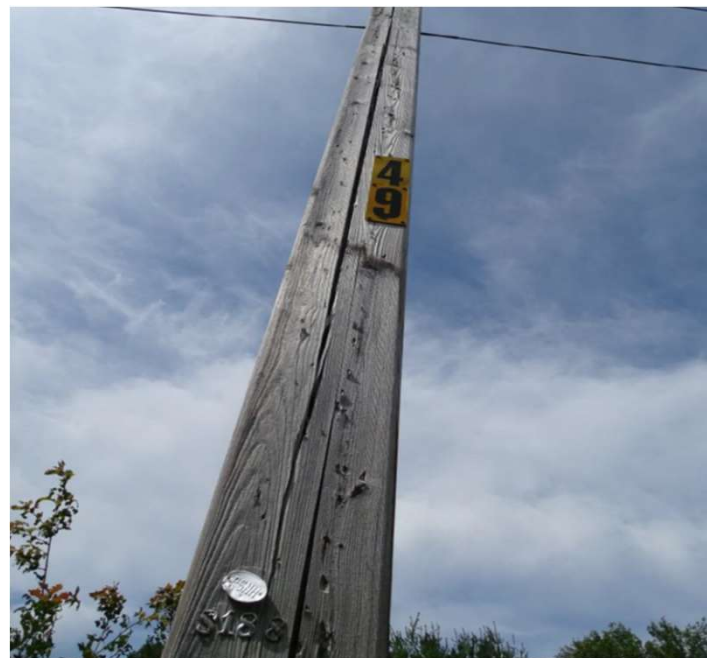
Side Crack –
S188 Line, Structure #49

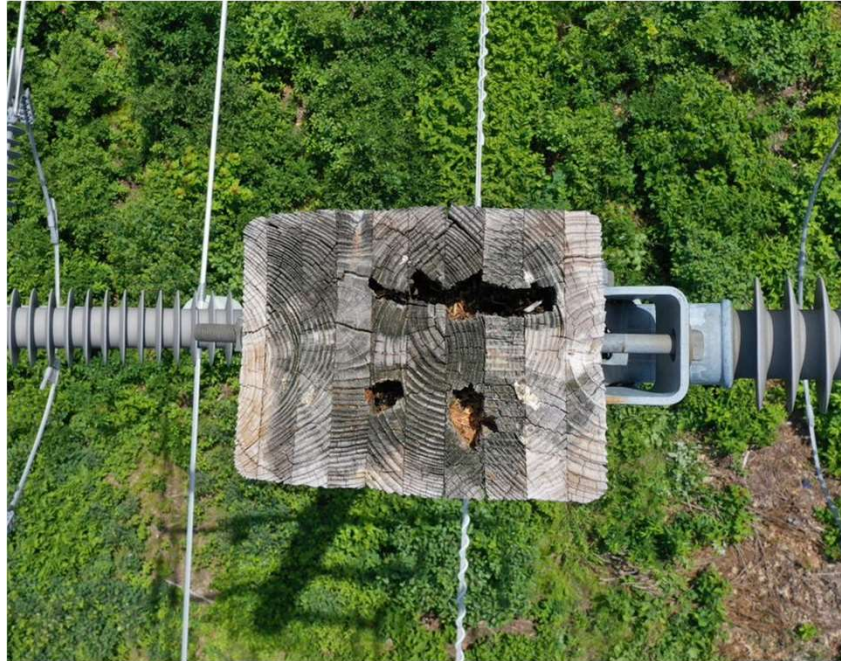
Pole Top Rot –
M164 Line, Structure #26
