345-kV 354 Line Structure Replacements

Planning Advisory Committee Meeting

June 21, 2017

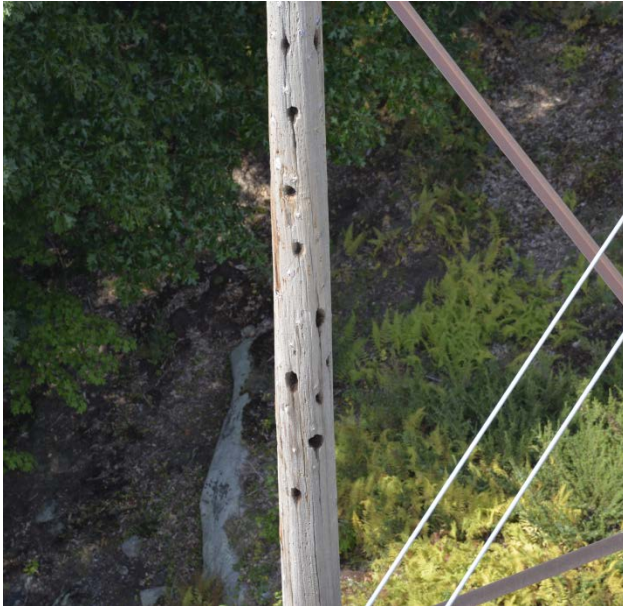
**Structure 34005: Woodpecker
Damage**

- Remove 45 Single Circuit H-Frame wood structures and replace with light duty weathering steel H-frames.
- Remove three dead end corner wood structures and replace with light duty weathering steel poles.
- Remove two running angle wood structures and replace with light duty weathering steel poles.
- Install new hardware and insulators.

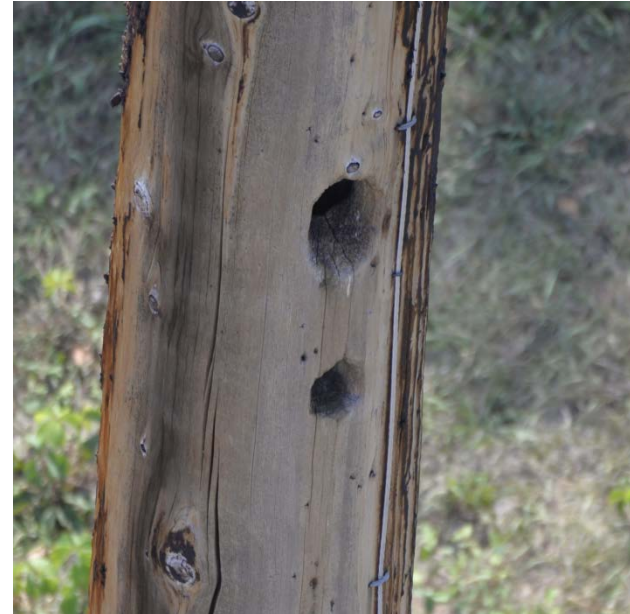
**Structure 34209: Woodpecker
Damage (medium)**

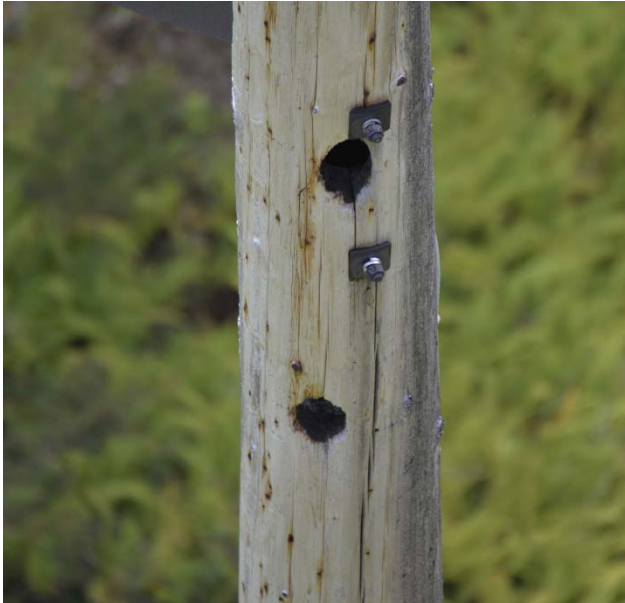
**Structure 34038: Woodpecker
Damage (heavy)**

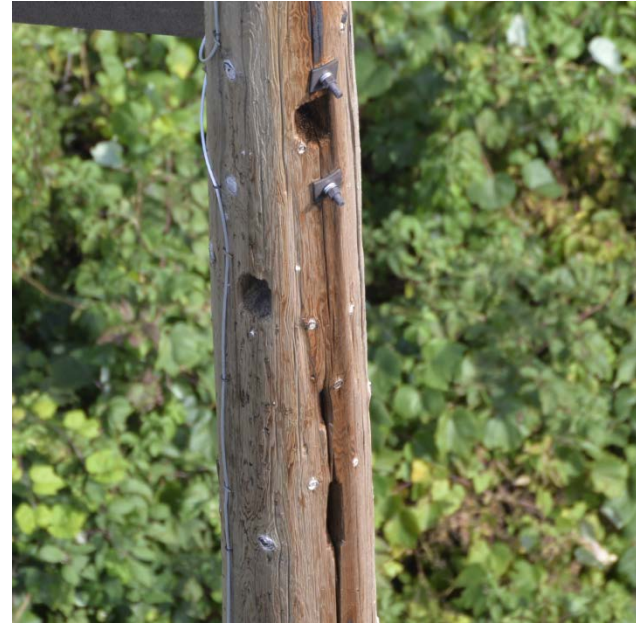
**Structure 34156: Woodpecker
Damage**

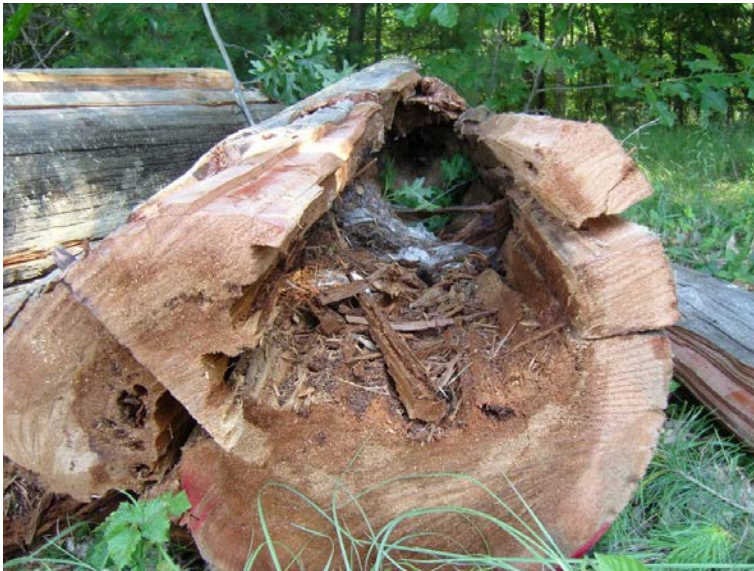
Degree of Woodpecker Damage (this is not a 354 Line structure)

Pictures illustrating the amount of damage woodpeckers can do.

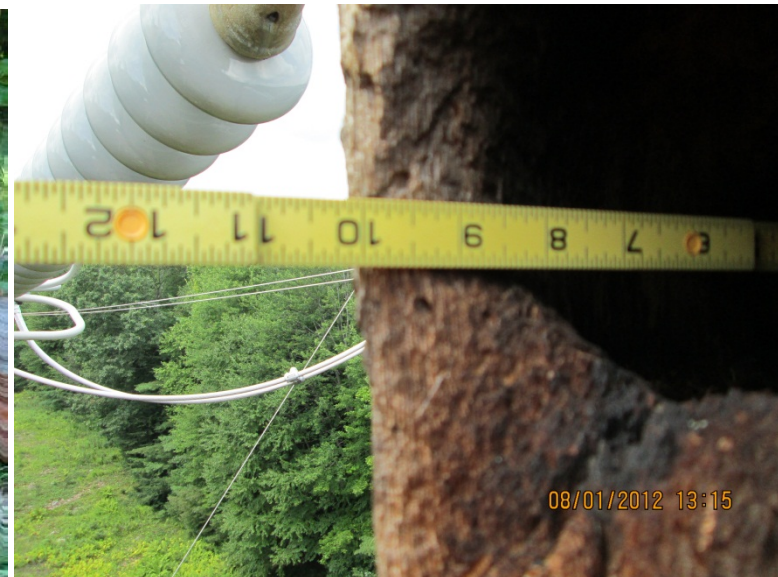
Depth of Woodpecker Damage
