Eversource NH 115-kV Laminated Wood Structure Replacement Program Phase I

Reliability Committee Meeting
February 15th, 2022

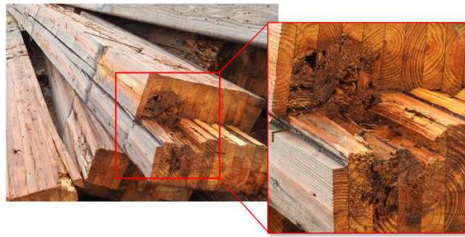
Sample Laminated Structure Base –
Sawdust from Insect Damage –
G128 Line

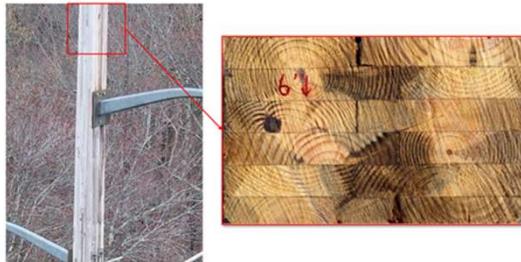
Comparison of 2019 Visual Inspection (Left)
and 2020 Cross-Section Photos Showing
Internal Splitting (Right)
G128 Line, Structure #75

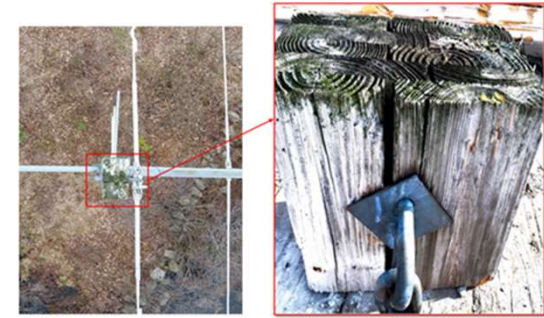
Comparison of 2019 Visual Inspection (Left)
and 2020 Cross-Section Photos (Right) –
G128 Line, Structure #76

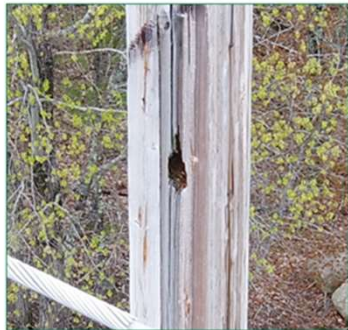
Woodpecker Damage –
G128 Line, Structure #57

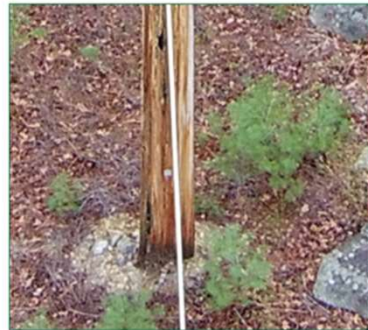
Woodpecker Damage –
G128 Line, Structure #63

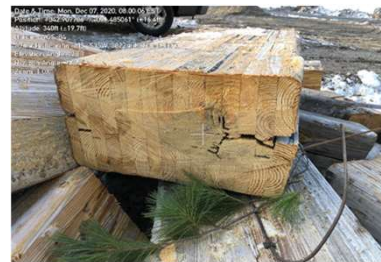
Rot and Splitting at Joints –
K105 Line, Structure #32

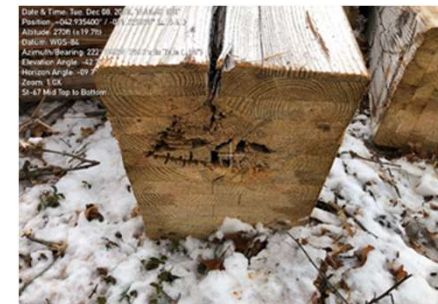
Extensive Rot –
K105 Line, Structure #67

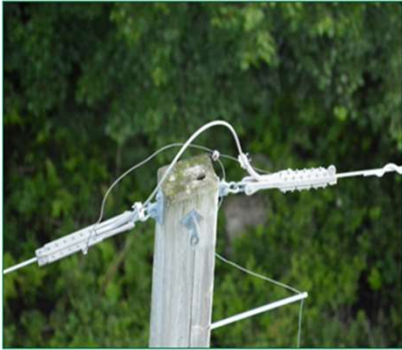
Rotten Pole Top –
K105 Line, Structure #20

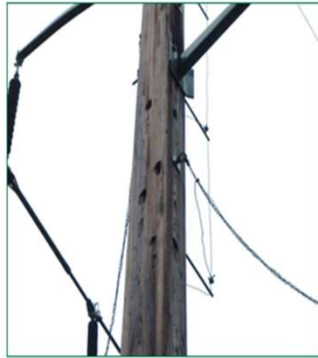
Woodpecker Damage –
K105 Line, Structure #54

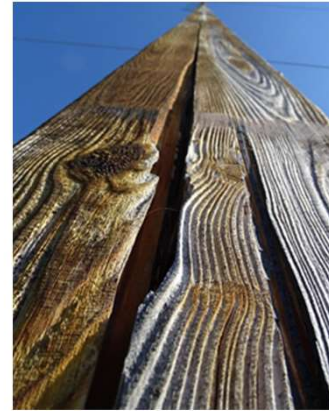
Side Crack –
L175 Line, Structure #122

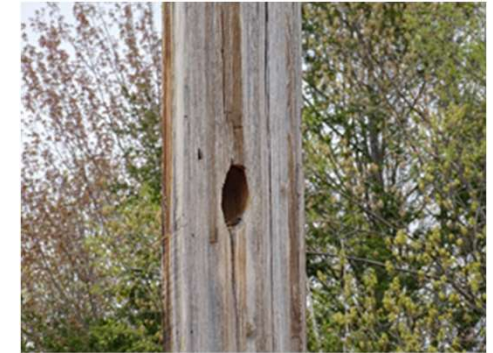
Crack Through Woodpecker Hole –
L175 Line, Structure #139

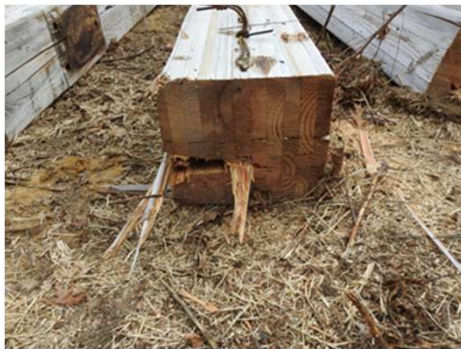
Large Crack –
X116 Line, Structure #133

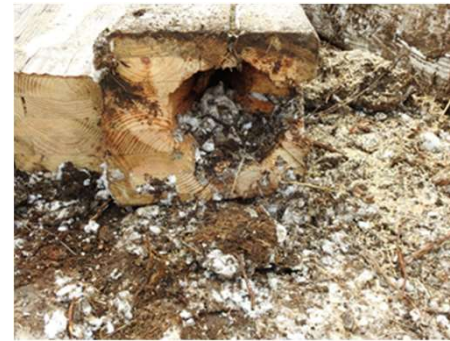
Extensive Rot –
Z119 Line, Structure #137
