# **Eversource 345-kV Structure Replacement Projects (2021-2022)**

Reliability Committee Meeting

December 14<sup>th</sup>, 2021

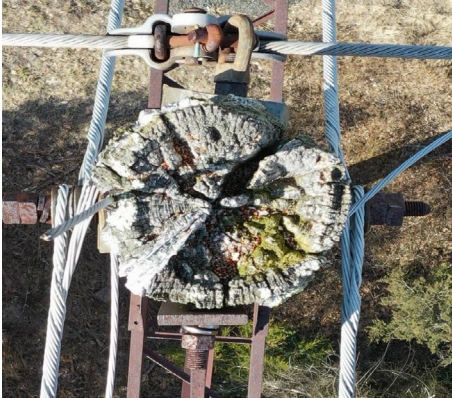
387  
Pole Top Rot

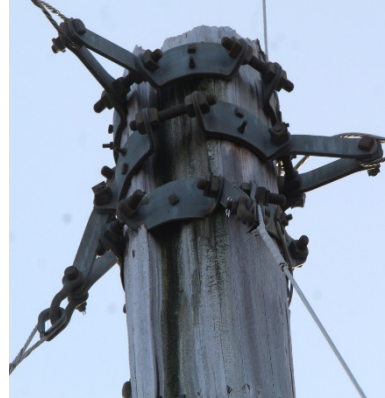
310  
Pole Splits

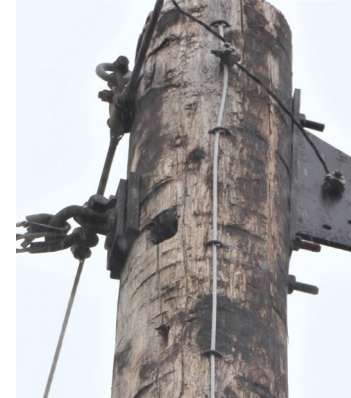
3041  
Woodpecker Damage

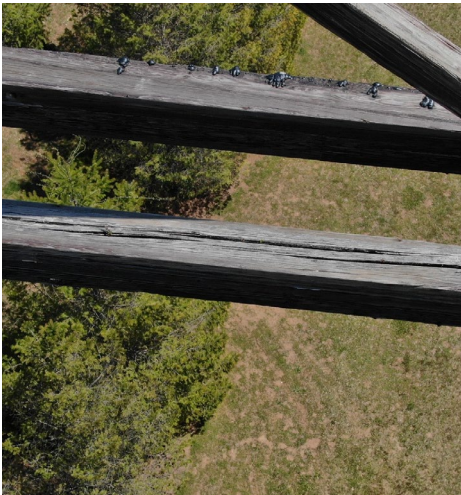
3754  
Cross Arm Damage

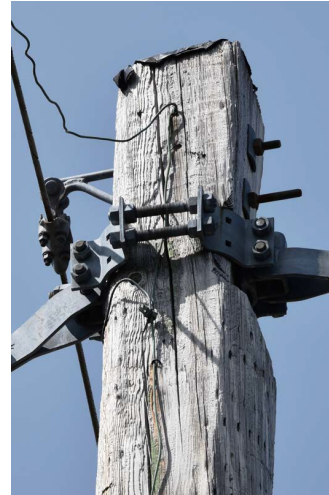
319  
Pole Splits

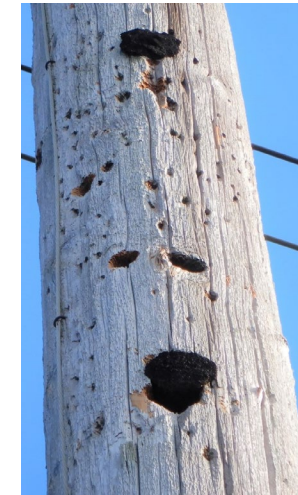
387  
Woodpecker Damage

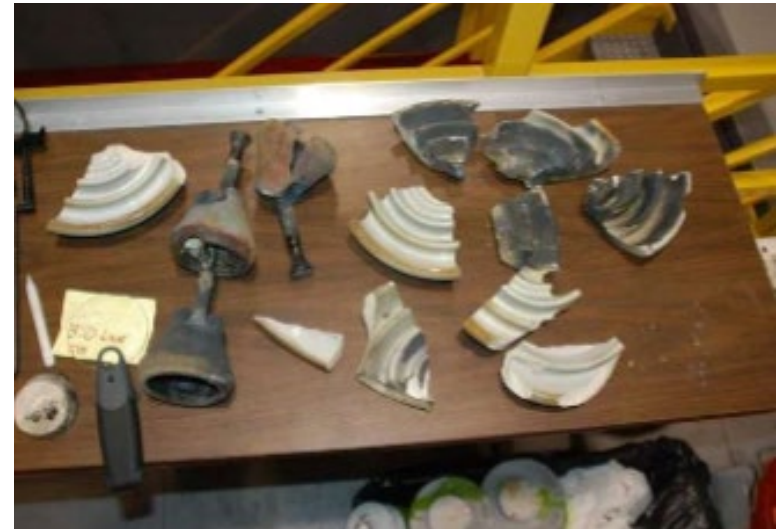
- PINCO insulators must be replaced to ensure continued reliability
  - PINCO insulators have not been installed on Eversource system since the late 1980s
  - May 2017 PINCO insulator failure on 310 line prompted additional testing
  - EPRI testing revealed that PINCO insulators were defective and failed below mechanical and electrical ratings
- Replacements of PINCO insulators, where applicable, will be coordinated with structure replacements

Fragments of Failed PINCO Insulator –  
Line 310
