ISO-NE PAC MEETING

05/15/2024

W-149 115kV Line Asset Condition Refurbishment

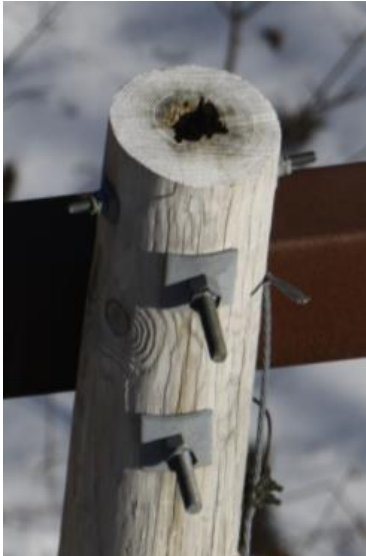
Str 94

Project Needs – Points of Concern: Pole Top Deterioration

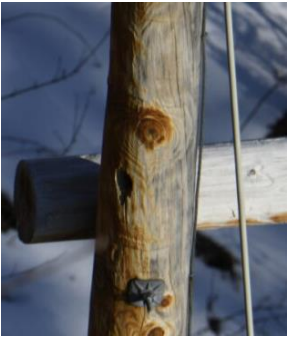
Str 95

Project Needs – Points of Concern: Woodpecker

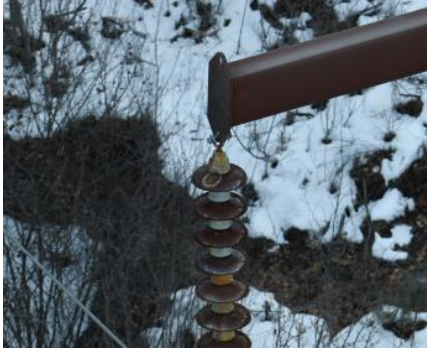
Str 34

Project Needs– Points of Concern: Insulators
