SEC 2024-02 DE-24-087

kris pastoriza

January 6, 2025

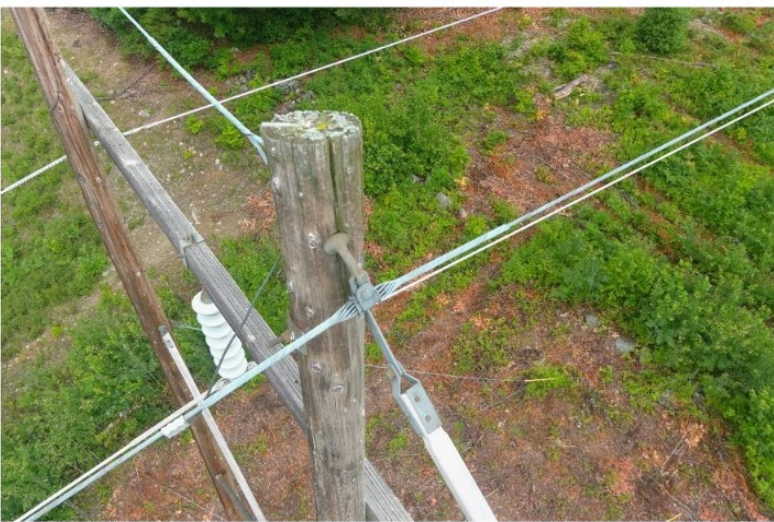
2022 Photo

Photo of dry pole

Crosss-arm anchor facing toward viewer

No white marking on r. side of ground wire

Ratio of ground wire attachment 4: 2.4

This ratio difference could be due to the fact that the photos are not comparable. Note that the cross-arm brace anchor appears to end at ground wire in the 2022 photo and the cross-arm brace anchor is clearly seen to end below the ground wire anchor in the 2024 photo.

It is not clear that these photos are even of the same pole.

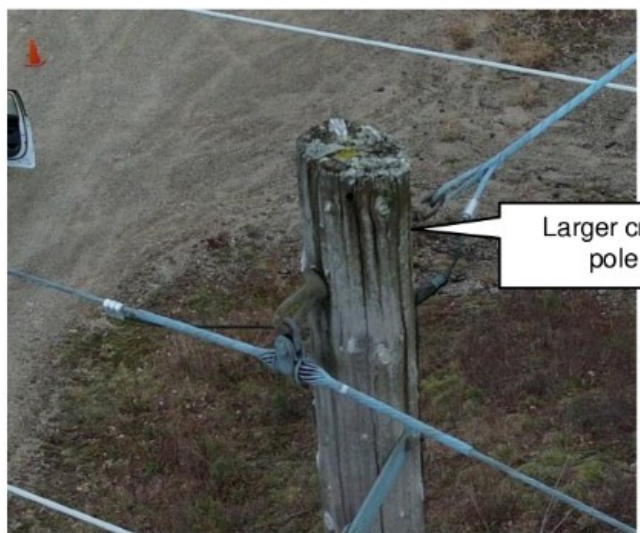
2024 Photo

Photo of wet pole

Anchor facing 90 degrees left

Cracks labeled as larger not visible in 2022 photo

White band on r. side of ground wire

Ratio of ground wire attachment 3: 3.5

The cross-arm that was replaced would have been easy to photograph after it was removed and on the ground but Eversource chose not to show its condition.
