March 20, 2024

To the PAC and ISO-NE,

I request that the PAC request that Eversource clarify whether the 43 Category C structures it claims are on the X-178 line are structures or poles.

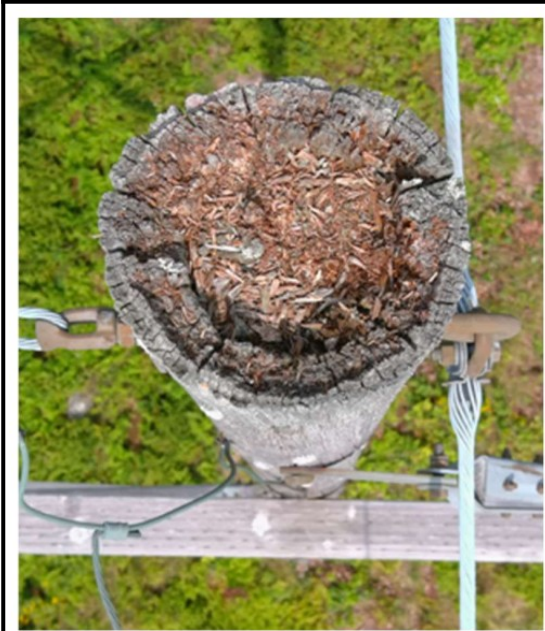
Structure 212 – Pole Top Rot & Rusted Hardware

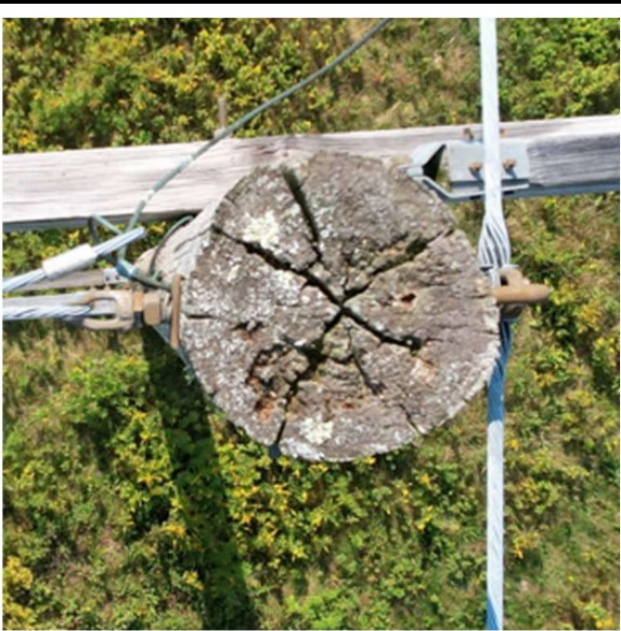
Structure 356 – Split Pole Top

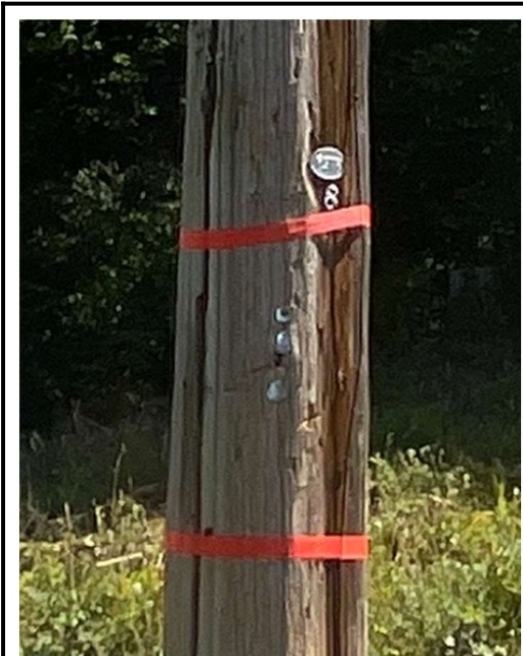
Structure 8 – Severe Structure Splitting

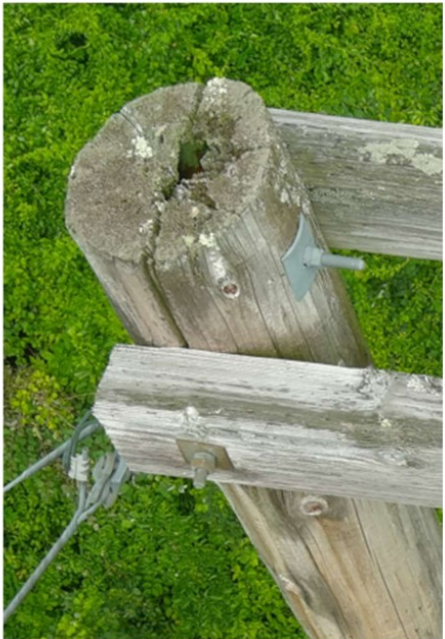
Structure 25 – Pole Top Rot and Splitting at Hardware Attachment Point
