1/18/24kris pastoriza questions to Eversource about structures 424, 212 and 356 and a repeatedrequest for the locations of the Category C poles.

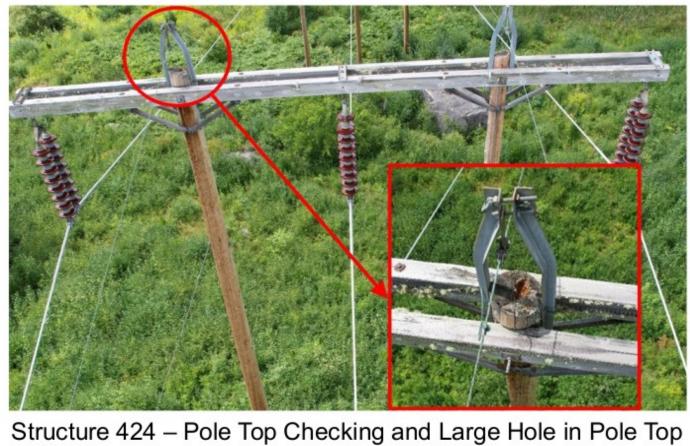
-Structure 423 was recently replaced with a metal structure.

-You can see the former tangent structure 423 in the background:

-Why didn't Eversource proactively embrace efficiency and replace structure 424, or the pole, when it replaced structure 423?

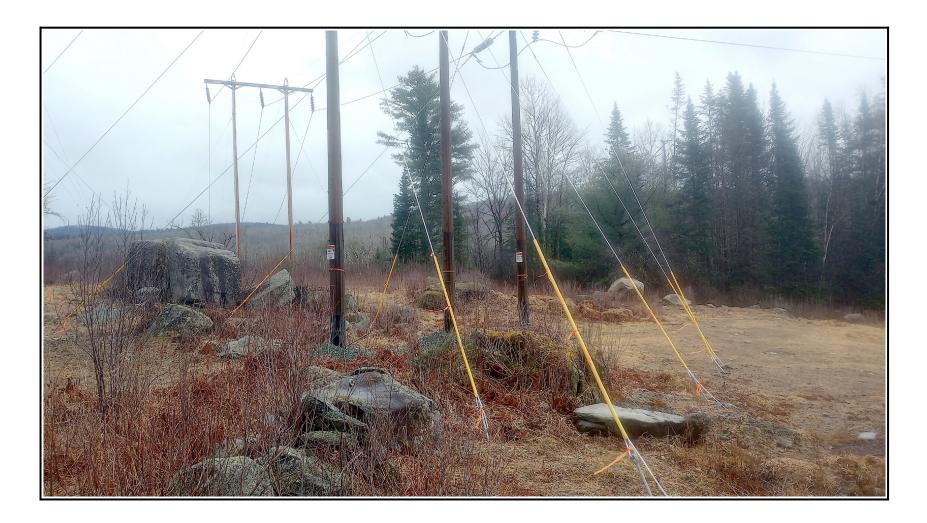
New structure 424 in foreground. Structure 323 behind.

There is no construction pad and the towers are quite short. Is this a temporary structure?

Are the metal poles constructed in two sections, allowing the upper section to be replaced with a taller one?

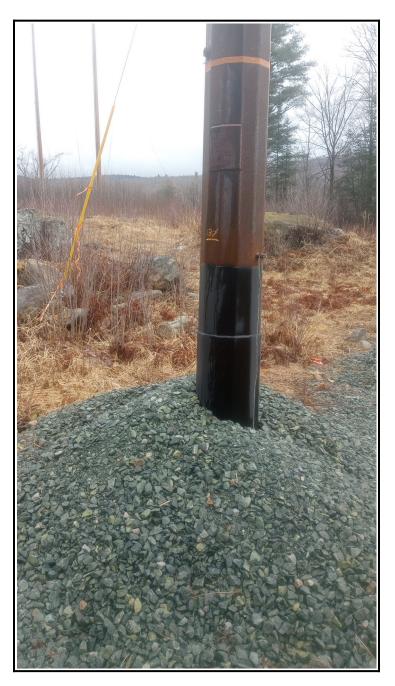
Structure 424 at right. Photos taken 3/17/24

Has Eversource's failure to cover its wood pole tops increased the rate of damage not only to the tops of its poles, but also the lower sections, by increasing water infiltration?

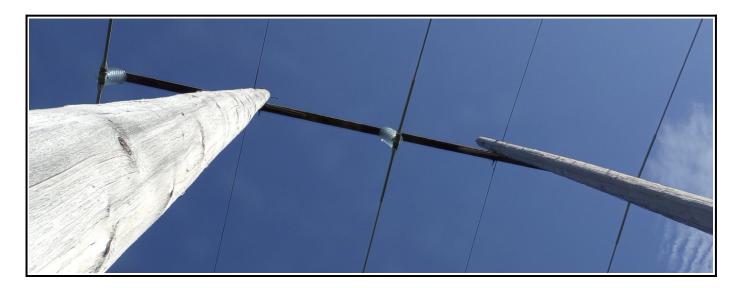
Structure 215: Glass insulators are replacement insulators, along with the crossbars.

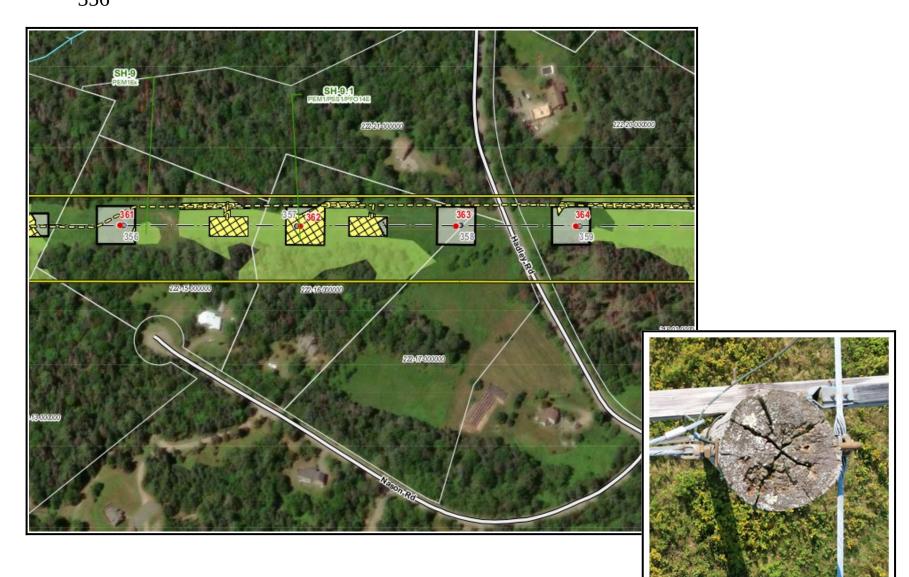
Structure 356 - Split Pole Top
