# NH Line A152 & M127 Structure Replacement Projects

Planning Advisory Committee Meeting

December 20, 2023

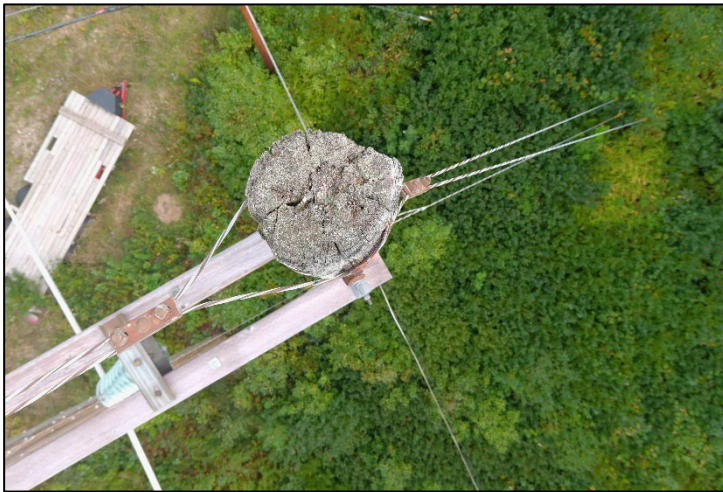
Structure 119 – Top rot, rust

- Line A152
  - Replace 21 wood structures with 20 steel H-frame structures and one three-pole steel structure
  - Solution Alternatives:
    - Based on targeted project scope and drivers, no alternatives were considered

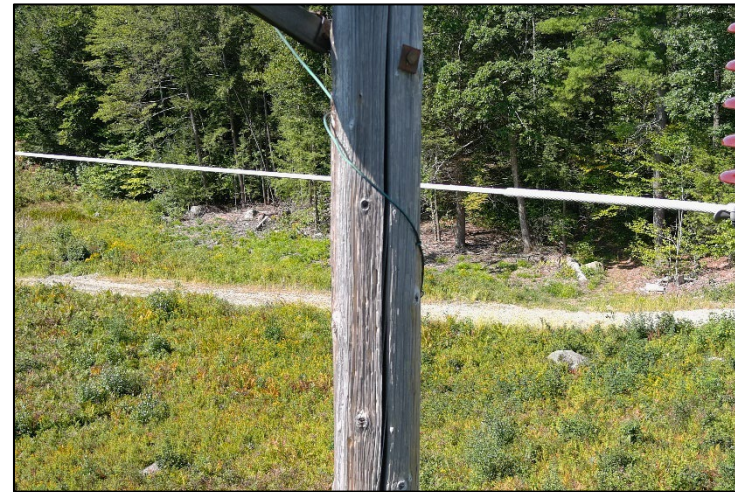
Structure 190 – Pole splits

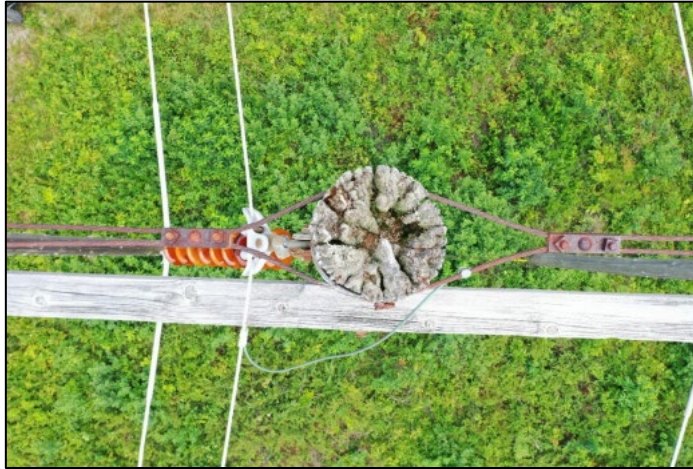
Structure 21 – Top rot, hollow at pole top, rust, splits

- Line M127
  - Replace 22 wood structures with steel H-frame structures
  - Replace three wood structures with light duty steel running angle and dead-end structures
  - Remove one wood structure
  - Solution Alternatives:
    - Based on targeted project scope and drivers, no alternatives were considered

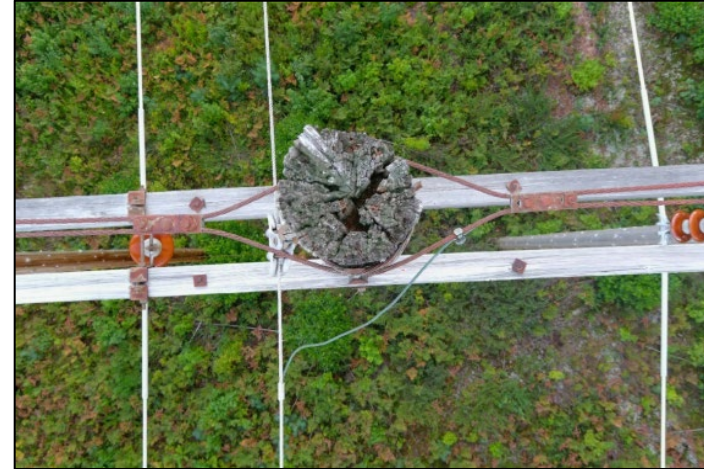
Structure 155 – Top rot, splits, rust

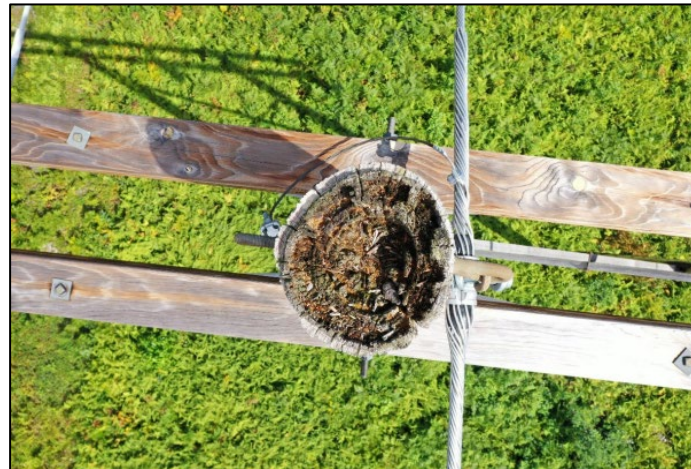
Structure 286 – Top rot, hollow at pole top
