Eversource Laminated Wood Structure Replacement Program Phase III

Planning Advisory Committee Meeting

June 15th, 2023

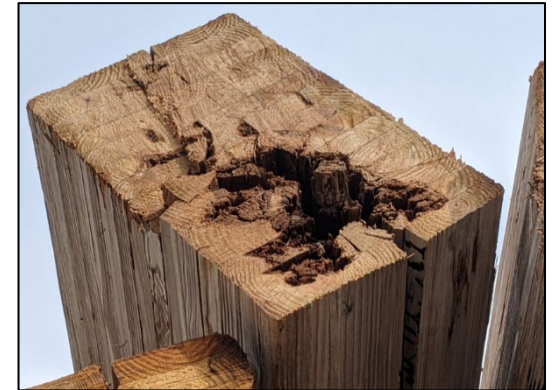
Phase I: Line G128 internal rot & insect damage

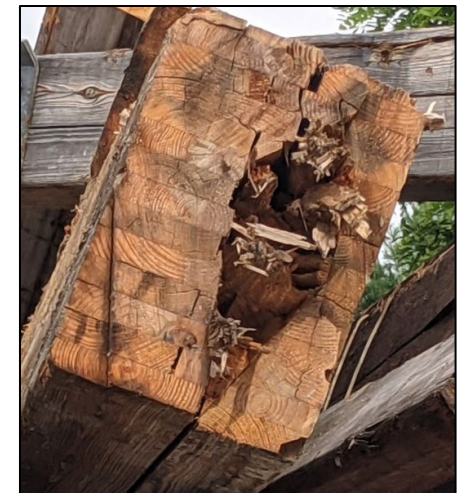
Phase I: Line L175 internal rot & insect damage

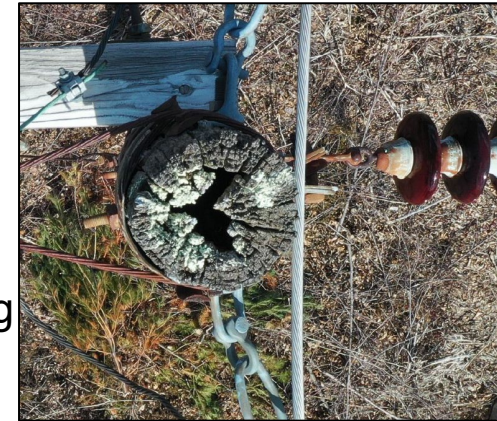
*Line H141 Structure 290
Rusty insulator bells, large
hole and top rot*

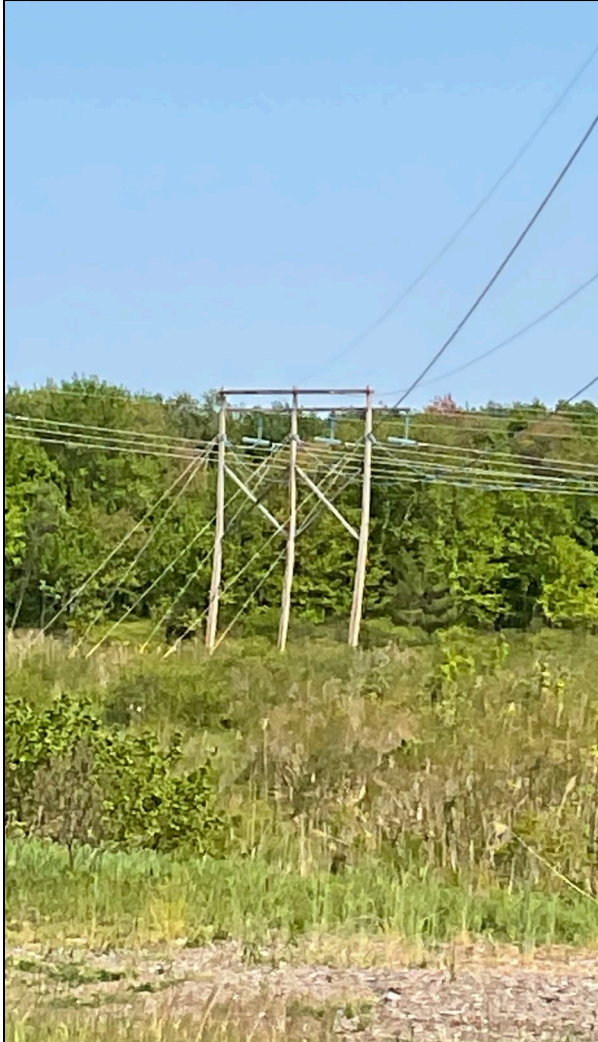
Line I158 Structure 73: Leaning and Bowing

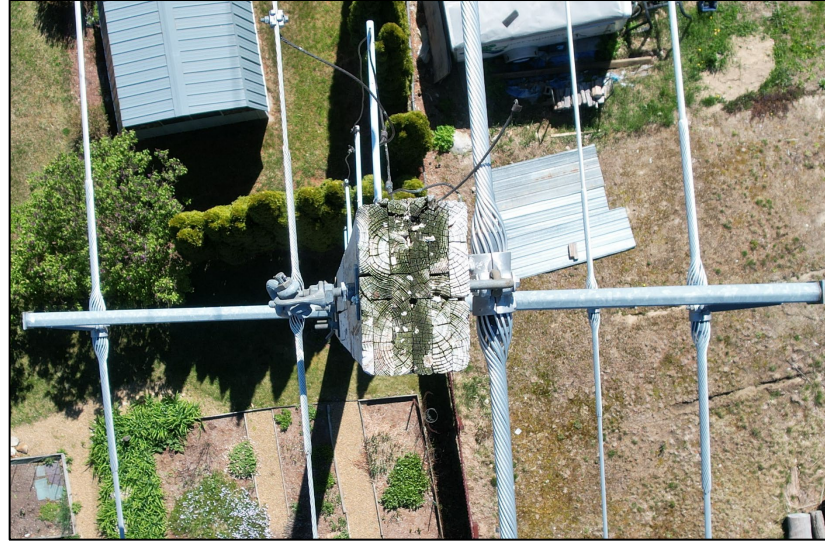
Line F162
Structure 18:
Delamination

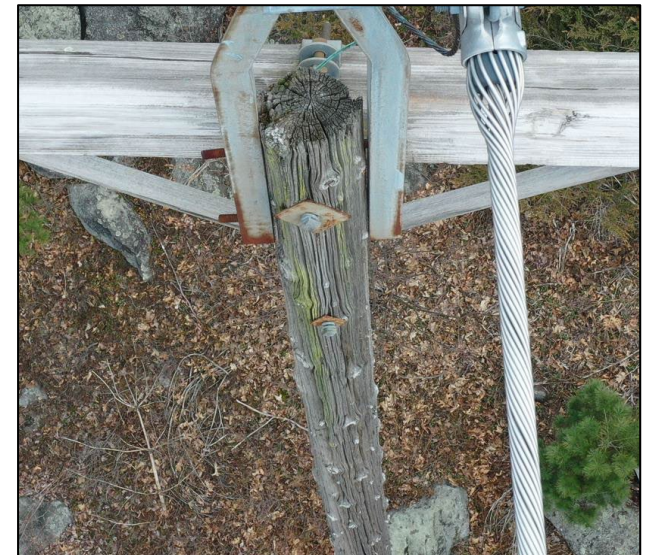
Line H141 Structure
160: Shell Rot on
Pole Top Impacting
Shieldwire Bracket
