New Hampshire Asset Condition Structure Replacements – Line S153

Planning Advisory Committee Meeting

July 23, 2025

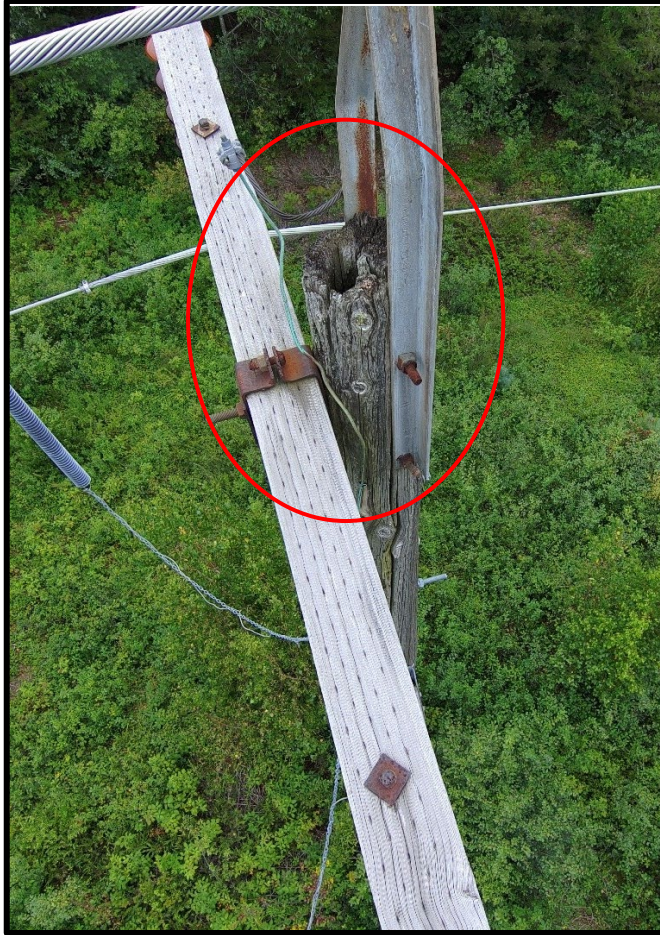
Line S153
Structure 88
Pole top rot, checking,
woodpecker damage

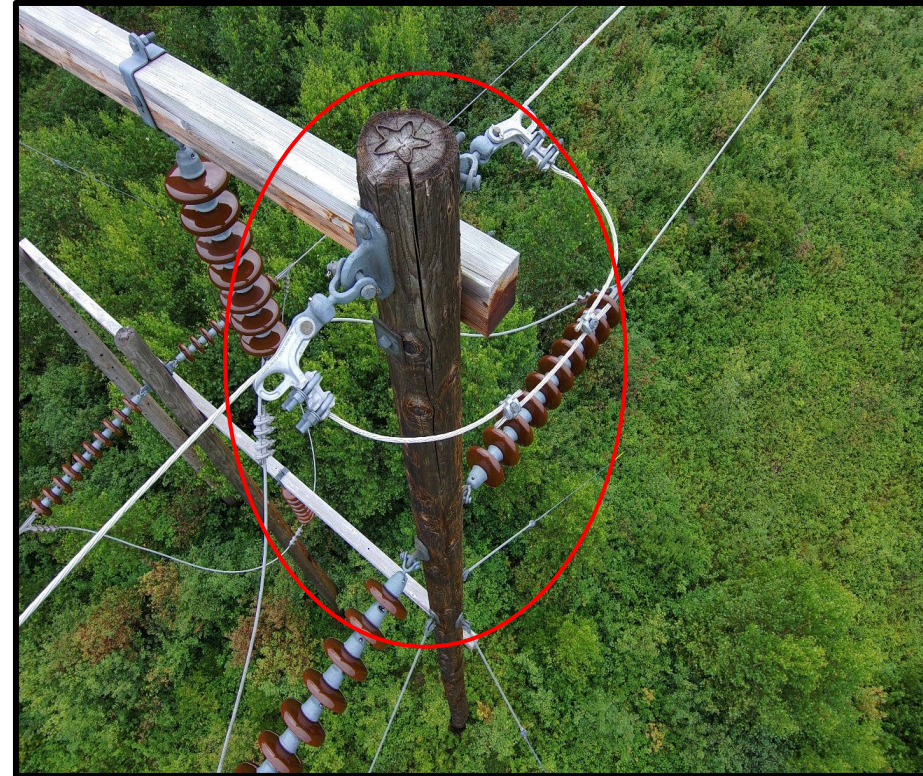
Line S153
Structure 89
Pole top checking
