New Hampshire Asset Condition Structure Replacements – Line T198

Planning Advisory Committee Meeting July 23, 2025

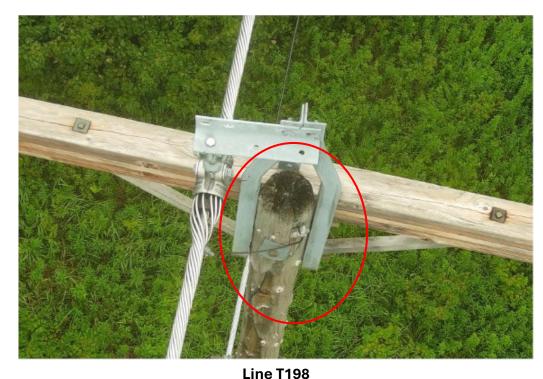
Structure 119
Pole top rot,
checking through
crossarm
attachment

Line T198
Structure 133
Large splits through top and hardware

- Recent inspections performed in 2024 have identified 25 wood structures with woodpecker damage, pole top rot, pole top splits, checking through insulator/equipment connections, and other forms of decay
- These structures must be replaced to maintain reliability and ensure ongoing integrity of the line
- Three Category B structures must be replaced due to uplift issues
- Two Category B original wood structures will be removed due to seasonal flooding concerns
- Affected structures are on average 63 years old and are reaching the end of the typical useful life for 115 kV natural wood structures (40 – 60 years)
