New Hampshire Line X-178 Rebuild

Planning Advisory Committee Meeting

Commentary, March 17, 2024

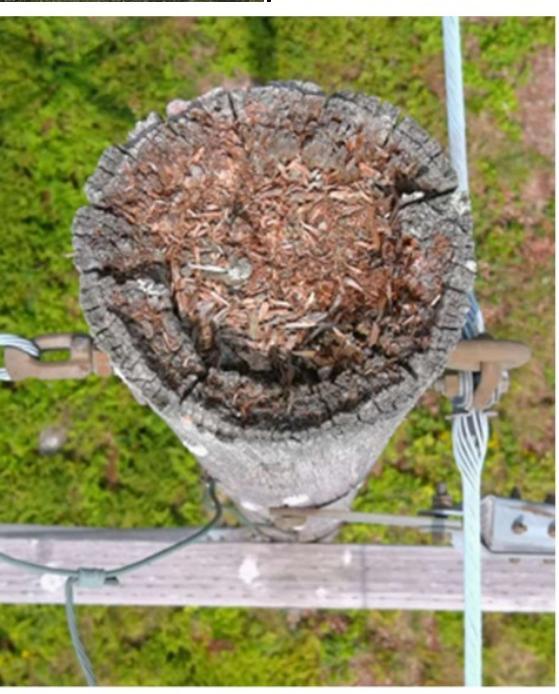
Structure 212 - Pole Top Rot & Rusted Hardware

Eversource claims it needs to build a permanent road and construction pads here, in White Mountain National Forest, to access structure 212. Rusted hardware can be replaced. Why was this pole not covered when structures 214 and 216 had insulators and crossbar replaced, via helicopter, in 2016?

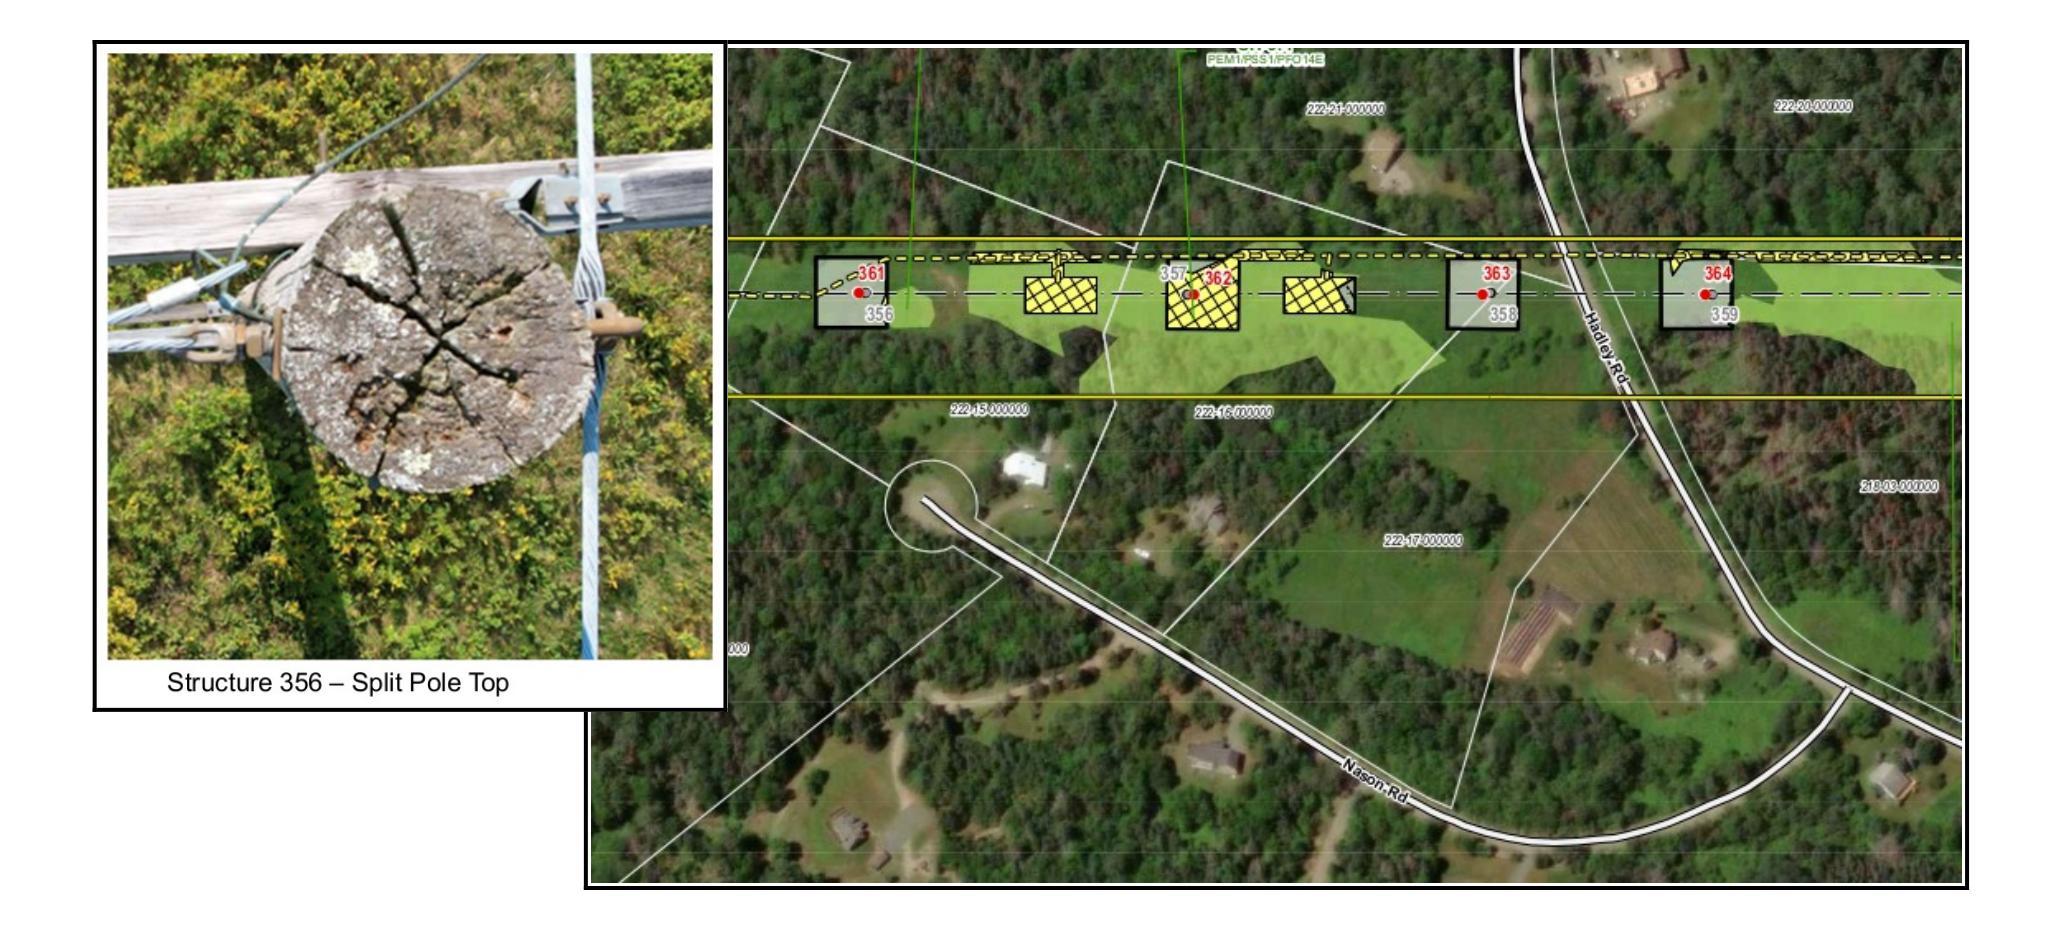
Structure 356, easily accessible from Hadley Road, Sugar Hill. Why was this pole not filled or covered in 2016, when Eversource hired contractors to replace crossbars and insulators (with helicopters) and the line de-energized, in 2016?

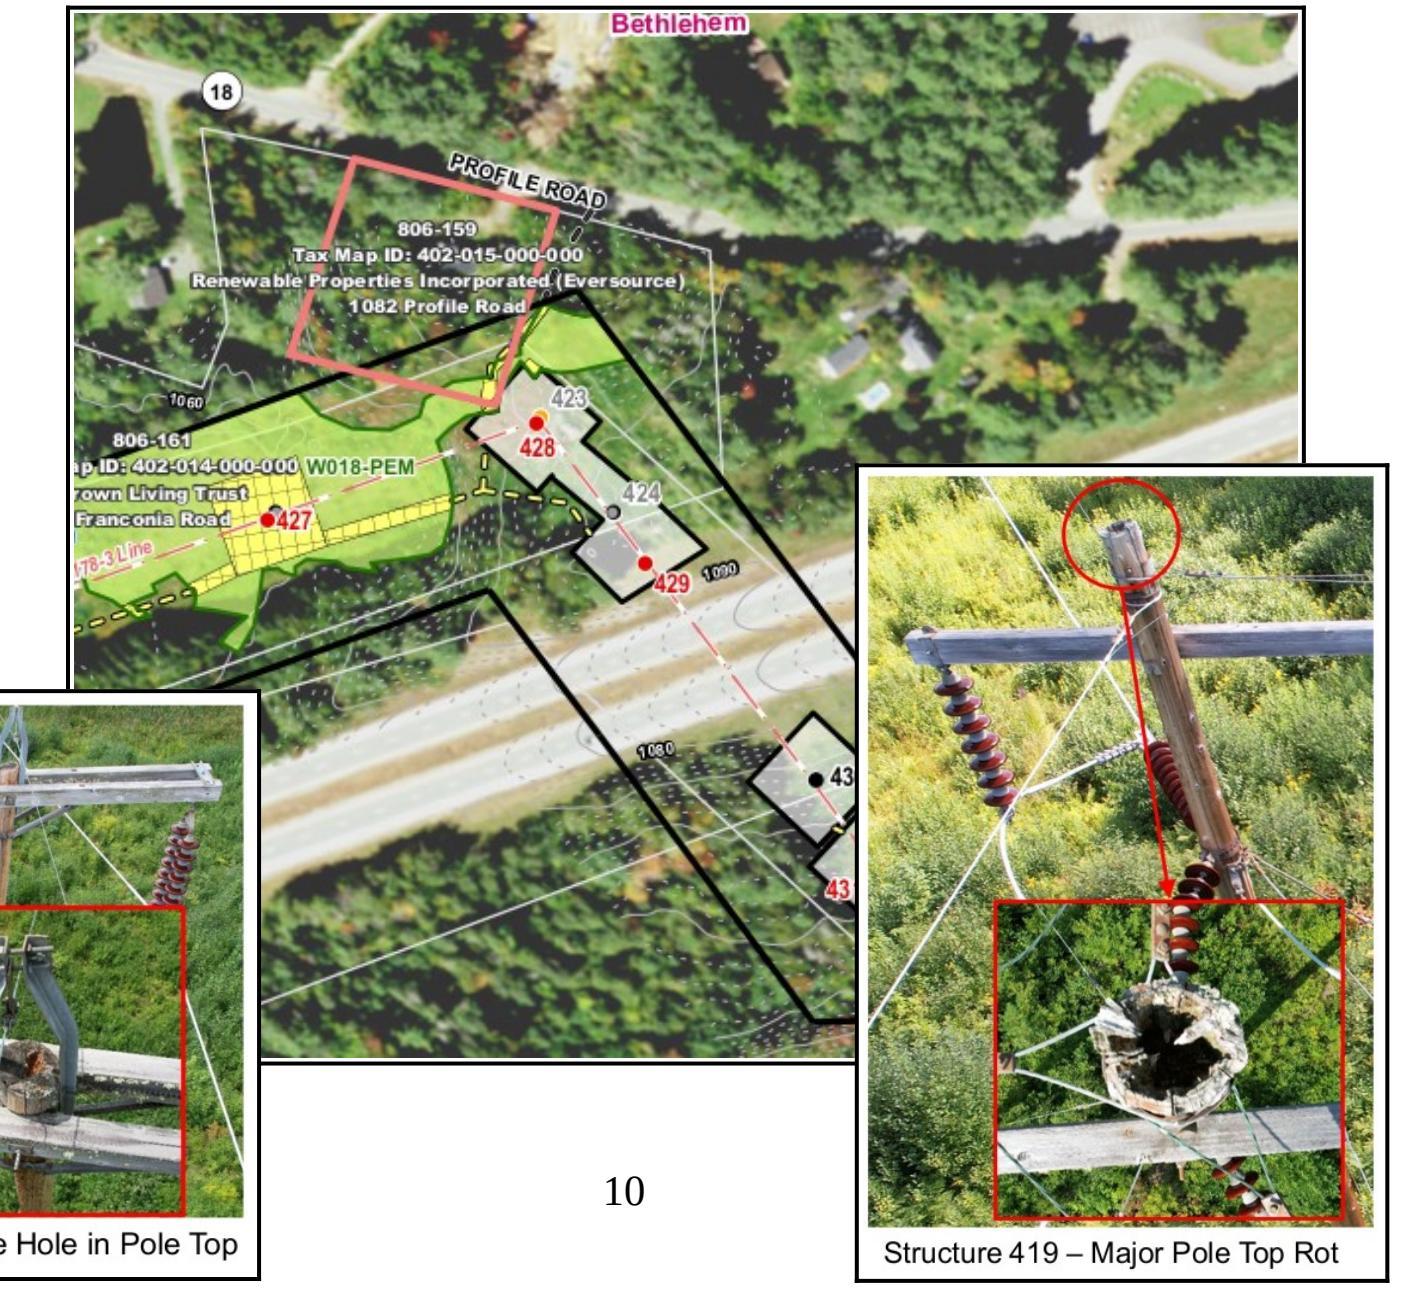
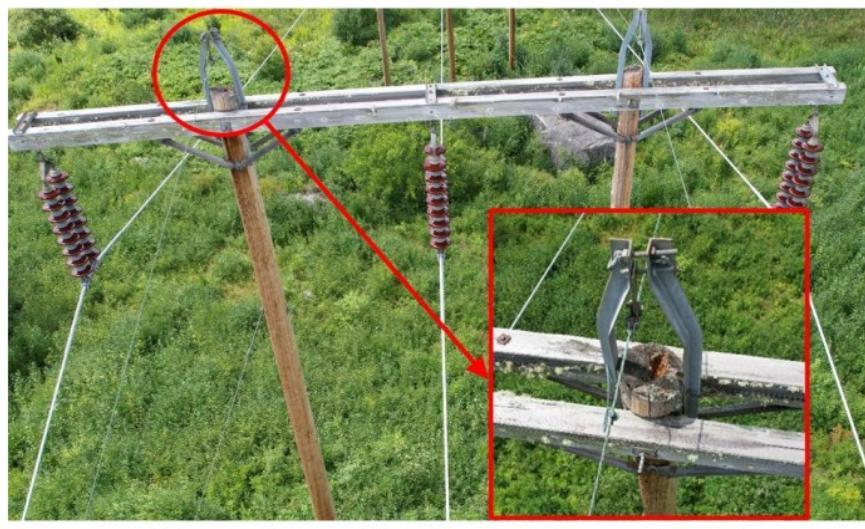
Structure 424 – Pole Top Checking and Large Hole in Pole Top

Structure 424, a 1969 structure easily accessible from the property in Sugar Hill that Eversource

bought during Northern Pass.

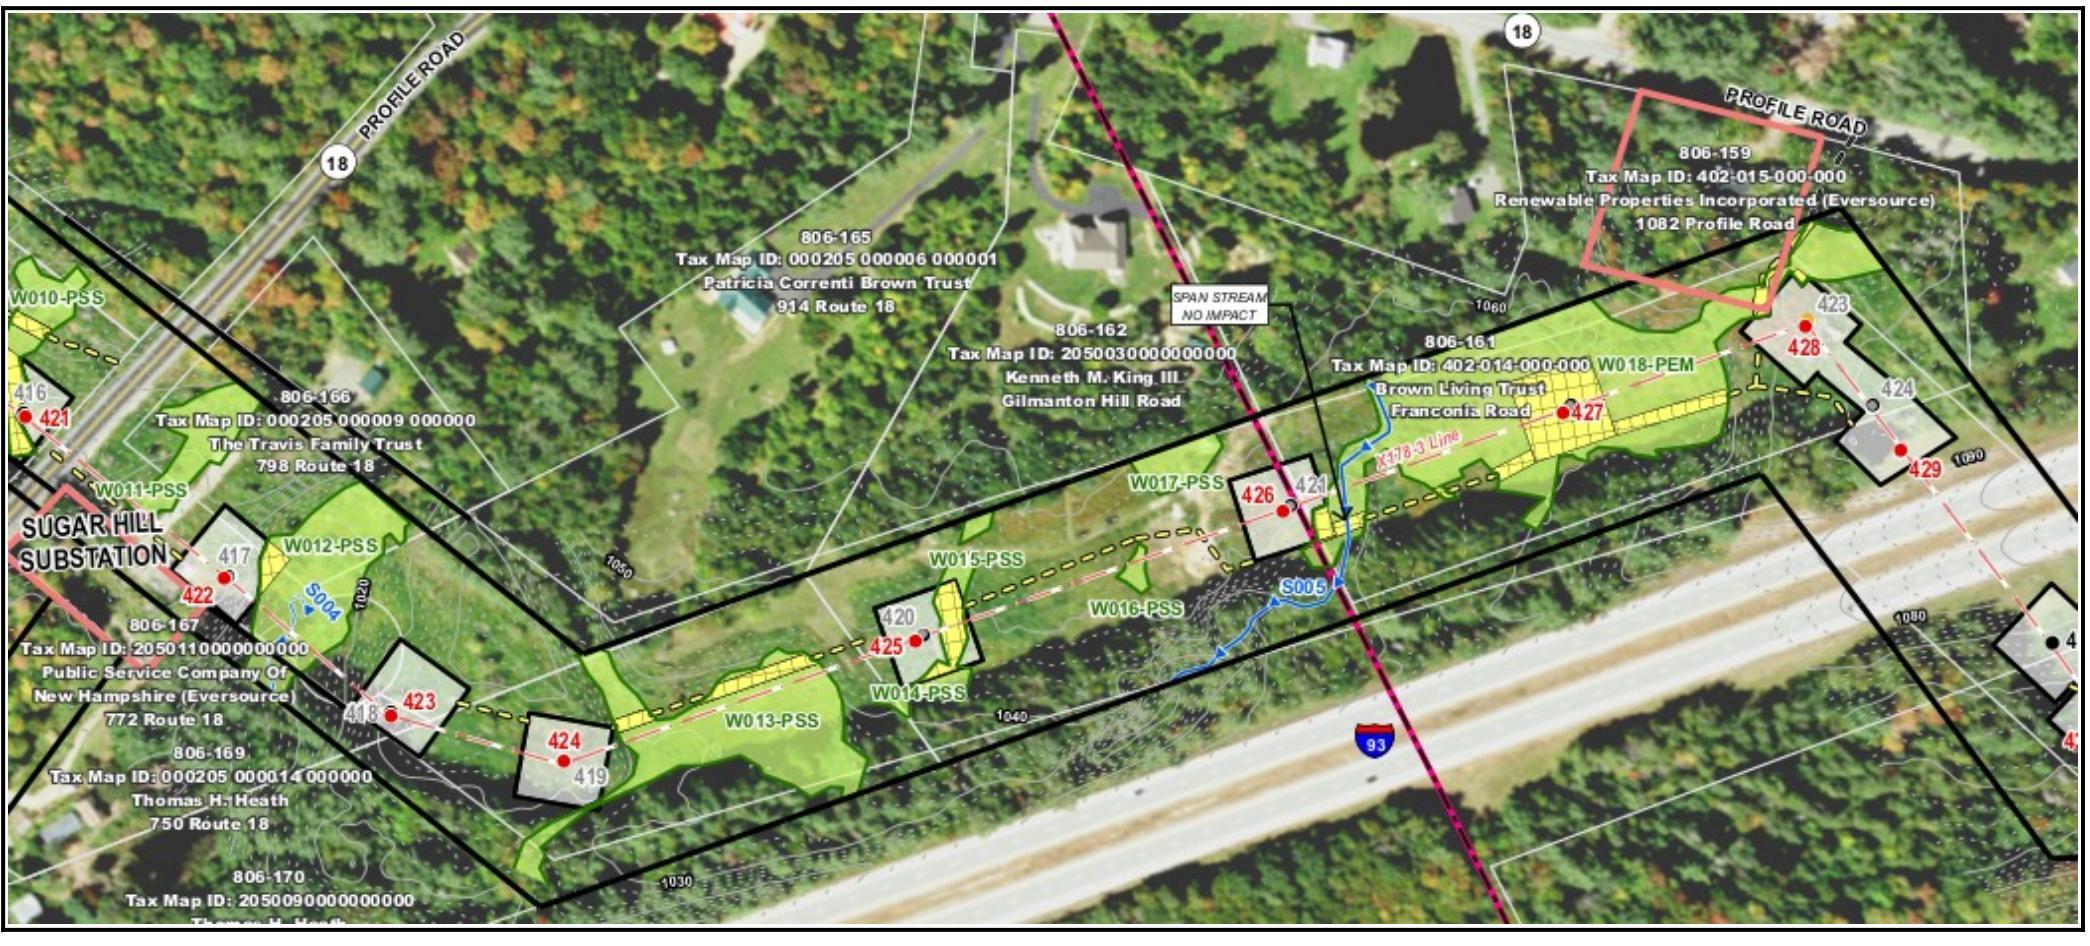
Structure 419, a 1969 structure easily accessible from the Eversource-owned Sugar Hill Substation.

419

424
