326 and 380 Transmission Line Structure and Optical Ground Wire Replacement Project Eversource Energy

**Litchfield, Londonderry, Hudson, and Pelham
New Hampshire**

NHDES Alteration of Terrain Permit Application

March 29, 2022

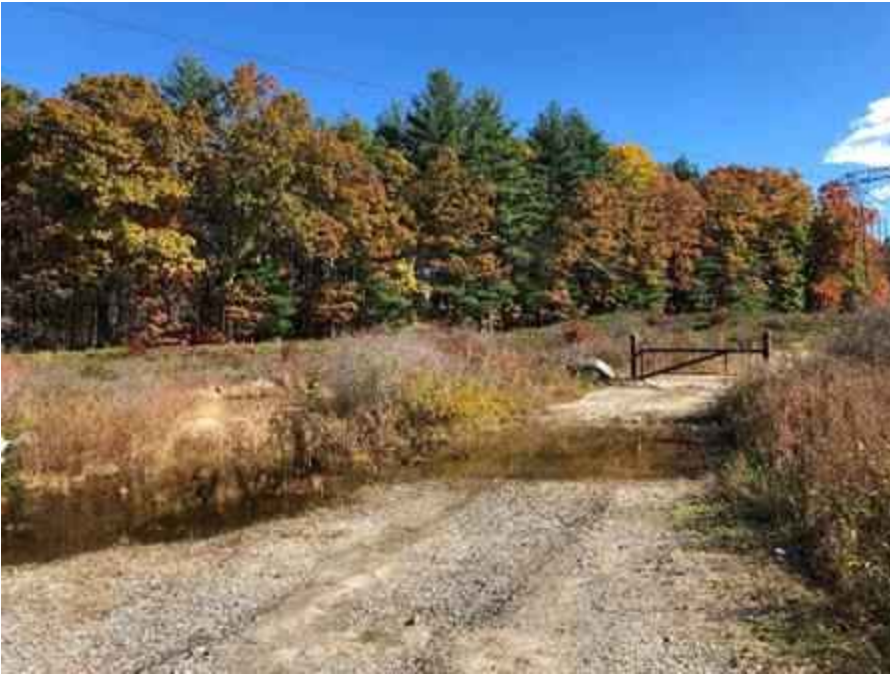
Photograph No. 1: Looking southerly at proposed access within wetland LDW-88.1 off Wiley Hill Road.

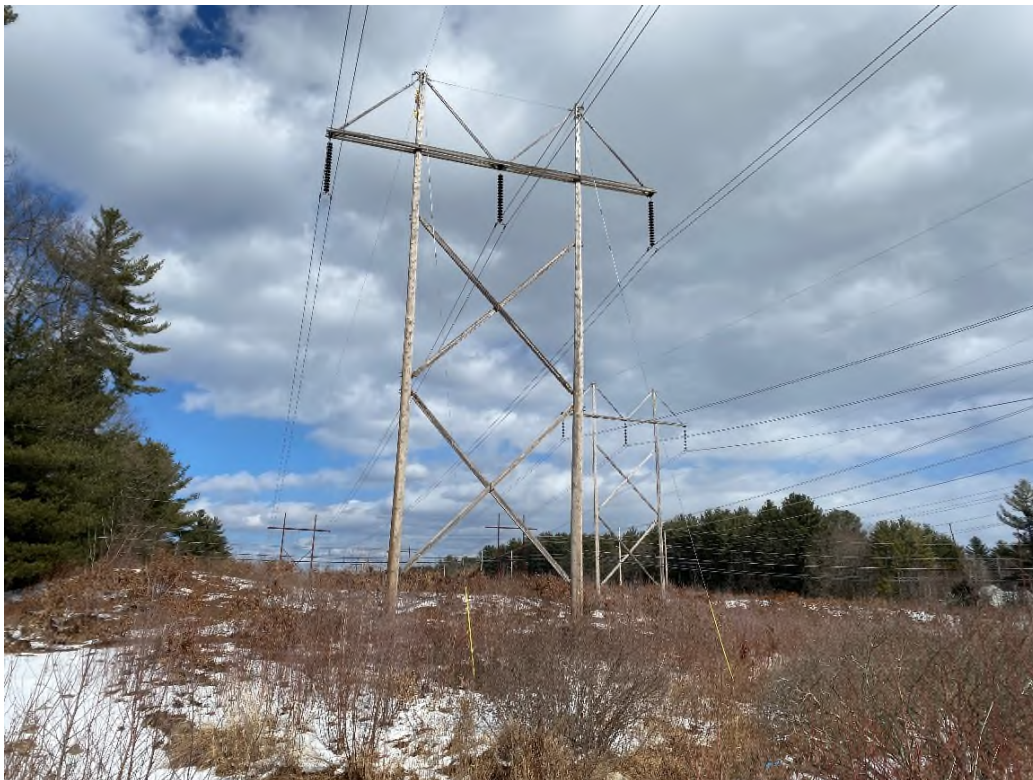
Photograph No. 8: Looking at proposed access and work pad location adjacent to Structure 55 of the 380 Line.

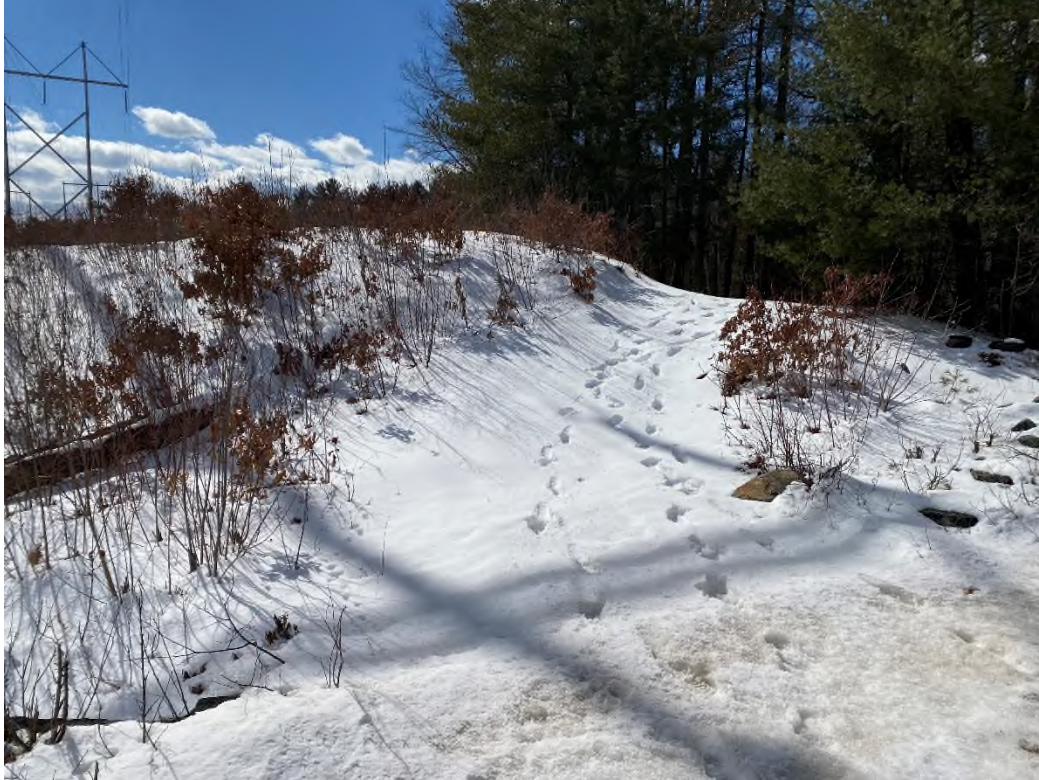
Photograph No. 9: Looking at proposed access adjacent to Structure 55 of the 380 Line from Wiley Hill Road.

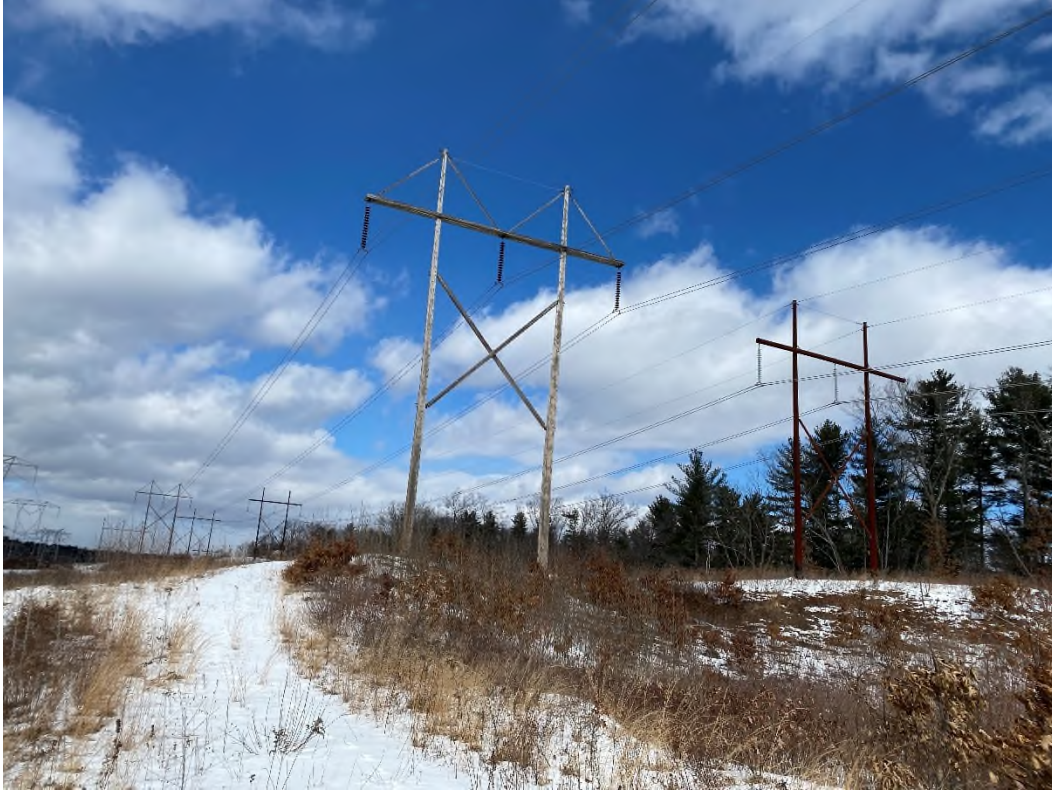
Photograph No. 13: Looking at work pad location for Structure 72 of the 326 Line.

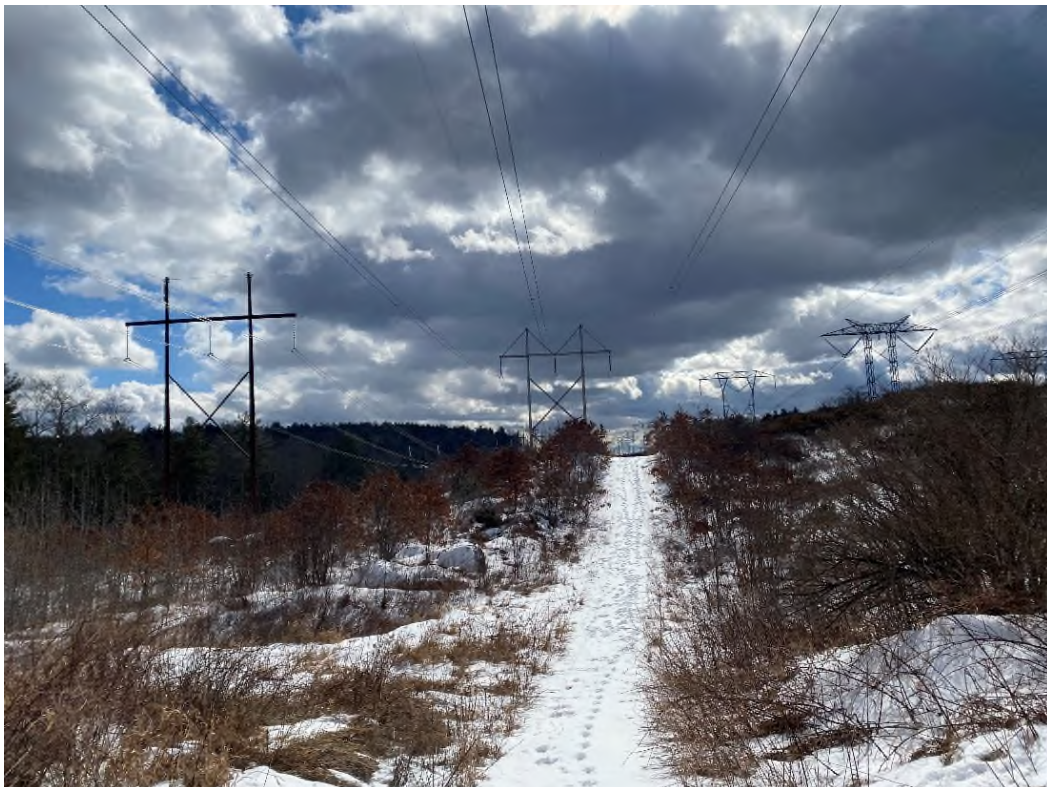
Photograph No. 16: Looking at proposed access and work pad location for Structure 79 of the 326 Line.

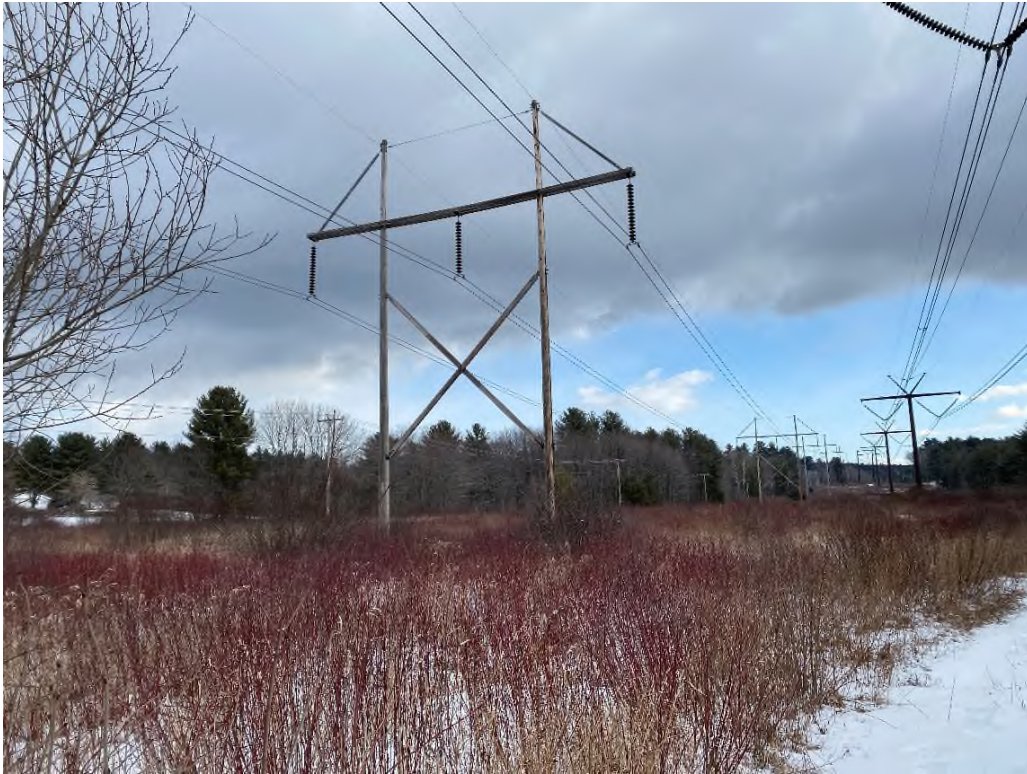
Photograph No. 21: Looking at proposed work pad location for Structure 153 of the 326 Line.

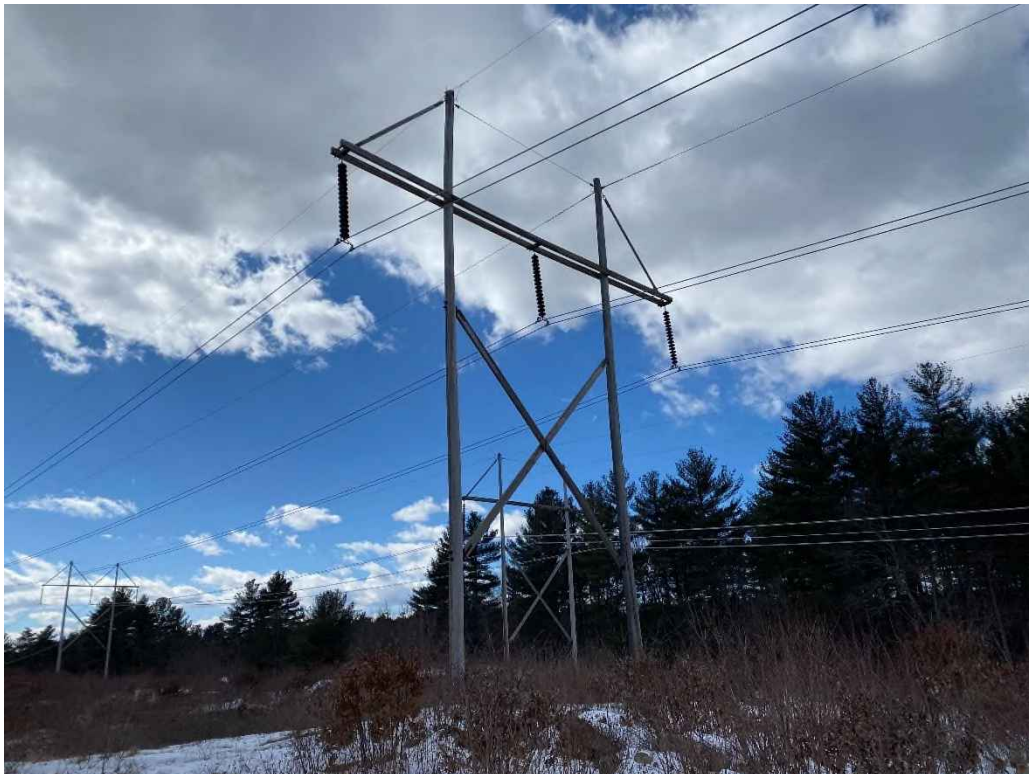
Photograph No. 26: Looking at proposed work pad location adjacent to Structure 49 of the 326 Line.

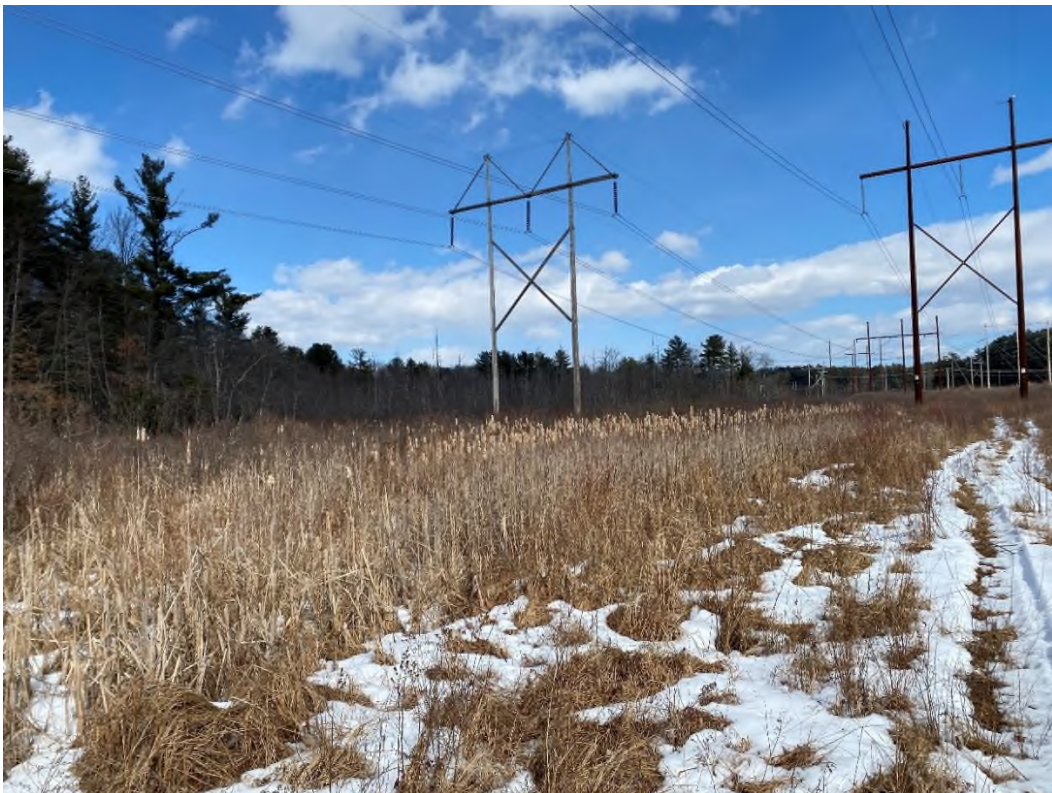
Photograph No. 28: Looking at proposed access and work pad location adjacent to Structure 28 of the 380 Line.

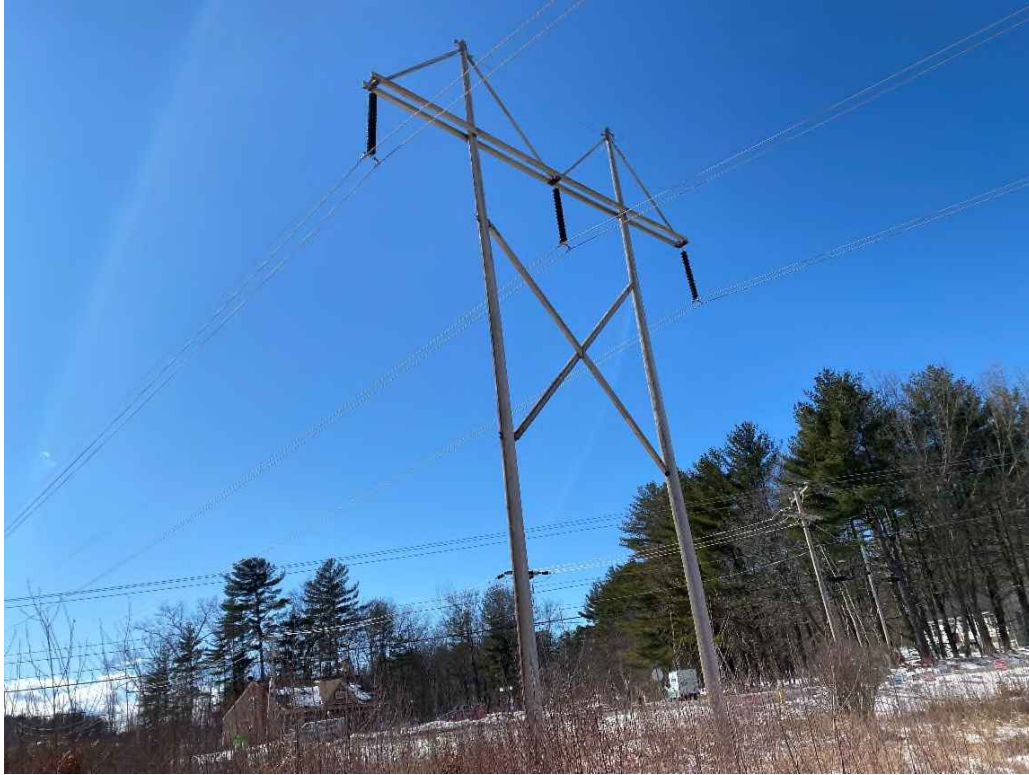
Photograph No. 29: Looking at proposed work pad location adjacent to Structure 25 of the 380 Line.

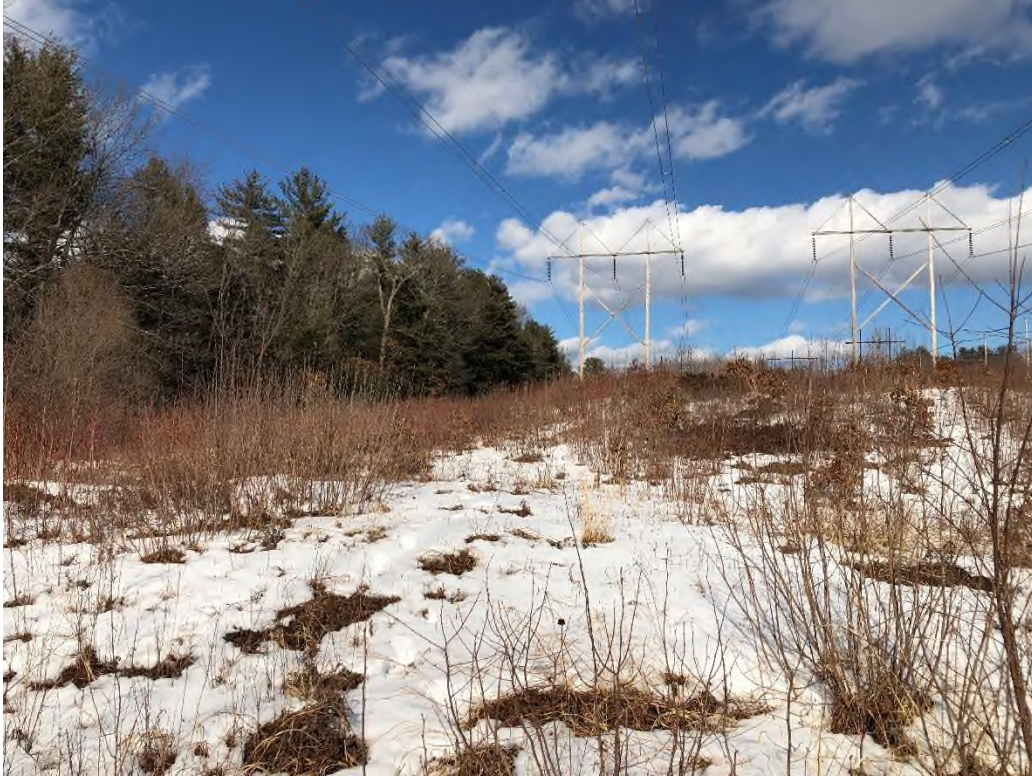
Photograph No. 31: Looking at proposed access and work pad location adjacent to Structure 23 of the 380 Line.

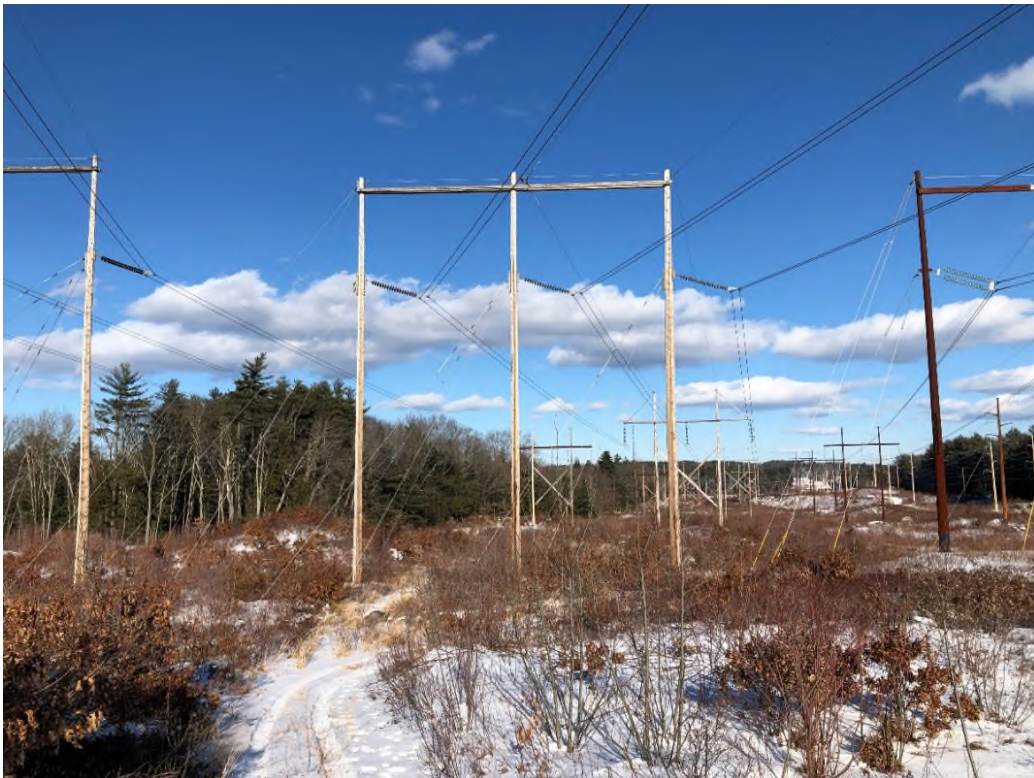
Photograph No. 38: Looking at proposed access and work pad location adjacent to Structure 10 of the 326 Line.

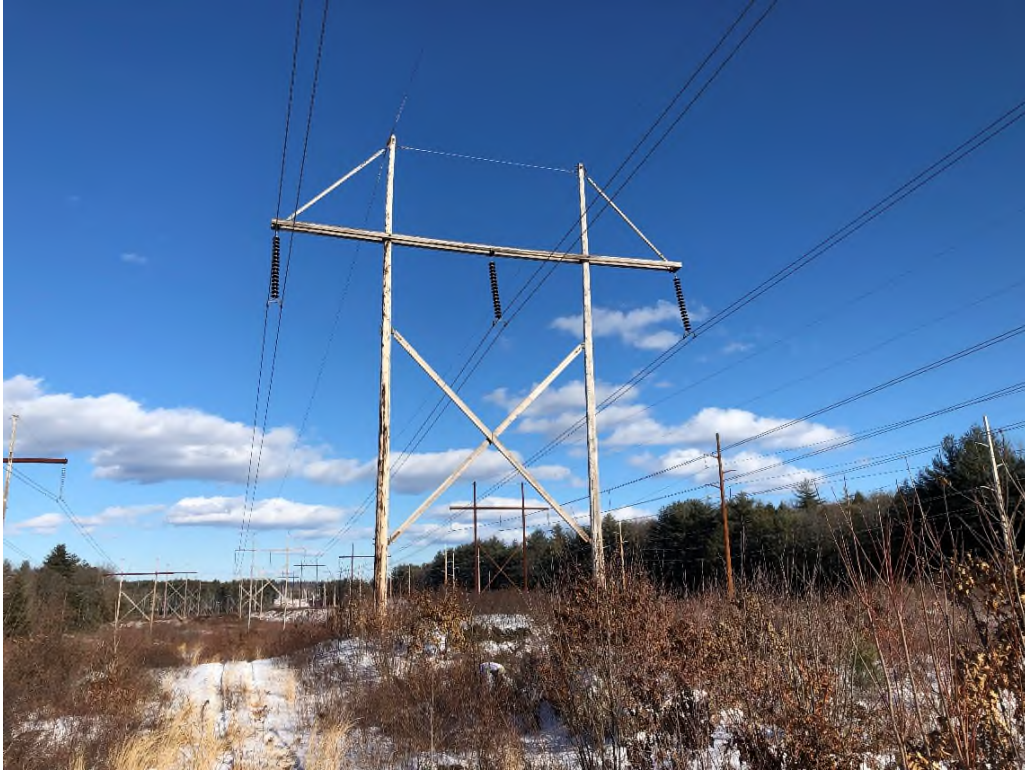
Photograph No. 39: Looking at proposed access and work pad location for Structure 9 of the 326 Line.

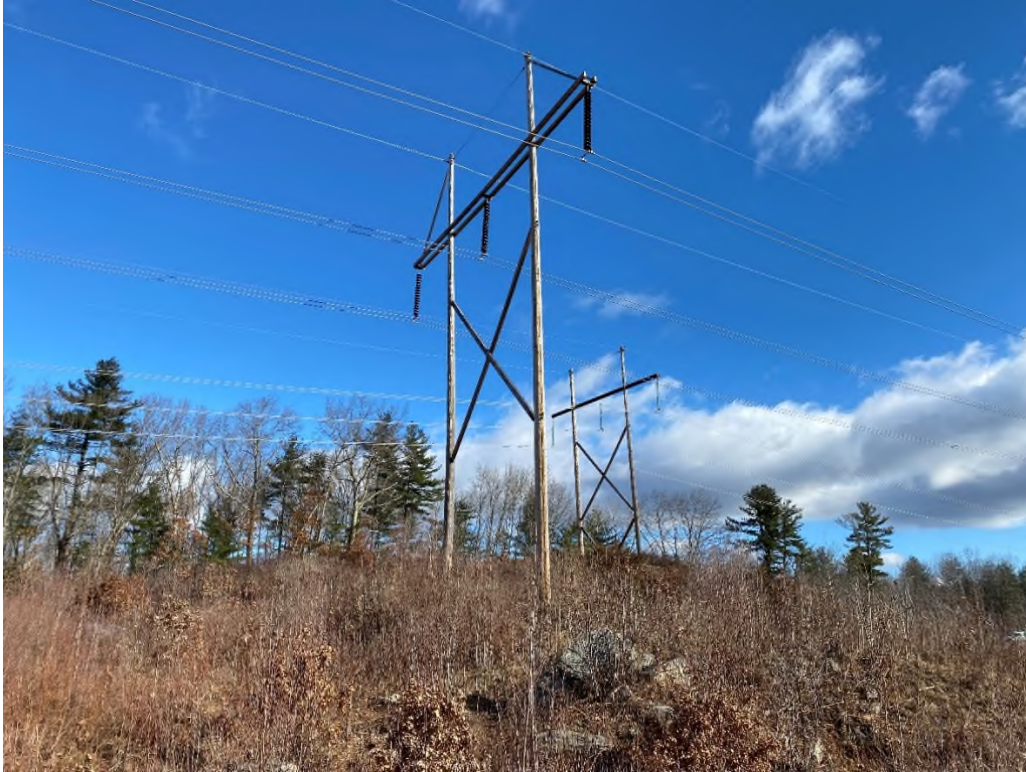
Photograph No. 41: Looking at proposed access and work pad location adjacent to Structure 7 of the 326 Line.
