391, 385 and 373 Transmission Line Structure Replacement Project Eversource Energy

Chester, Deerfield, and Strafford, New Hampshire

NHDES Alteration of Terrain Permit Application

January 20, 2020

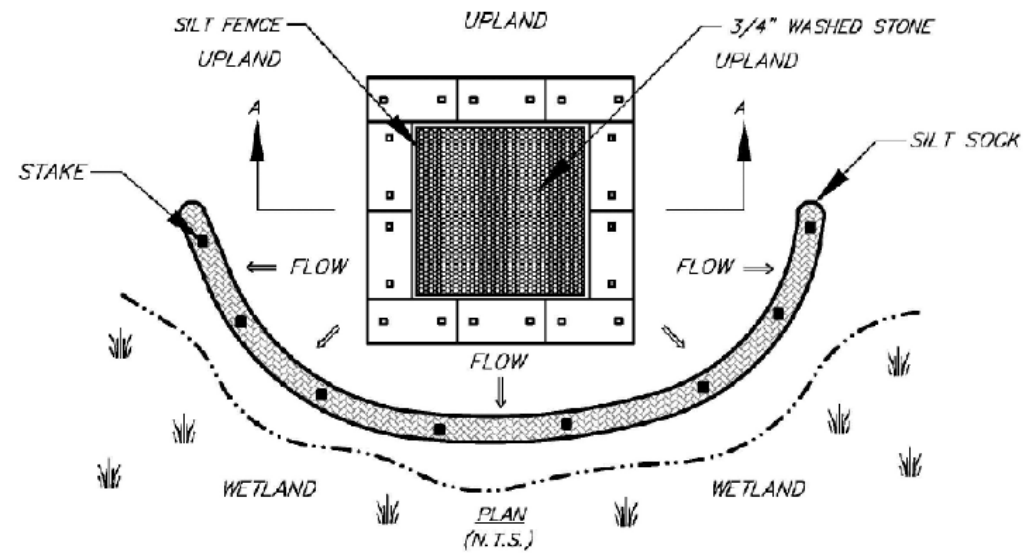
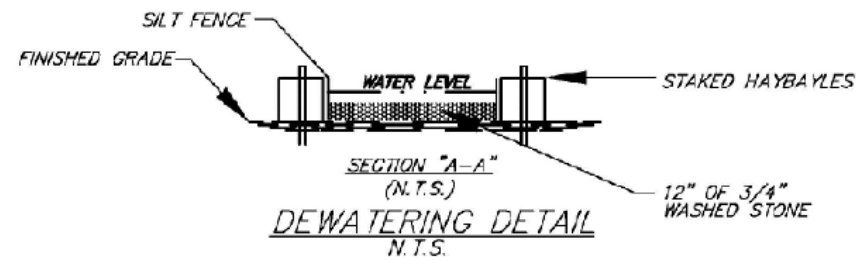
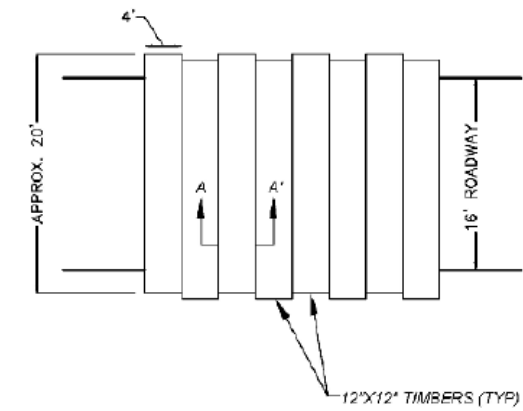
TYPICAL SWAMP MAT PLAN VIEW
N.T.S.

Timber matting will be used in wetlands and in some upland areas to minimize impacts and provide level work pads. Upon completion of work where timber matting is implemented in upland areas, those upland areas will be restored and stabilized to pre-existing conditions and areas of exposed soils will be seeded and/or mulched. Additionally, should any removal of BMPs be necessary, it will occur during restoration activities.

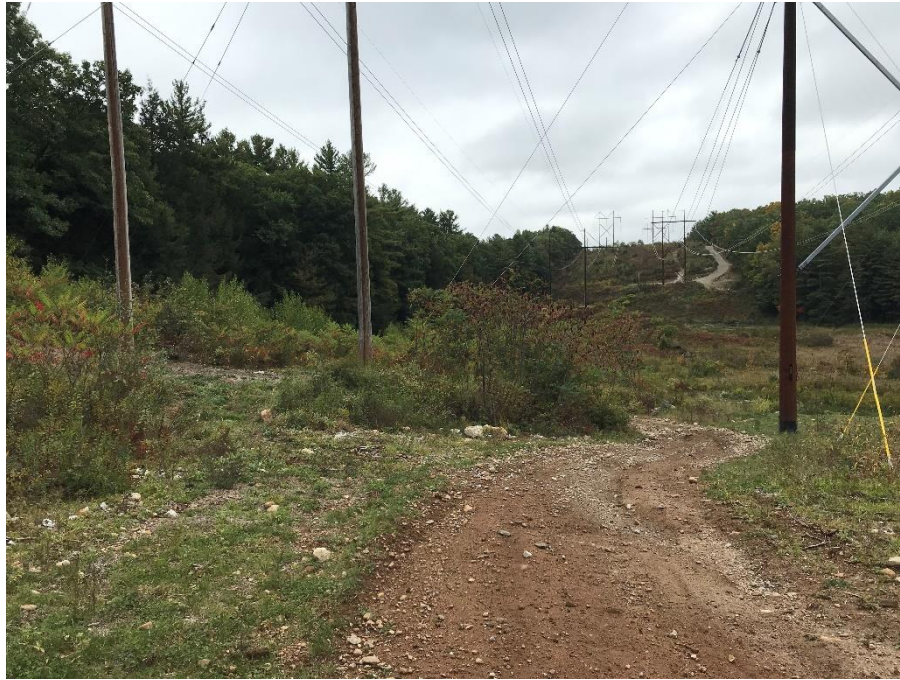
Photograph No. 1: Looking northeasterly at proposed access route toward 373 Structure 286 in Chester.

Proposed access road improvements include 12- to 16-foot-wide gravel and stone roads with a 20-foot total width limit of disturbance. The roads will provide access to existing utility structures for routine maintenance activities. Improved access will provide reliable, permanent and quick efficient access to utility structures for future maintenance activities and when emergency repairs are required. Majority of proposed access road improvements are located within already existing dirt and grass access routes (see **Appendix E – Photo Log**).

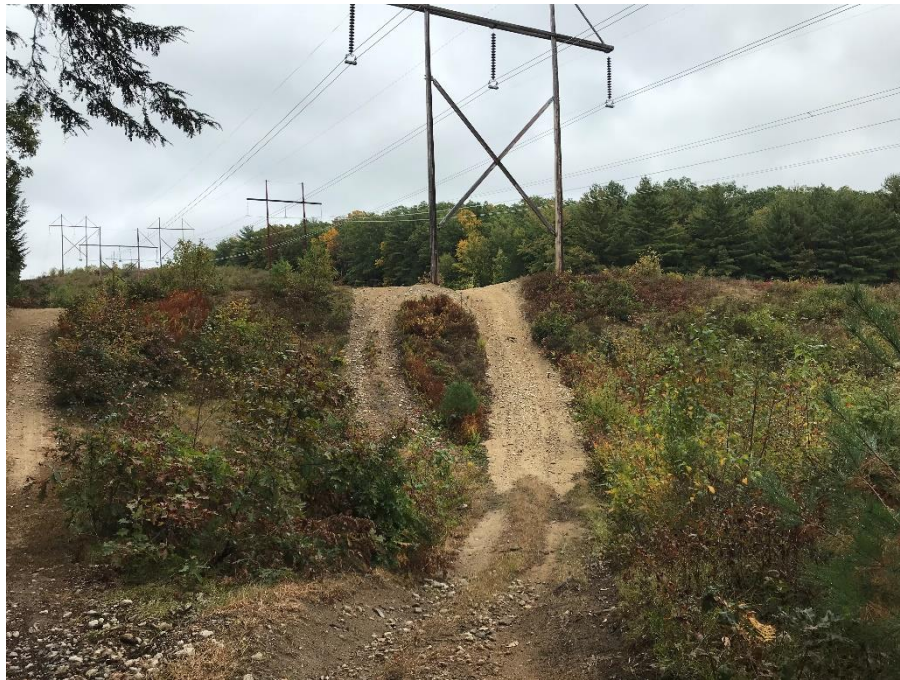
Photograph No. 2: Looking northwesterly at proposed structure replacement 391 Structure 286 in Chester.

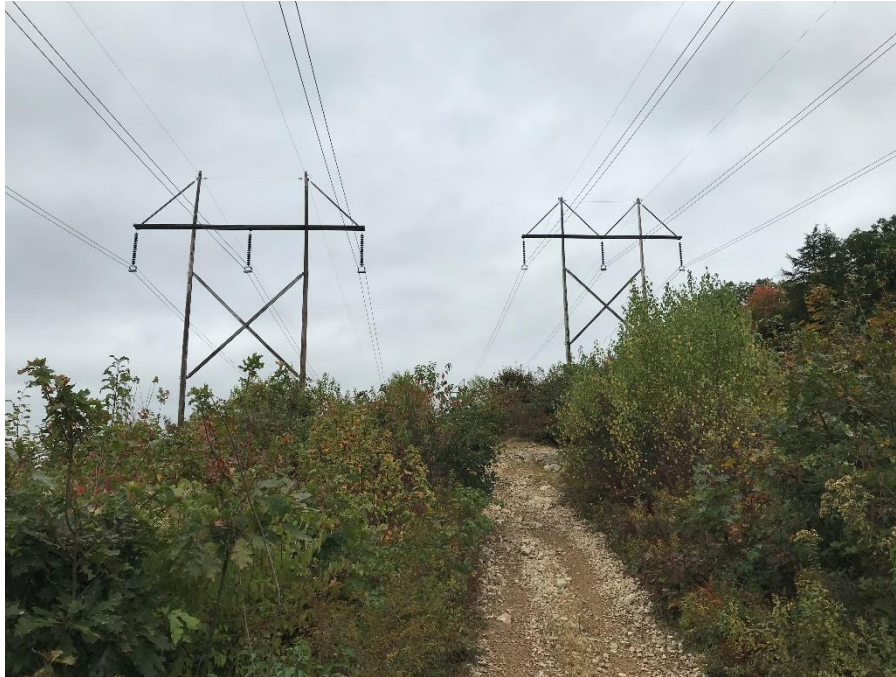
Photograph No. 3: Looking northerly at proposed access route toward 391 Structure 278 in Chester.

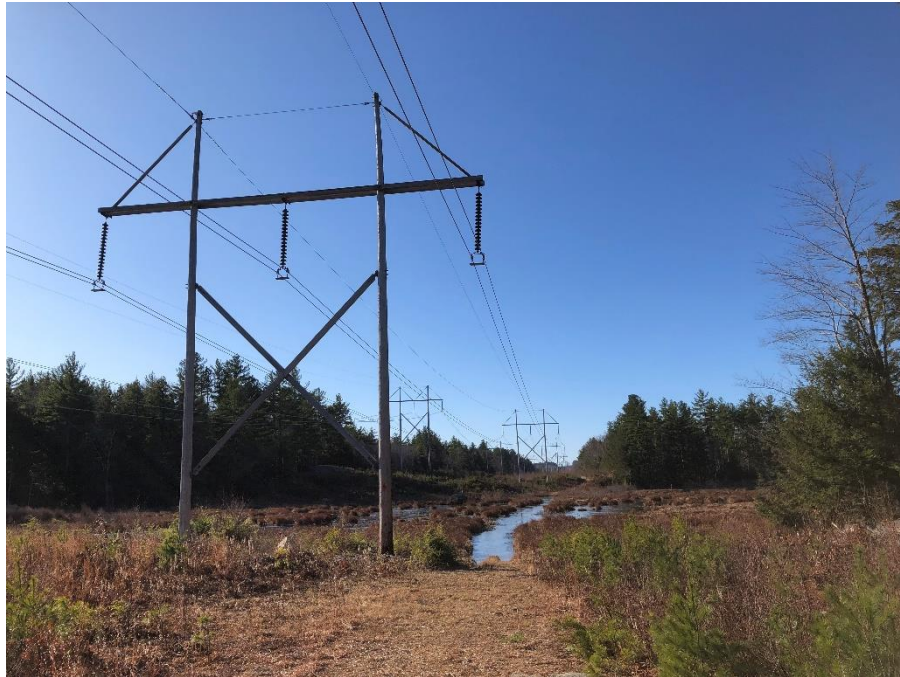
Photograph No. 5: Looking southwesterly at proposed structure replacement 385 Structure 158 in Deerfield.

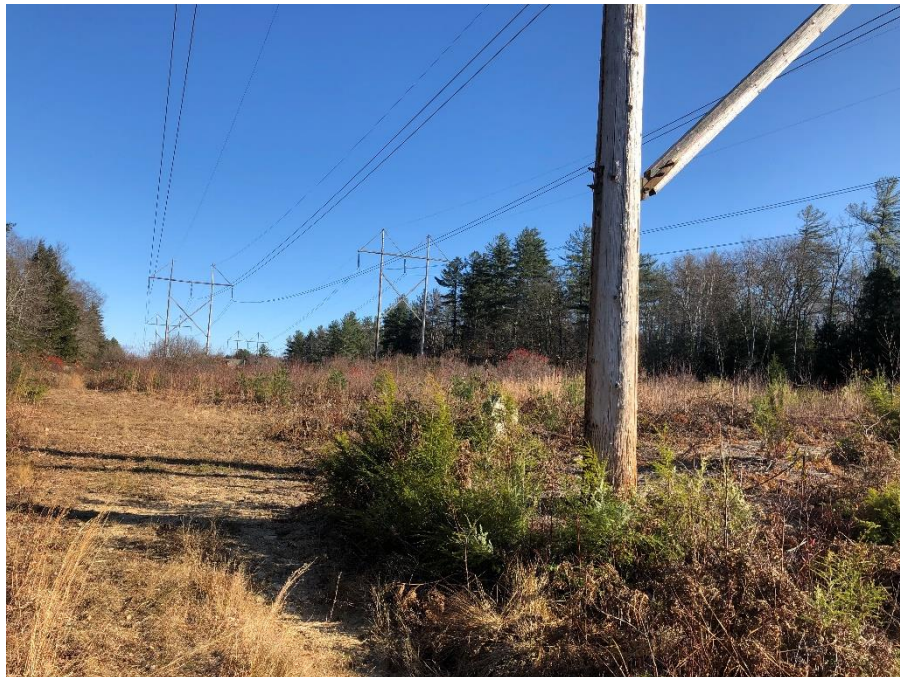
Photograph No. 6: Looking northeasterly at proposed work area at 385 structure 158 in Deerfield.

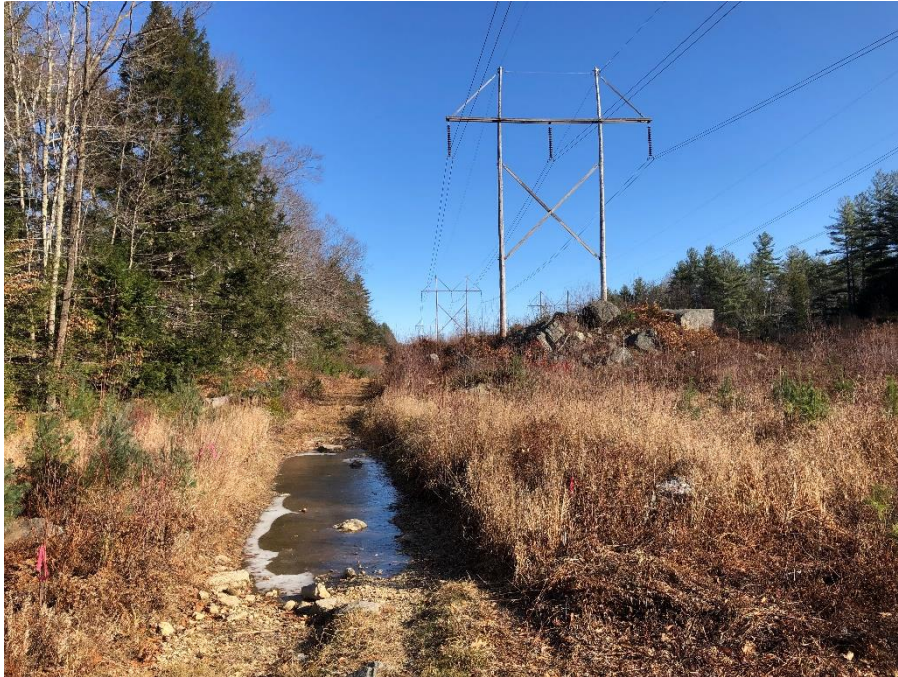
Photograph No. 7: Looking northwesterly at proposed structure replacement 385 structure 157 with proposed access route in Deerfield.

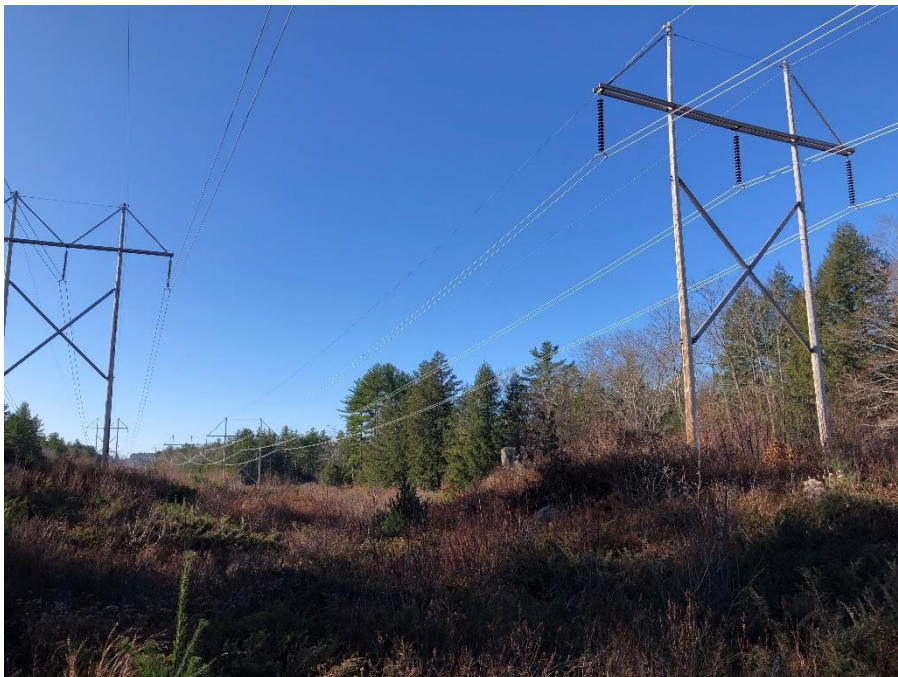
Photograph No. 8: Looking southwesteryly at proposed structure replacement 385 structure 157 on right in Deerfield.

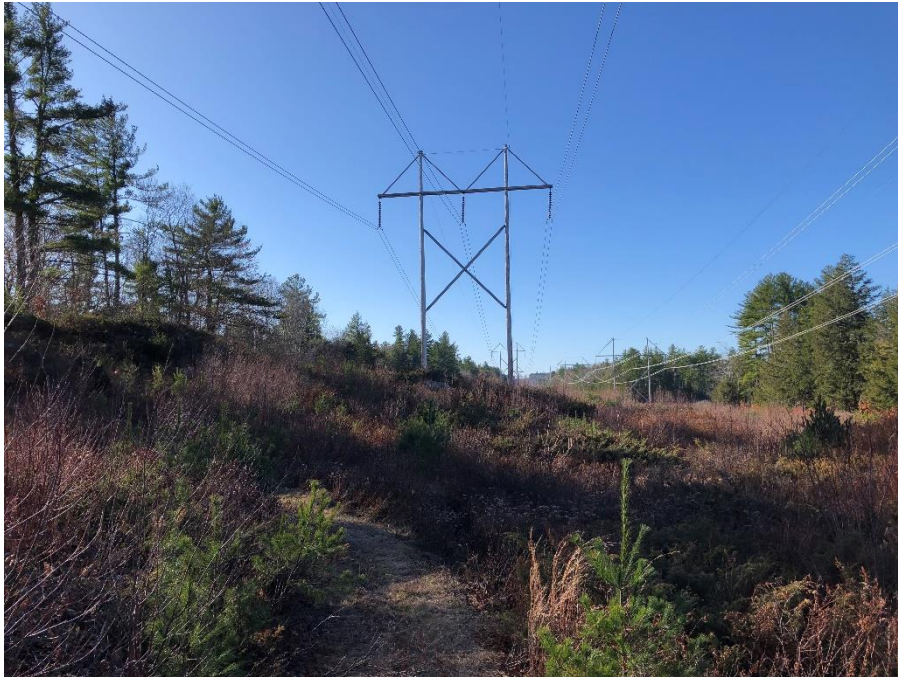
Photograph No. 9: Looking southwesterly at proposed structure replacement 391 structure 162 and proposed access in Deerfield.

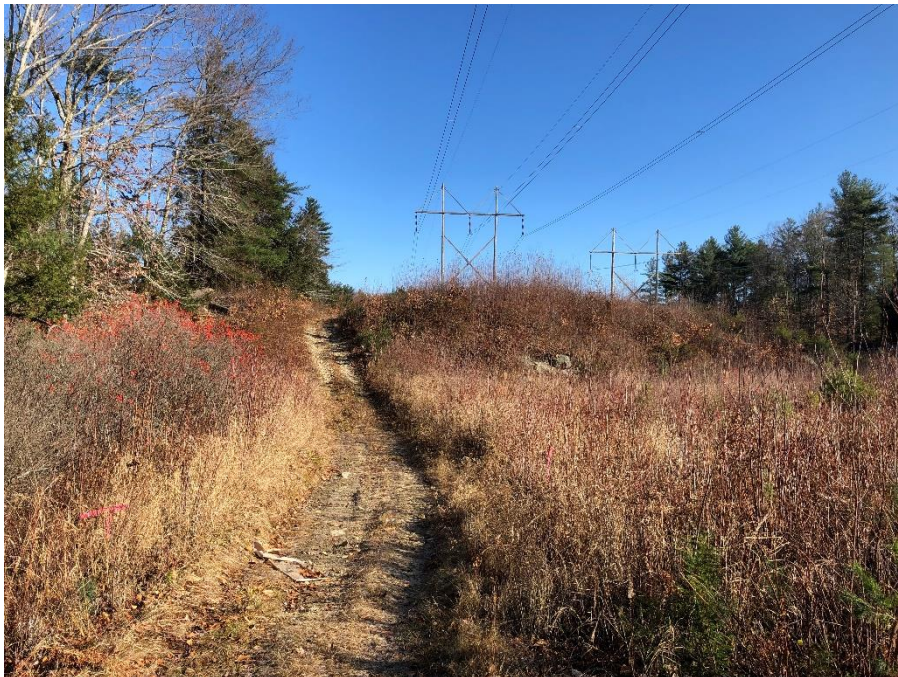
Photograph No. 10: Looking northeasterly at proposed access route between 385 structures 157 & 156 in Deerfield.

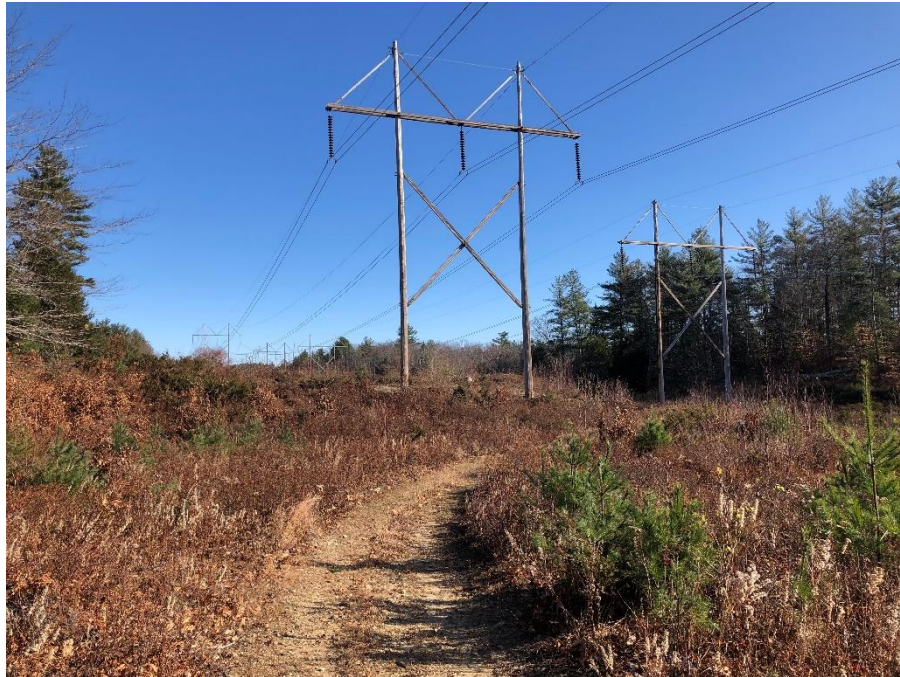
Photograph No. 11: Looking northeasterly at proposed structure replacement 385 structure 156 in Deerfield.

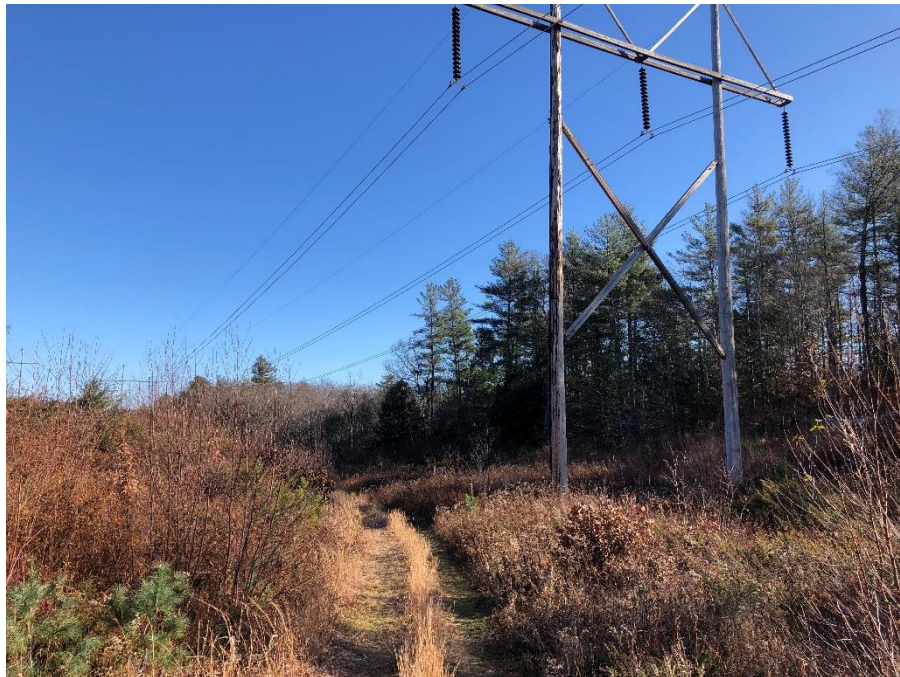
Photograph No. 12: Looking easterly at proposed access and proposed structure replacement 391 structure 161 in Deerfield.

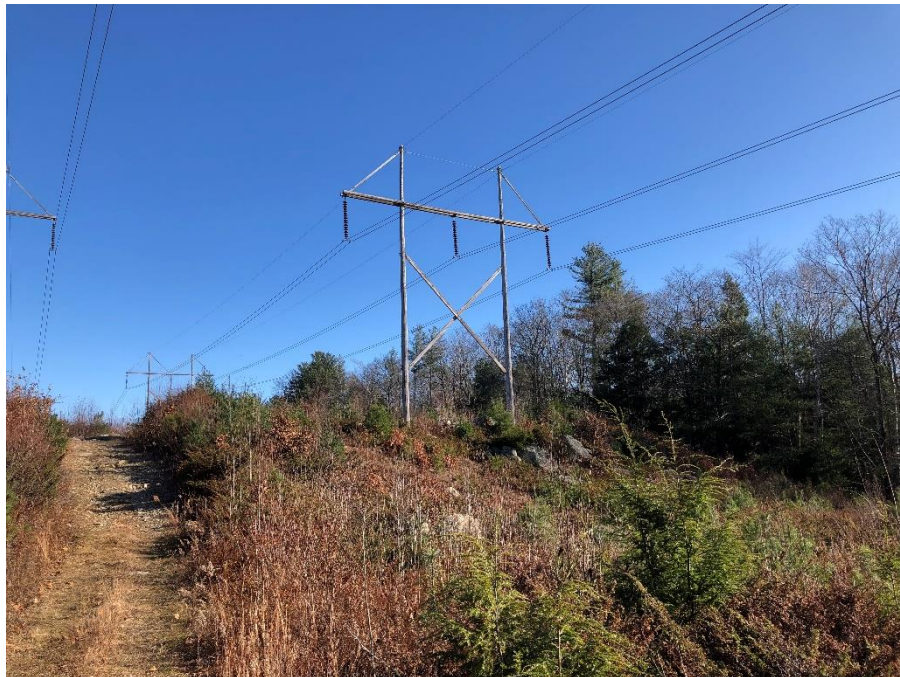
Photograph No. 14: Looking northeasterly at proposed structure replacement 385 structure 160 (right) with proposed access (left) in Deerfield.

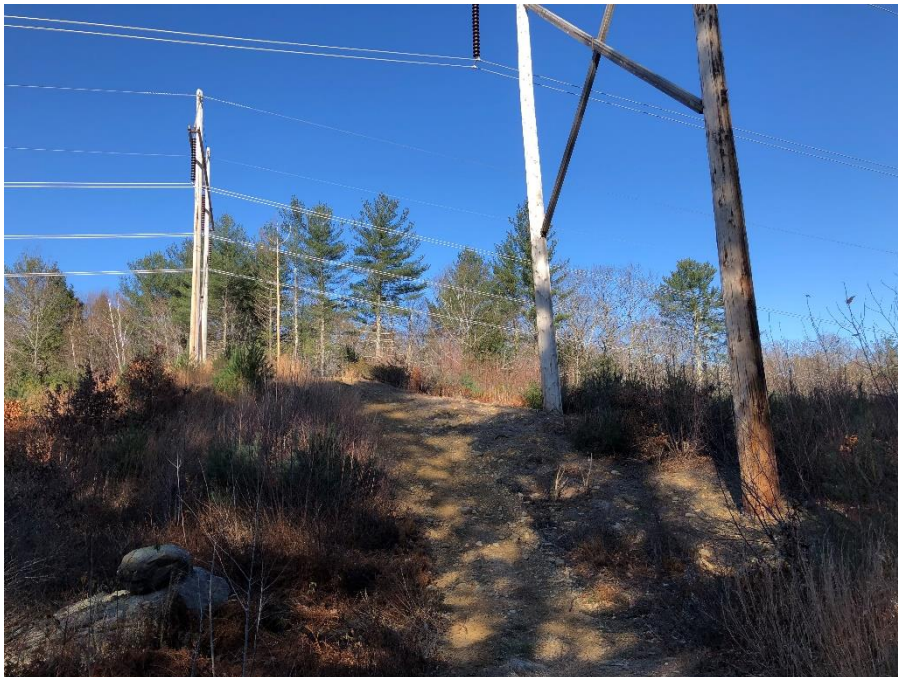
Photograph No. 18: Looking northwesterly at proposed structure replacement 385 structure 154 (left) and 391 structure 158 (right) with proposed access in-between the two structures in Deerfield.

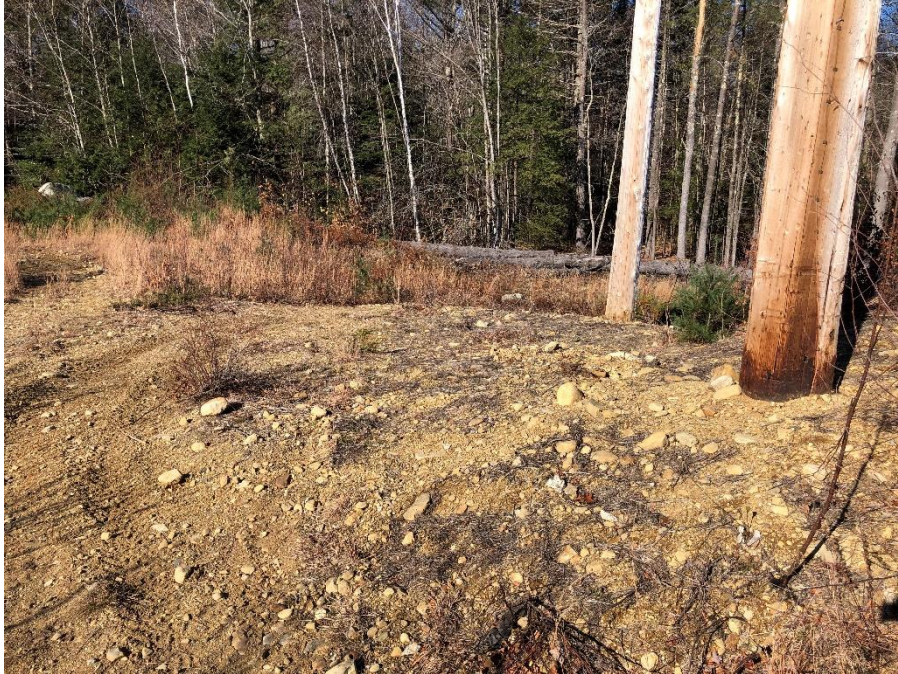
Photograph No. 19: Looking northwesterly at proposed structure replacement 385 structure 154 work pad in Deerfield.

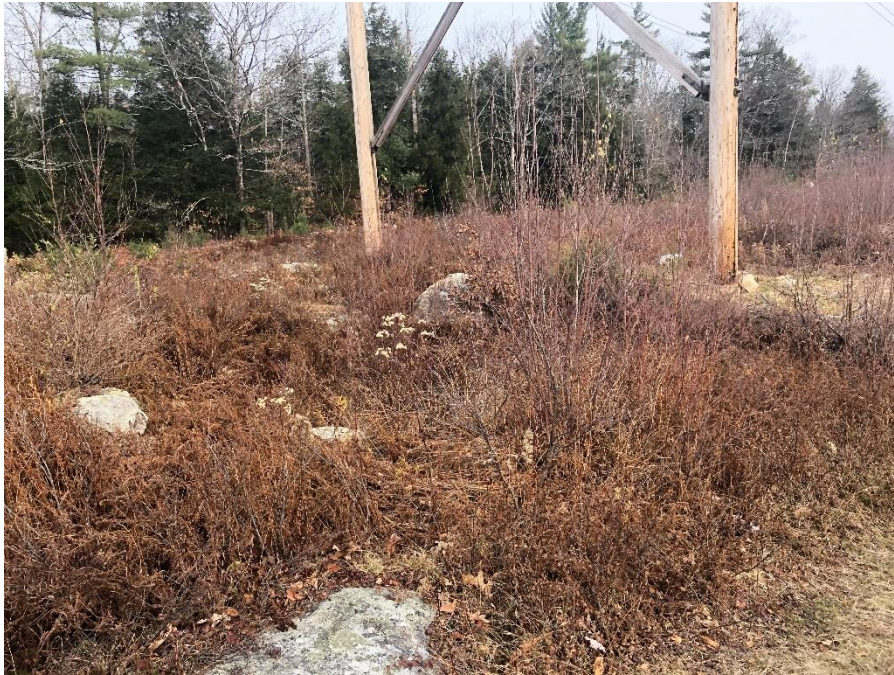
Photograph No. 41: Looking northeasterly at proposed work pad location adjacent to 385 Line Structure 94 Strafford.

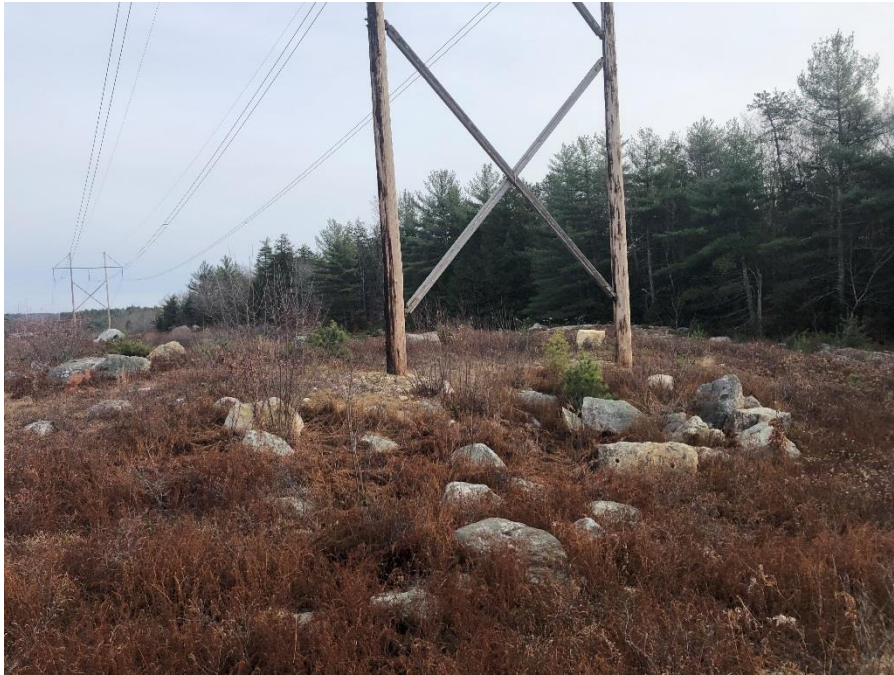
Photograph No. 43: Looking northeasterly at proposed work pad location adjacent to 391 Line Structure 98 Strafford.

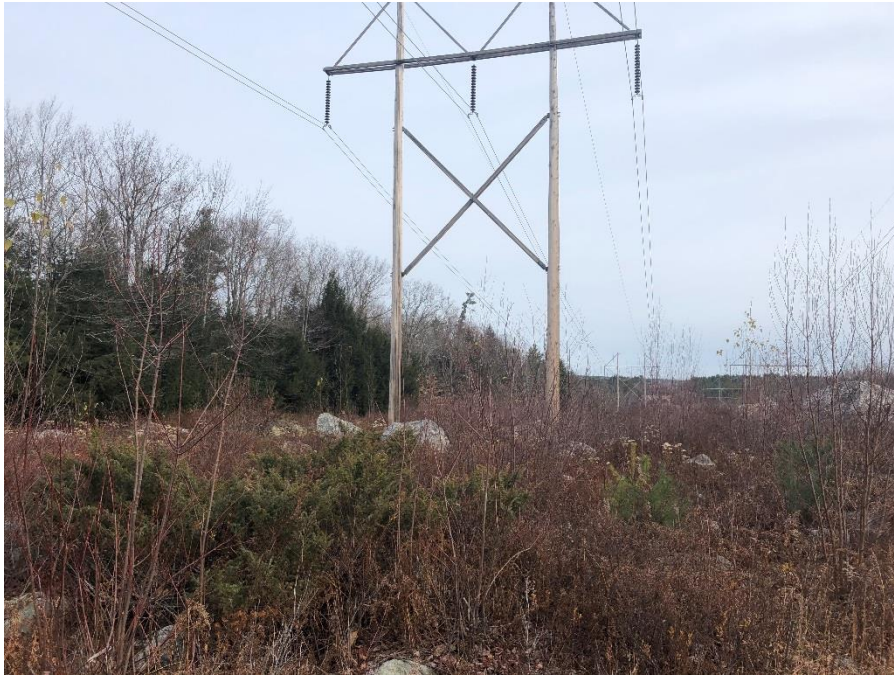
Photograph No. 47: Looking northeasterly at proposed work pad location adjacent to 385 Line Structure 92 Strafford.

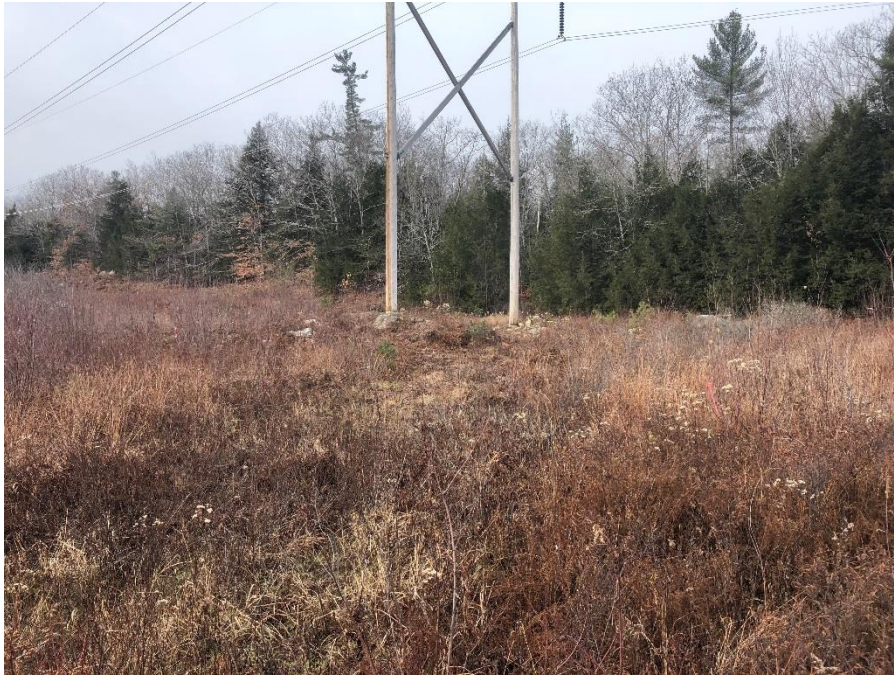
Photograph No. 49: Looking westerly at proposed work pad location adjacent to 385 Line Structure 91 Strafford.

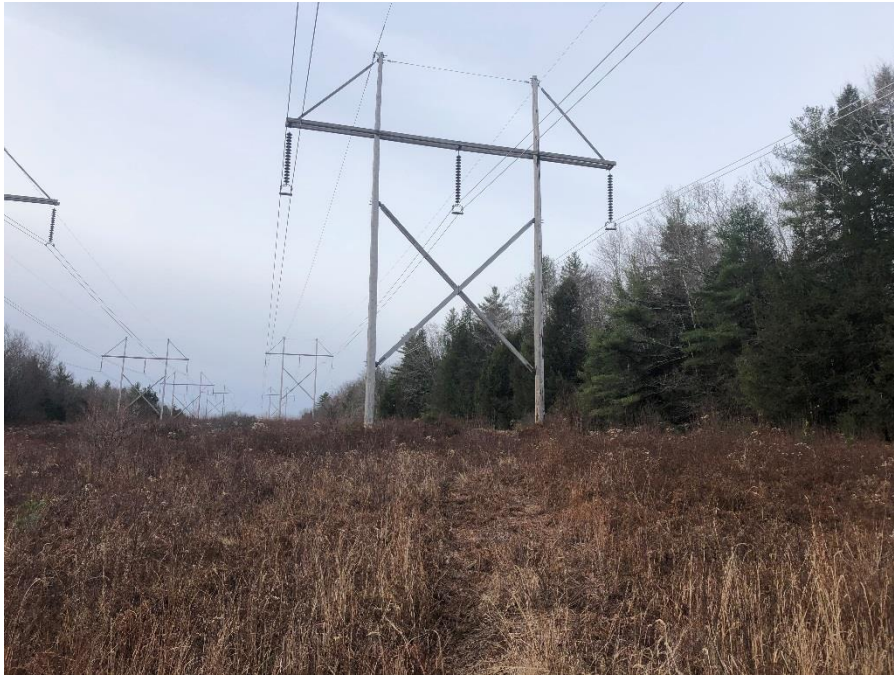
Photograph No. 51: Looking northeasterly at proposed work pad location adjacent to 385 Line Structure 90 Strafford.

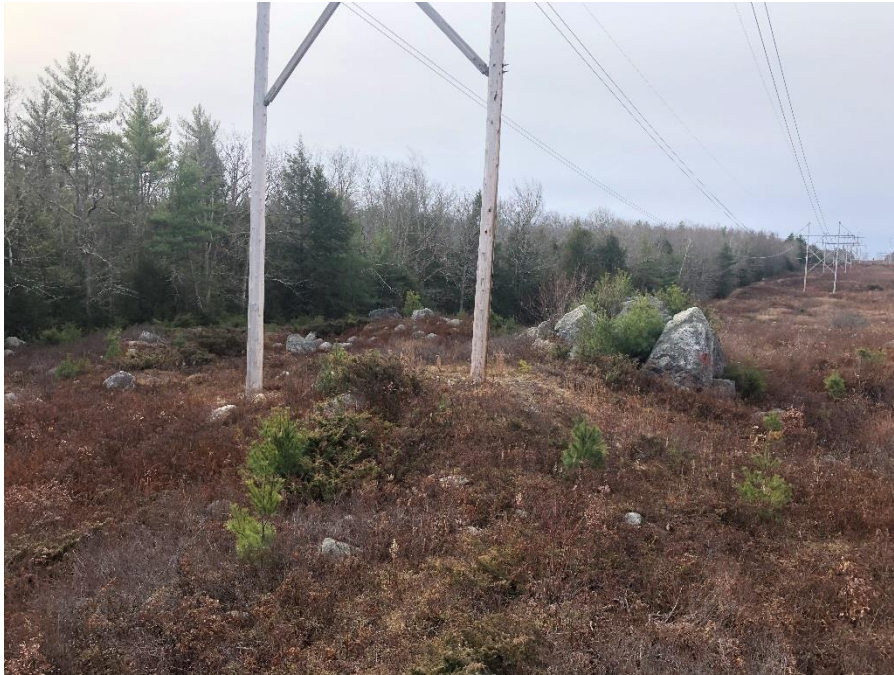
Photograph No. 53: Looking southerly at proposed work pad location adjacent to 391 Line Structure 93 Strafford.
