January 21, 2024

To ISO-NE and the PAC,

Comments on Eversource’s Hurd State Park project:

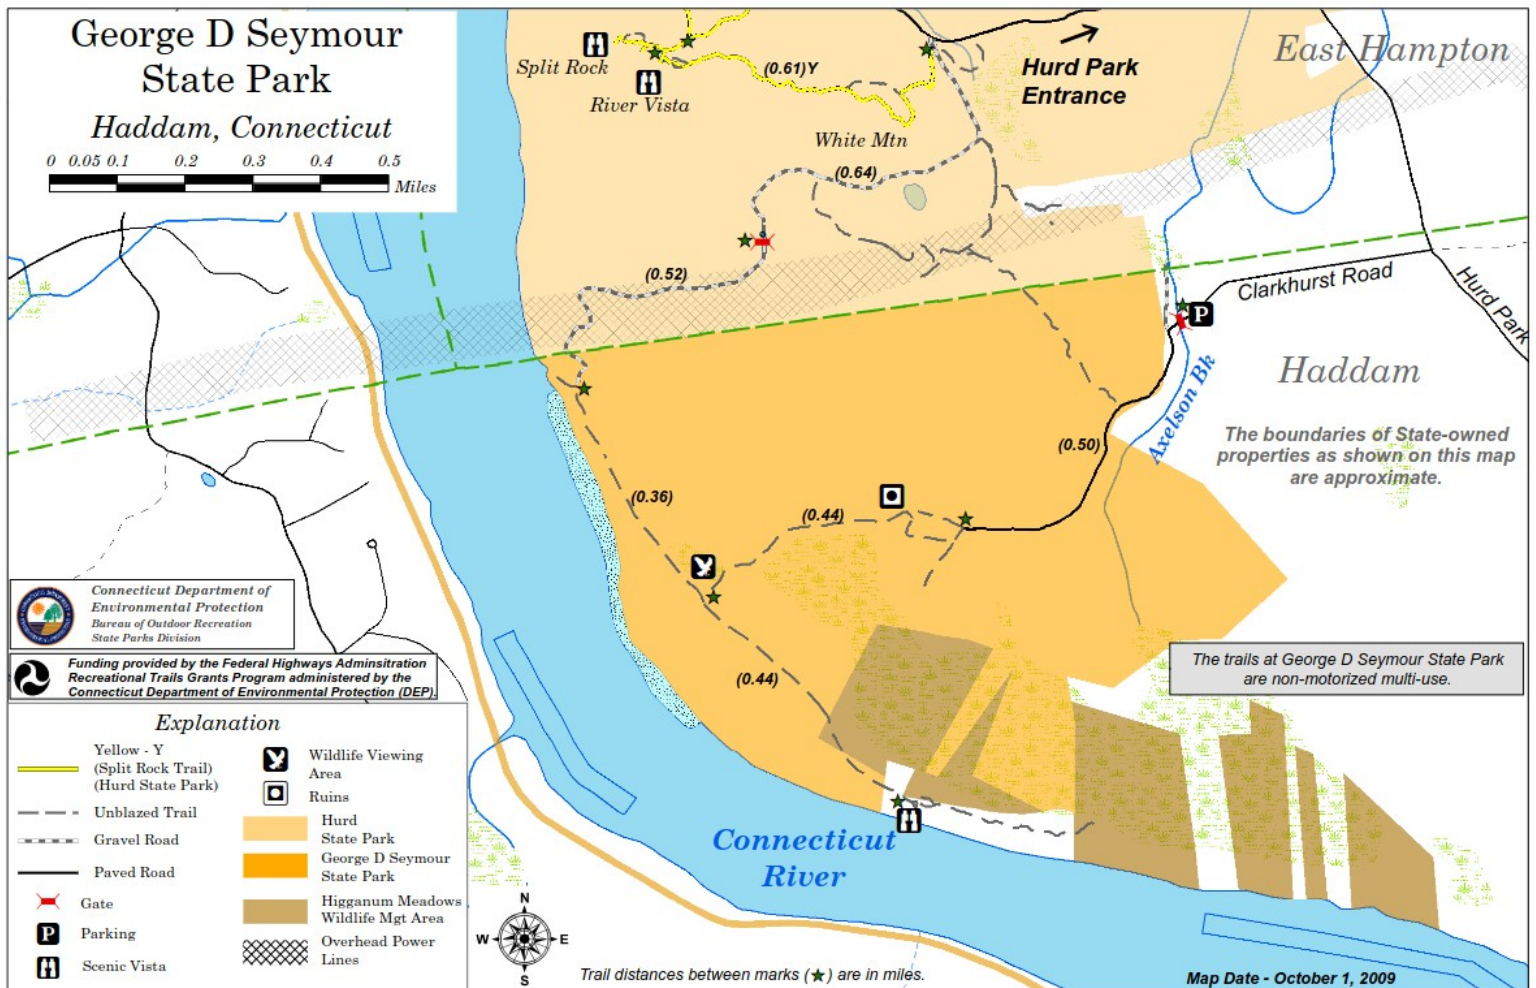
On the map below the faint grey cross-hatching shows the powerline easement. The author of a 12/26/2023 [article](#) about George D. Seymour State Park, wrote: “Follow the transmission right-of-way for about a half-mile and look for a path to a gate that will take you into [Hurd State Park](#). Follow to the end of the road and take the trail marked with orange blazes to the top of White Mountain north to the River Vista and Split Rock overlooks. It is one of the most impressive views in central Connecticut.”

Eversource should have provided, and needs to provide now, a map like the one below but with the addition of topo lines and the proposed locations of the structures Eversource plans to replace. This should have been posted months ago, at both Park entrances, to reach the real stakeholders.

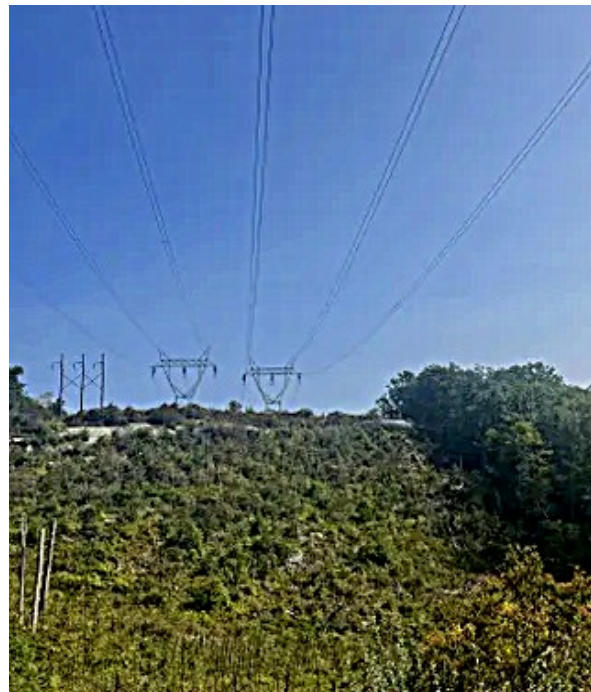
Right: Eversource transmission corridor in Hurd State Park. (AllTrails)

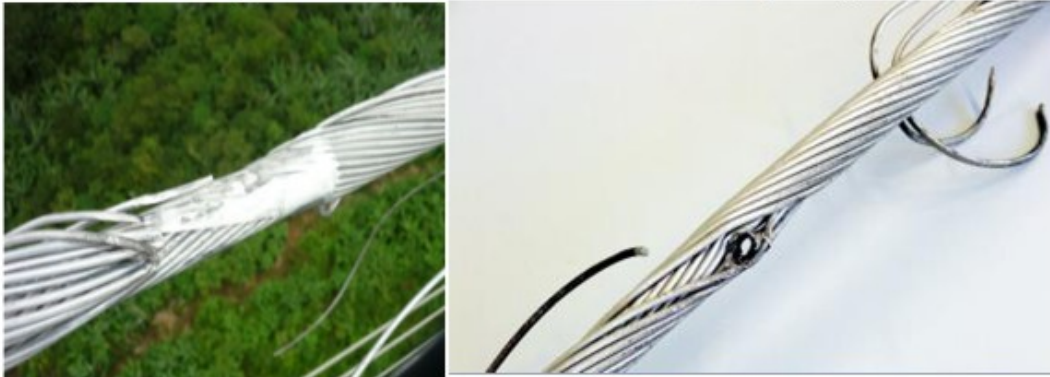
Conductor Damage and Broken Conductor Strands at suspension points are commonly related to Aeolian vibration. Fixed points are those components that are prone to reflect vibration, such as deadends, suspension clamps, and conductor spacers. Many photographs have been circulated in previous Cigre bulletins and other venues throughout the electrical transmission industry. The example photos below, illustrate wear and damage to conductor strands from dampers, spacer dampers, and of course, gunshots. Rarely is there damage to the core wires of ACSR conductors, but it gets very close on occasion.

Abraded Conductor

Gunshot Damage

The resultant damage forces current constriction, driving current through the remaining unbroken strands, which of course results in localized heating and if left unattended will eventually result in local conductor annealing and potentially tensile failure.

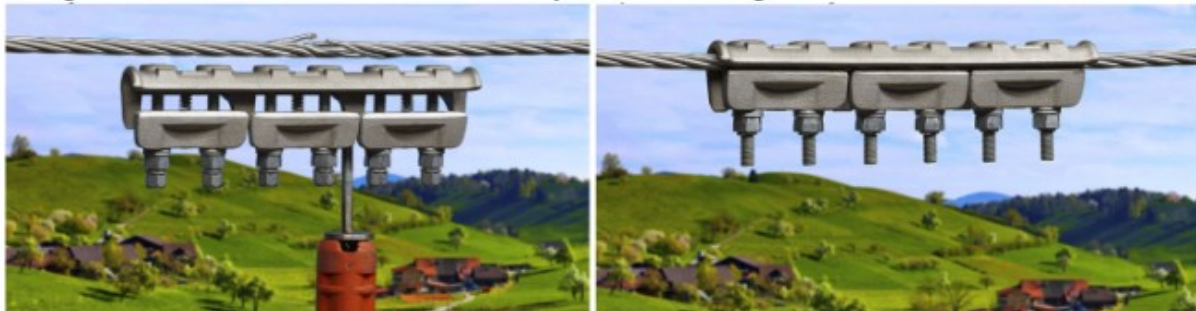
Mitigation of this type of problem is easily addressed with EEMS devices known as Conductor Repair Units (CRUs), which serve to provide an alternate current path and restore full mechanical integrity.

The following illustrations depict the installation of a smaller size CRU installed to restore conductor damage on a distribution line. These are commonly installed on energized lines with hotline tools.
