CONSTRUCTION MONITORING REPORT

Eversource Transmission Lines:

B112 Transmission Line

Campton, Sandwich, and Tamworth, New **Hampshire**

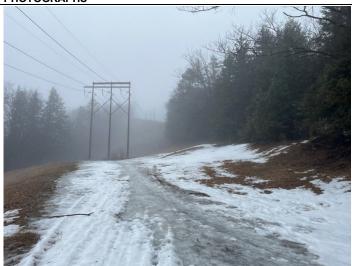
Looking northeast towards Structure 2 off NH Route 175, Campton.

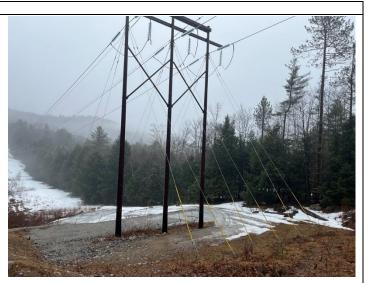
Looking southeast at Structure 8 off Page Road, Campton.

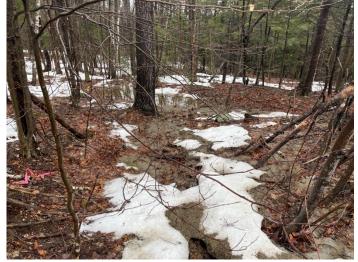
- Mount Israel Road, Sandwich
 - Rapid snow melt combined with rain has impacted locations, especially areas with steep slopes, along Mount Israel Road. GZA observed rills and sediment migration along the access road and in vicinity of Wetlands SW-65 and 66, and off-ROW woodlands between Structures 116 to 121.

Looking northeast at sediment migration within off-ROW woodlands between Structures 118 to 119 off Mount Israel Road, Sandwich. GZA recommends removal of sediment buildup down to native soils.

- GZA recommends perimeter control maintenance as well as sediment removal at several locations along the
 access road and four off-ROW locations. Sediment that migrated into wetlands and off-ROW woodlands should be
 removed down to native soils using shovels. Native soils should be left in place and stabilized.

- Remove sediment buildup in two sediment traps, maintain water bars, and remove sediment accumulated within approximately 80 sqft of off-ROW woodlands between Structures 118 to 119,

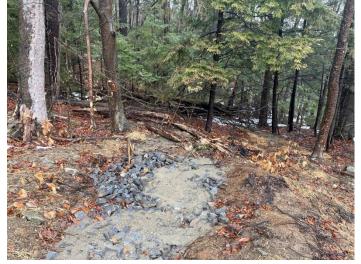
Looking northeast at a sediment trap between Structures 119 to 120 off Mount Israel Road, Sandwich. GZA recommends removal of sediment buildup.

- Remove sediment buildup in one sediment trap, maintain water bars, and remove sediment accumulated within approximately 25 sqft of off-ROW woodlands between Structures 119 to 120, and
