**NHDES Alteration of Terrain
Permit Application**

C189, M108, H137, and G146 Structure
Replacement Project
Concord, Pembroke, and Bow, New Hampshire

January 27, 2023

Public Service Company of New Hampshire
d/b/a Eversource Energy
13 Legends Drive
Hooksett, NH 03106

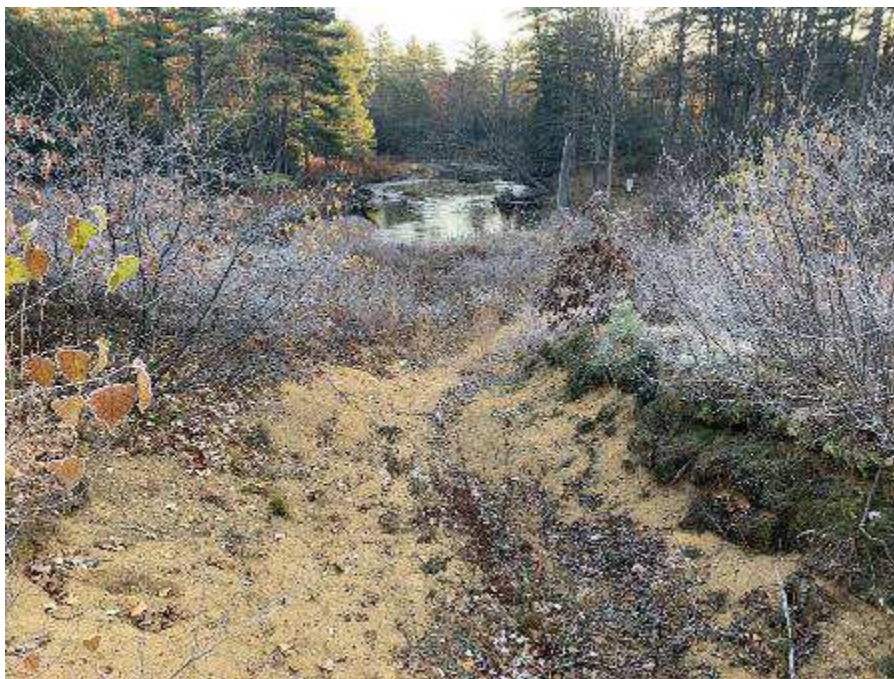
Photo 53. Sandy access trail in ROW near Soucook River. November 9, 2021.

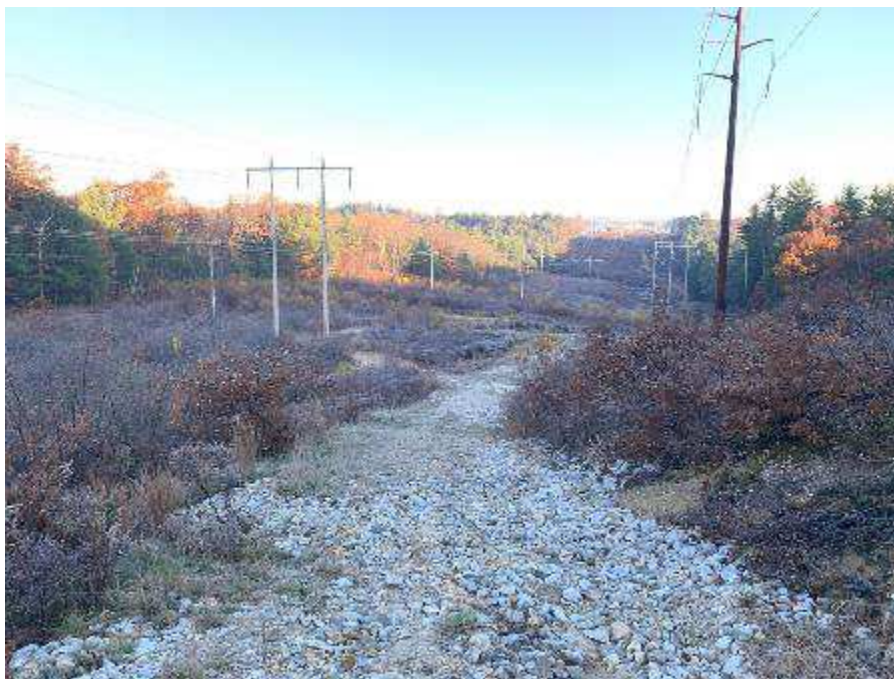
Photo 55. Shrub-dominated sandy uplands and existing access road near structure 73. November 9, 2021.

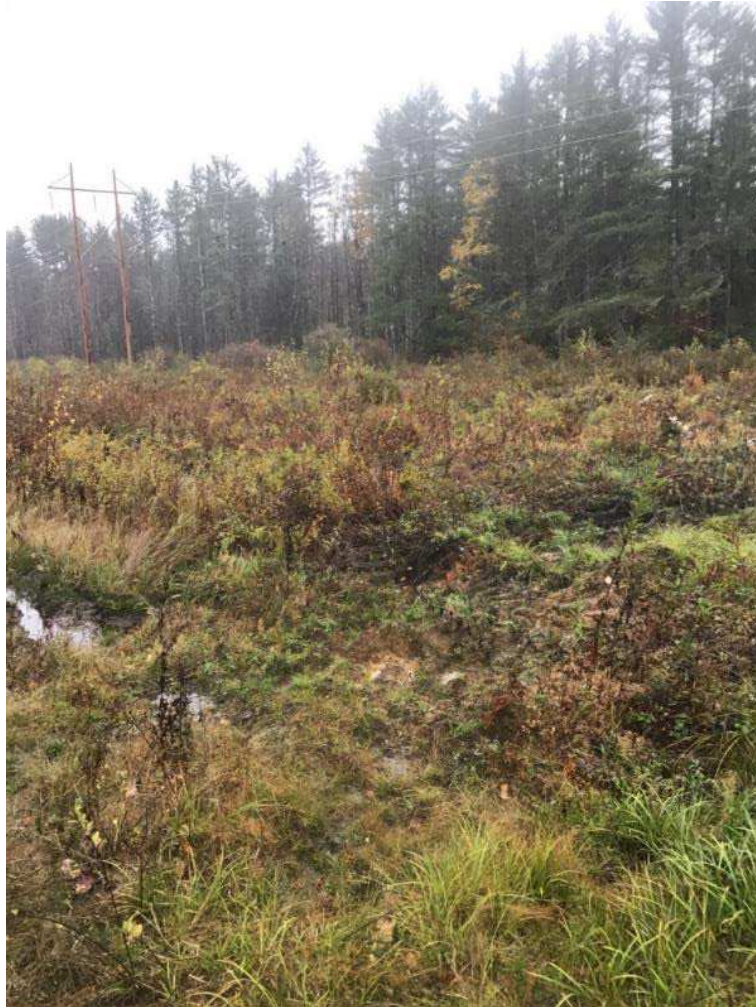
Photo 1. Existing ROW conditions near existing C189 Structure 109 and Farmwood S/S in Concord, NH. Stantec, October 25, 2021.

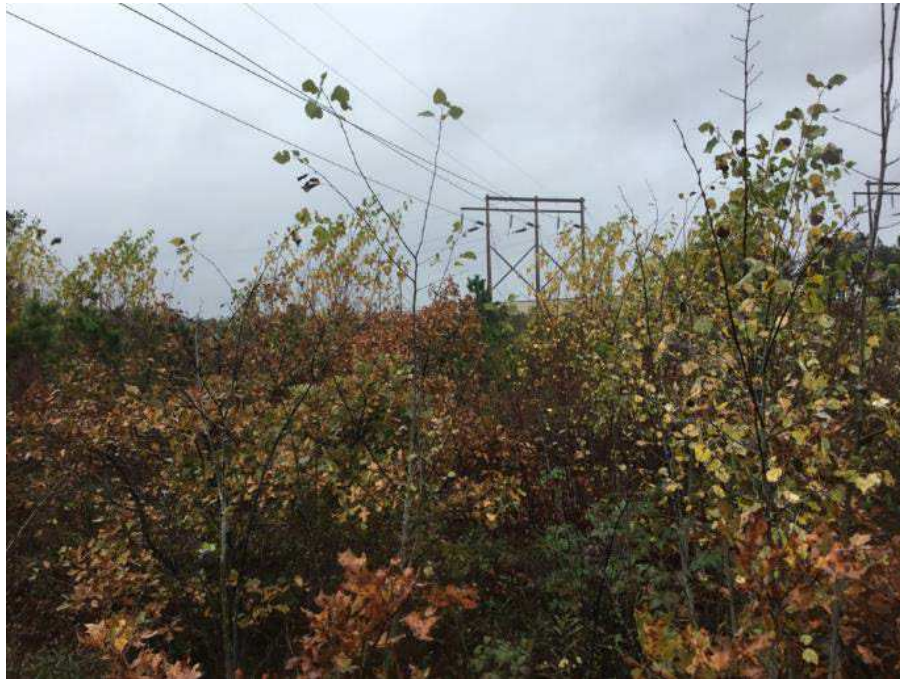
Photo 12. Existing ROW conditions near proposed Structure 46 in Concord, NH.
Stantec, October 26, 2021.

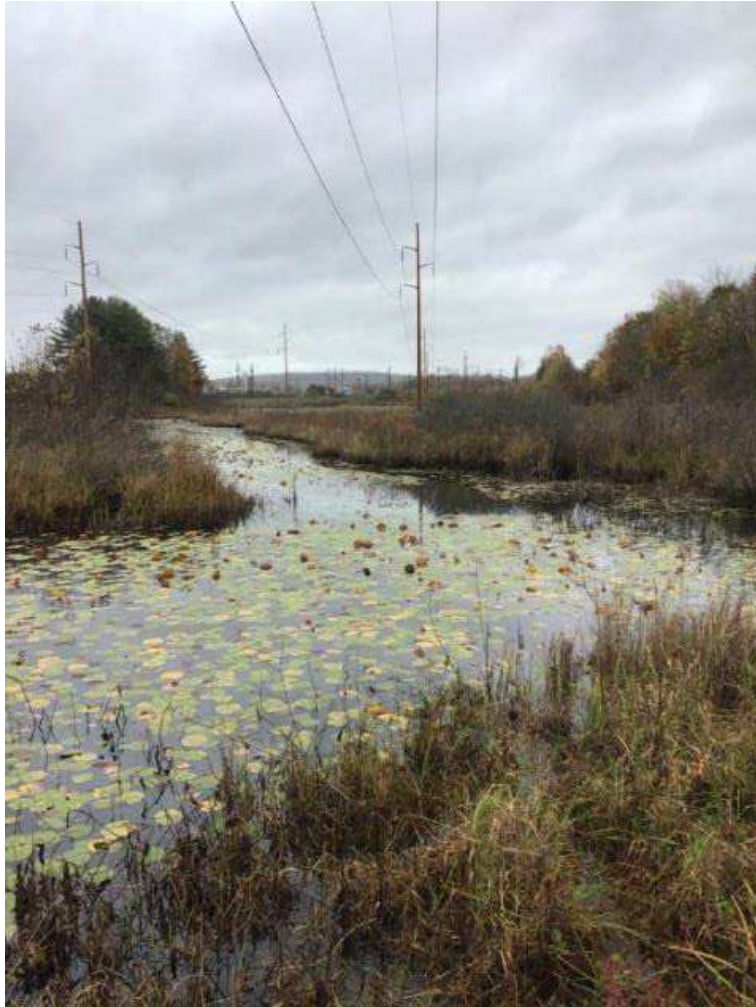
Photo 23. Existing ROW conditions and large ponded wetland near proposed H137 Structure 2 and the Merrimack substation in Bow, NH. Stantec, October 27, 2021.
