Concerns Identified During the Warner River Protected Instream Flow Study Reconnaissance
August 10 and 12, 2020

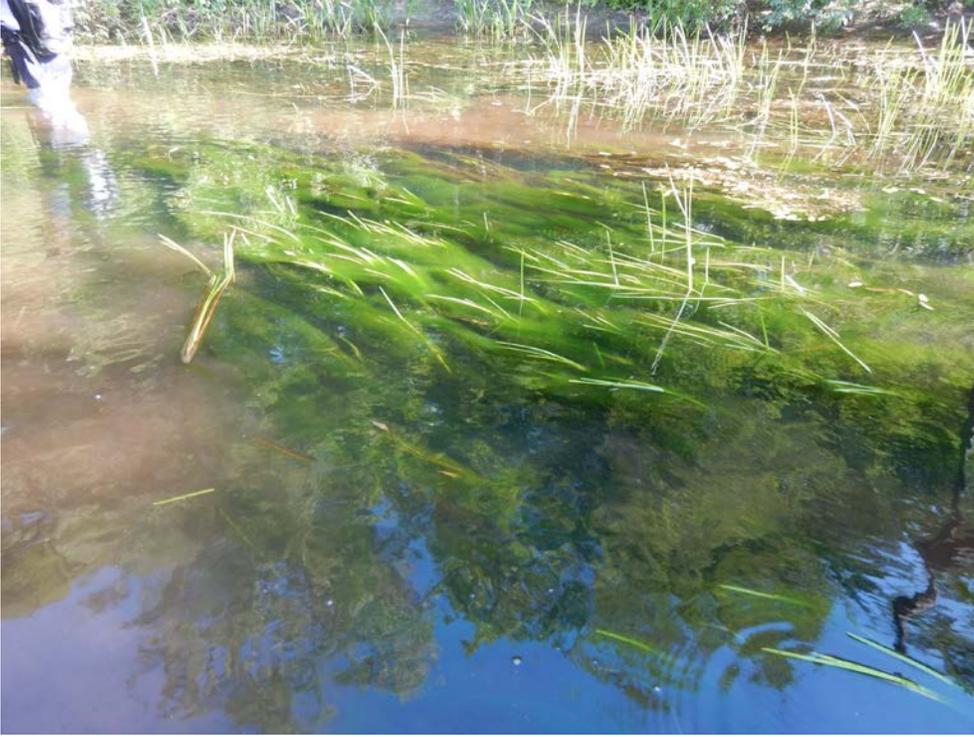
Photo 1189: Looking south at Warner River channel at the mouth of Schoodac Brook. Algal bloom appears suddenly at this point in the river.

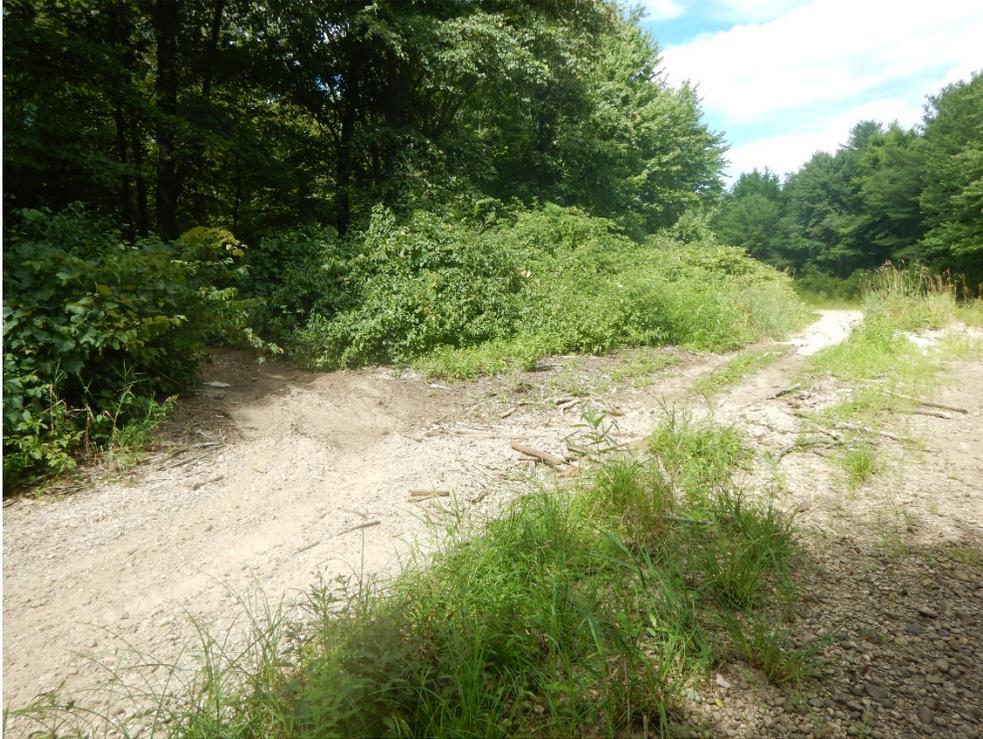
Photo 1207: Looking north along river-right bank of the Warner River at all-terrain vehicle tracks in the riverine, scrub-shrub/emergent wetlands, which are jurisdictional under Env-Wt 100-900.

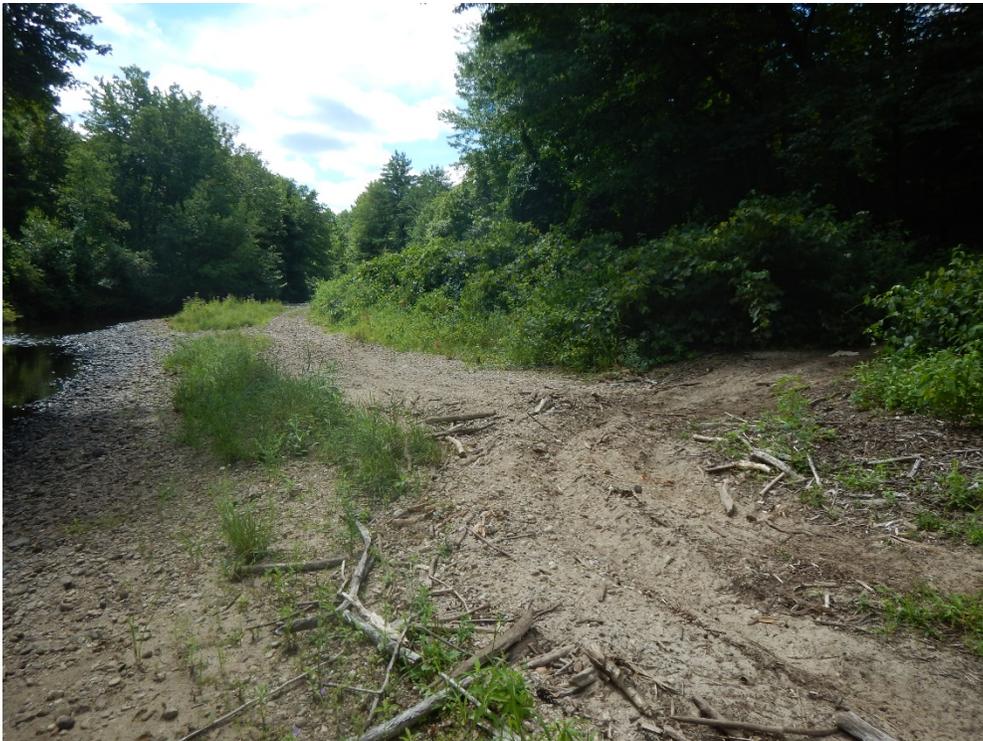
Photo 1208: Looking south along river-right bank of the Warner River at all-terrain vehicle tracks in the riverine, scrub-shrub/emergent wetlands, which are jurisdictional under Env-Wt 100-900.

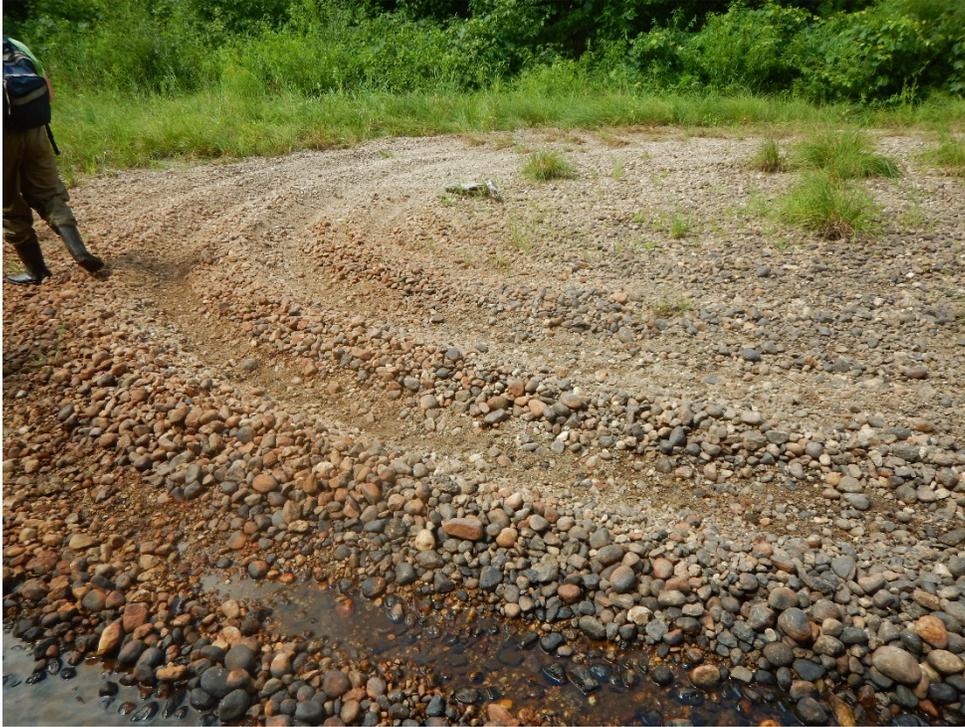
Photo 1209: Looking southwest along river-right bank of the Warner River at all-terrain vehicle tracks in the riverine, emergent wetlands, which are jurisdictional under Env-Wt 100-900.

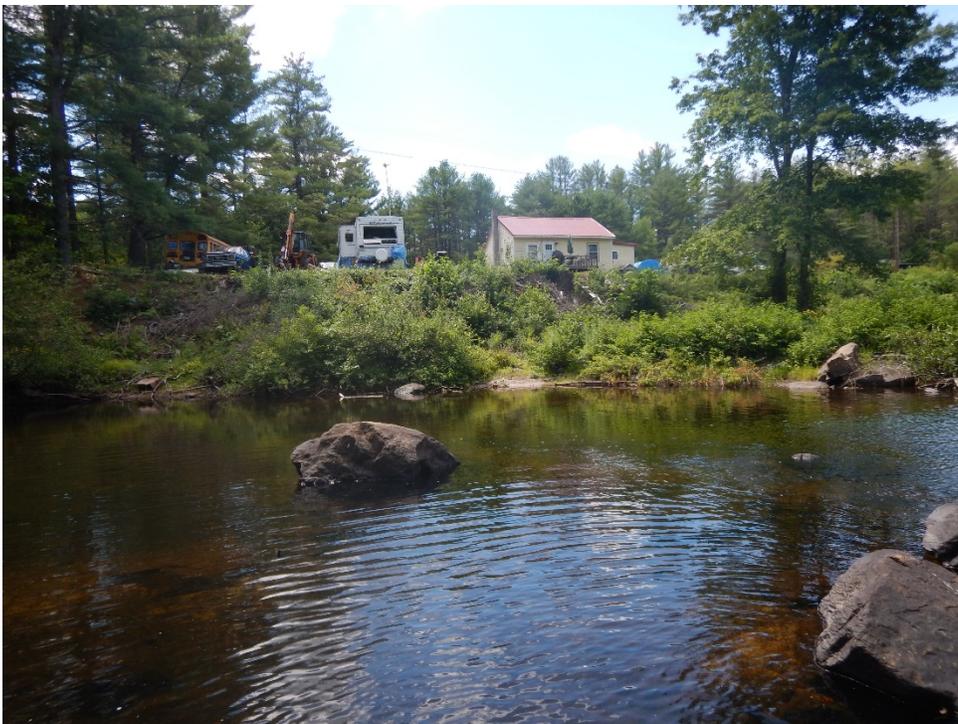
Photo 1213: Looking south at the river-right bank of the Warner River at development at the end of Willey Lane (perhaps #38 according to Google Maps). Extensive clearing of vegetation and possible filling of unknown provenance (e.g, timing, permitting status) in areas under the jurisdiction of Env-Wt 100-900 and Env-Wq 1400.

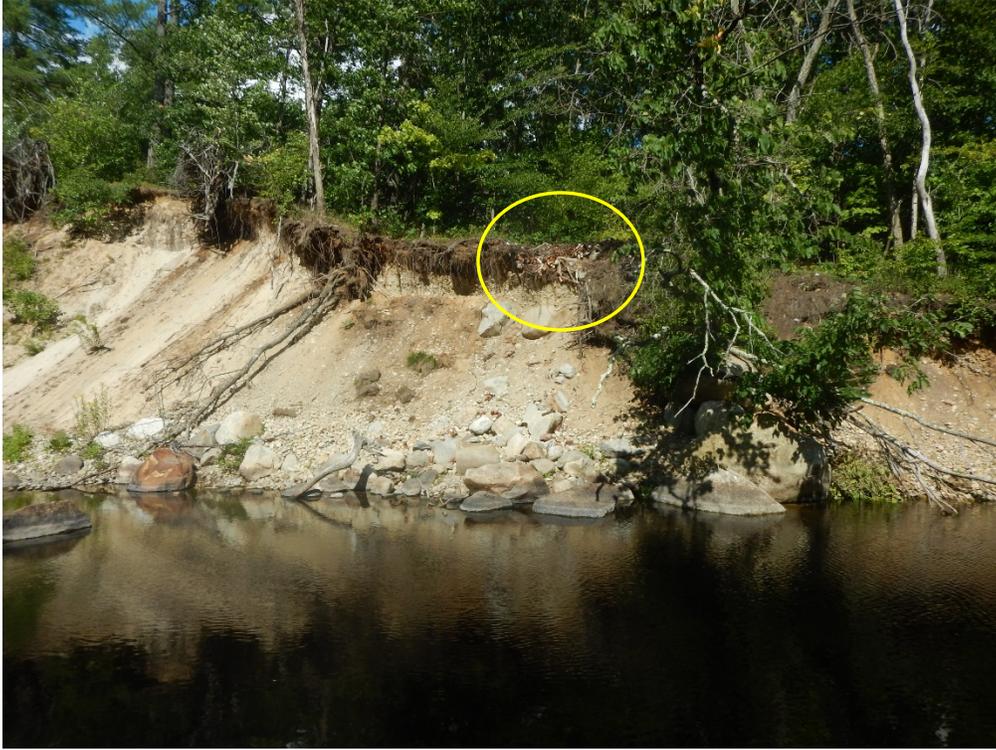
Photo 1223: Looking north at the river-left bank of the Warner River, which is eroding. At center of photo, the top of bank material includes an old dump, which is contributing waste materials to the river channel.

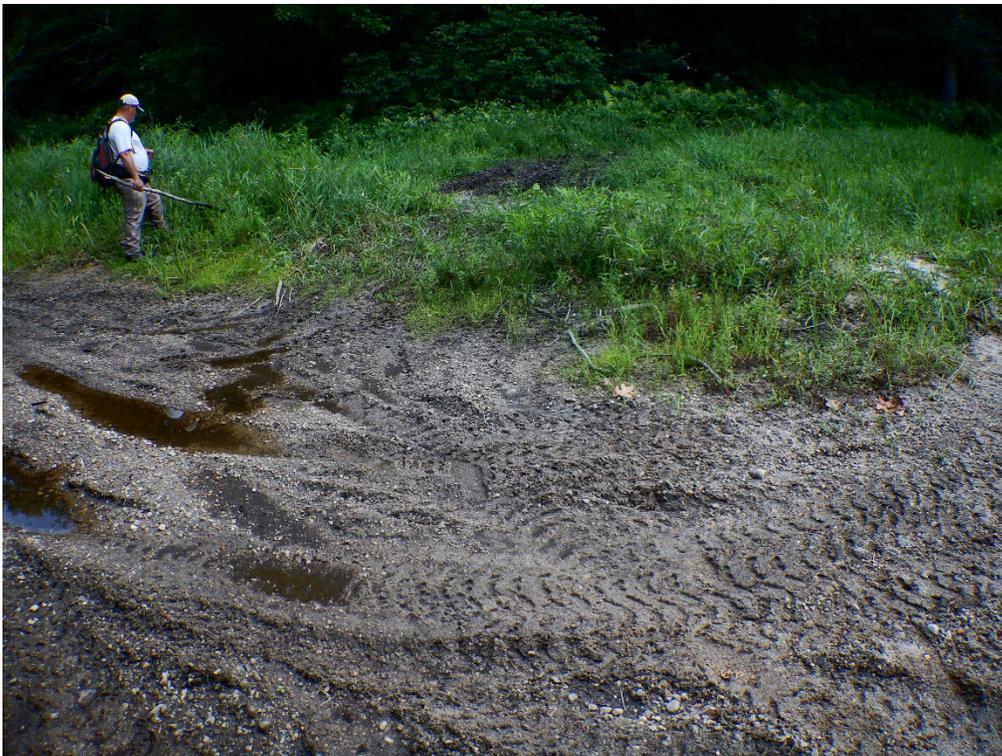
Photo 1231: Looking south at the river-right bank of the Warner River at all-terrain vehicle tracks in the riverine, emergent wetlands, which are jurisdictional under Env-Wt 100-900.

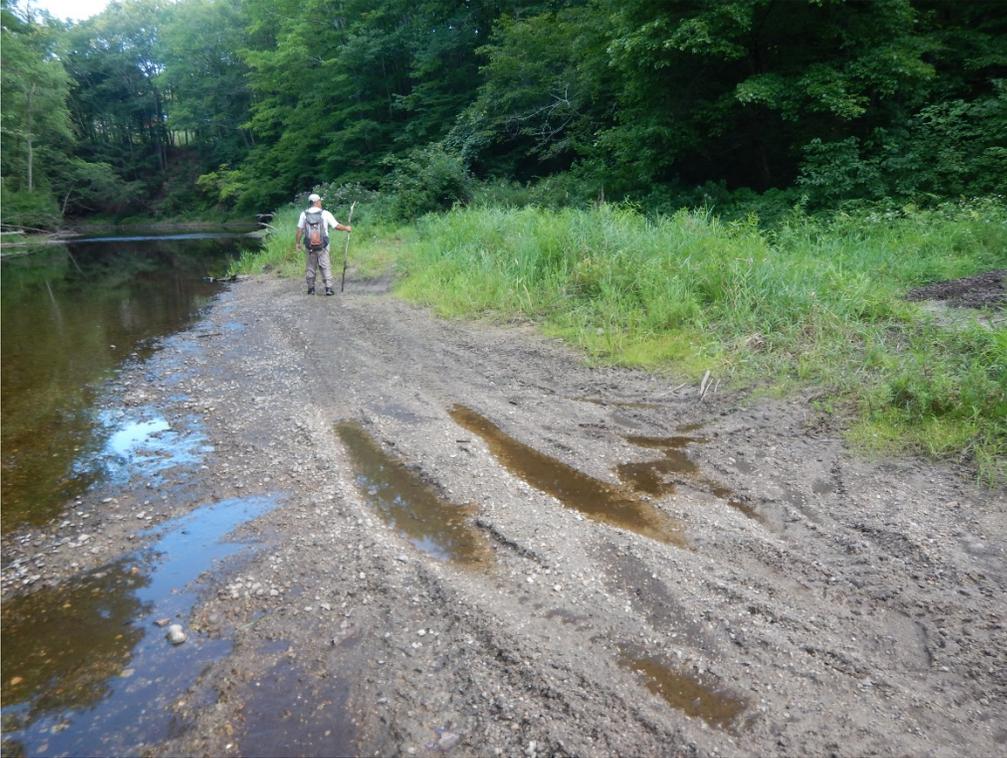
Photo 1232: Looking southeast along the river-right bank of the Warner River at all-terrain vehicle tracks in the riverine, emergent wetlands, which are jurisdictional under Env-Wt 100-900.
