Re: Conditional Use Permit Application
Eversource Energy
2021 E194, U181, & 3135 Transmission Line Structure
Replacement Project
Portsmouth, New Hampshire

E194, U181, & 3135 Transmission Line Structure Replacement Project Portsmouth, New Hampshire

E194, U181 & 3135 Transmission Lines - Structure Replacement Project

Environmental Resources Map

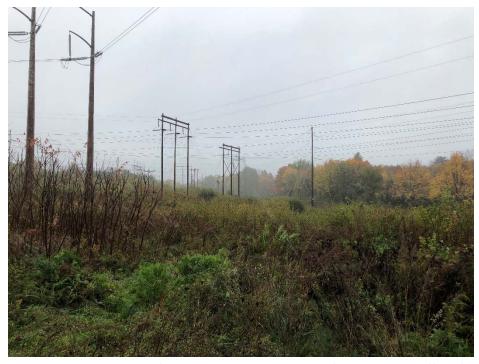
Photograph No. 1: Southeasterly view of proposed access in the 100-foot wetland buffer of Wetland PW-28 from Gosling Road towards E194 Structure 3 to be replaced.

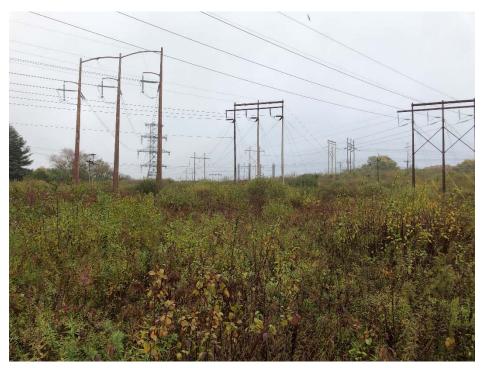
Photograph No. 2: Easterly view of E194 Structure 3 (center) to be replaced within Wetland PW-28.

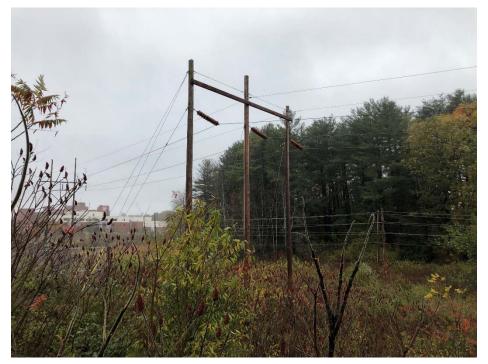
Photograph No. 3: Southwesterly view of proposed access and work area in the 100-foot wetland buffer of Wetland PW-11 for E194 Structure 34 to be replaced.

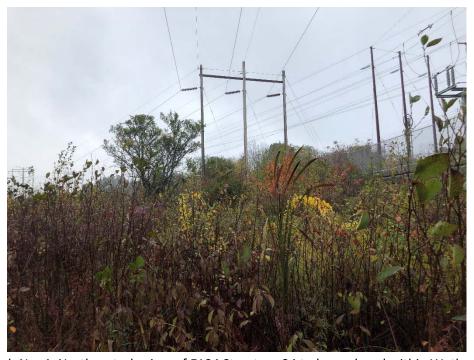
Photograph No. 4: Northeasterly view of E194 Structure 34 to be replaced within Wetland PW-11.

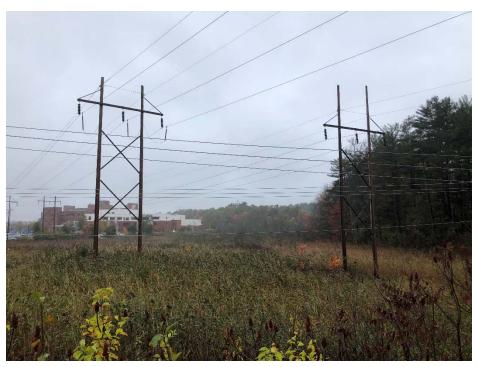
Photograph No. 5: Southwesterly view of E194 Structure 35 (right) and U181 Structure 35 (left) to be replaced within Wetland PW-11.

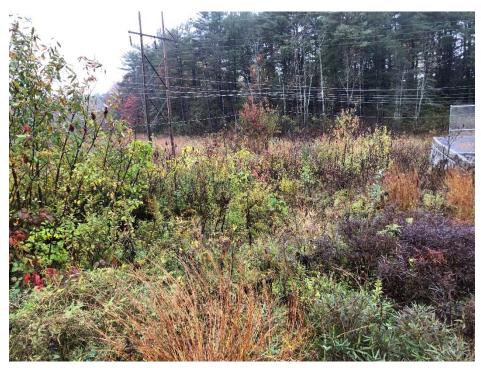
Photograph No. 6: Westerly view of proposed access in the 100-foot wetland buffer of Wetland PW-11.

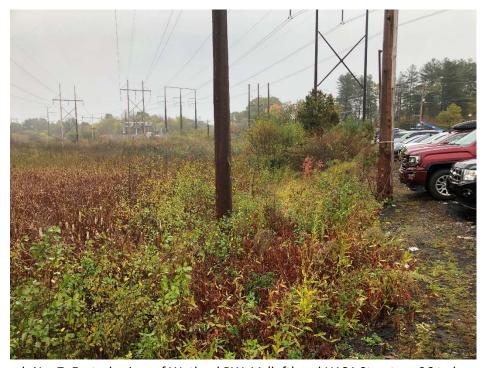
Photograph No. 7: Easterly view of Wetland PW-11 (left) and U181 Structure 36 to be replaced.

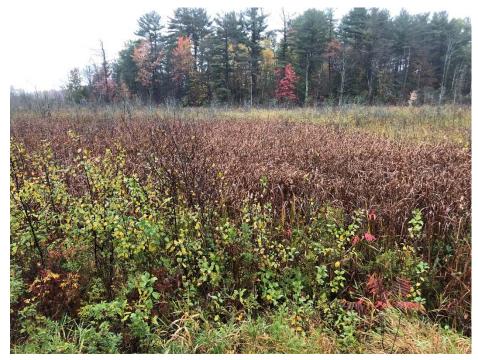
Photograph No. 8: Northerly view of Wetland PW-11 from U181 Structure 36 to be replaced.

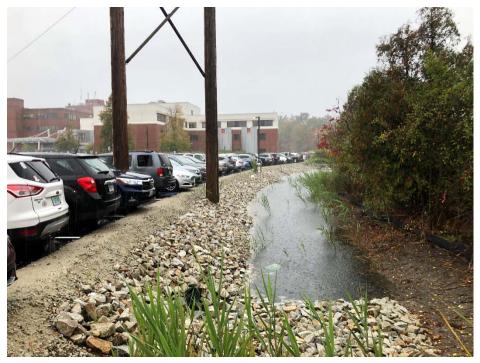
Photograph No. 9: Westerly view of Wetland PW-11 (right) and E194 Structure 36 to be replaced.

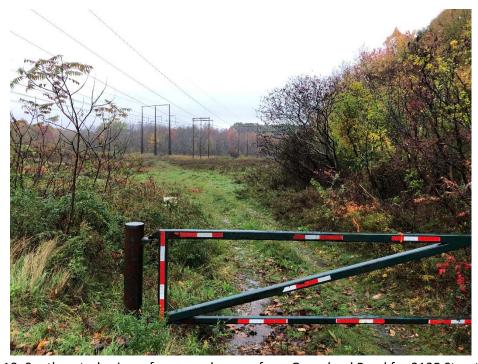
Photograph No. 10: Southeasterly view of proposed access from Greenland Road for 3135 Structure 105 and 106 to be replaced.

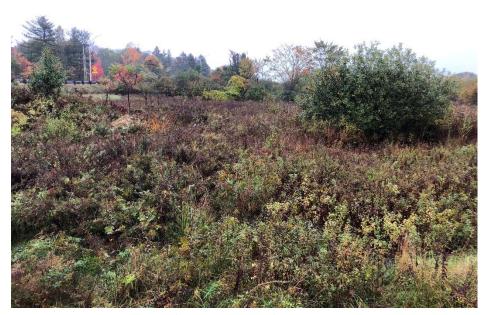
Photograph No. 11: Northeasterly view of Wetland PW-7 from proposed access route. There are no direct impacts to this wetland system.

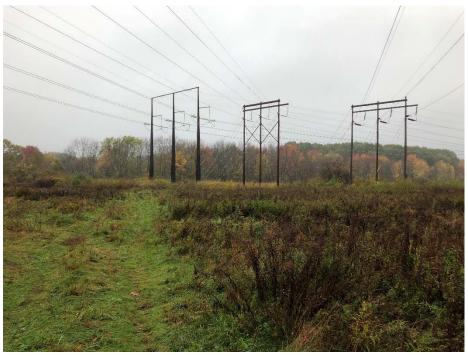
Photograph No. 12: Southeasterly view of proposed access in the 100-foot wetland buffer of Wetland PW-6 for 3135 Structure 105 and 106 to be replaced.

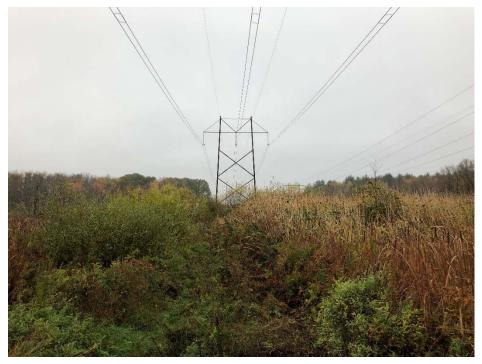
Photograph No. 13: Southwesterly view of 3135 Structure 106 to be replaced within Wetland PW-6.

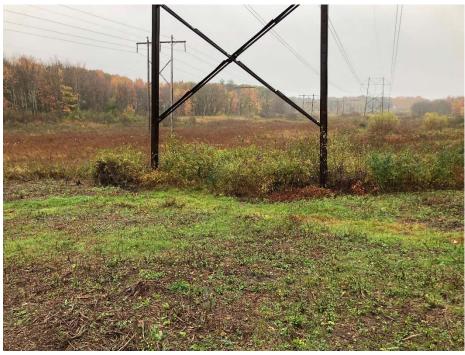
Photograph No. 14: Northeasterly view of 3135 Structure 105 to be replaced within the 100-foot wetland buffer of Wetland PW-6.

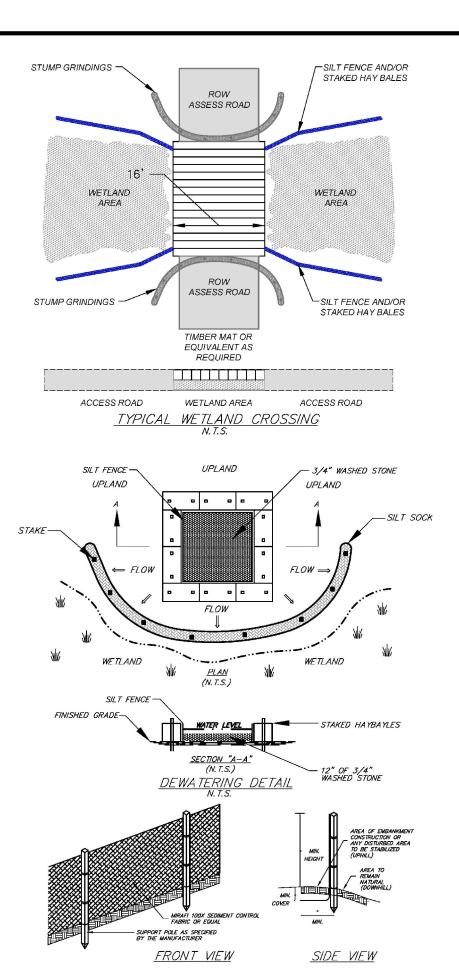
TYPICAL SWAMP MAT PLAN VIEW

- 9. TIMBER MATS AND PERIMETER CONTROLS WILL BE USED ALONG ACCESS ROUTES AND WORK PADS WITHIN WETLAND AREAS. THESE MATS ARE CONSTRUCTED OF HEAVY TIMBERS OR COMPOSITE MATERIAL, BOLTED TOGETHER, AND ARE PLACED END-TO-END IN THE WETLAND TO SUPPORT HEAVY EQUIPMENT. ALL SWAMP MATS SHALL BE PLACED AND REMOVED SO AS NOT TO CAUSE ANY RUTS, CHANNELS OR DEPRESSIONS, OR OTHERWISE CAUSE ANY UNDUE DISTURBANCE TO WETLANDS.

VEGETATION SURFACE TYPICAL SWAMP MAT SECTION DETAIL
