## **Kelsey Notch Trail Environmental Compliance Report 2022**

**Date Reviewed:** October 5, 2022

**Overview-** The Department of Natural and Cultural Resources is required to submit an environmental compliance report to CORD annually. This report is a requirement of the conditional approval by CORD, dated March 29, 2021, for the Kelsey Notch Trail.

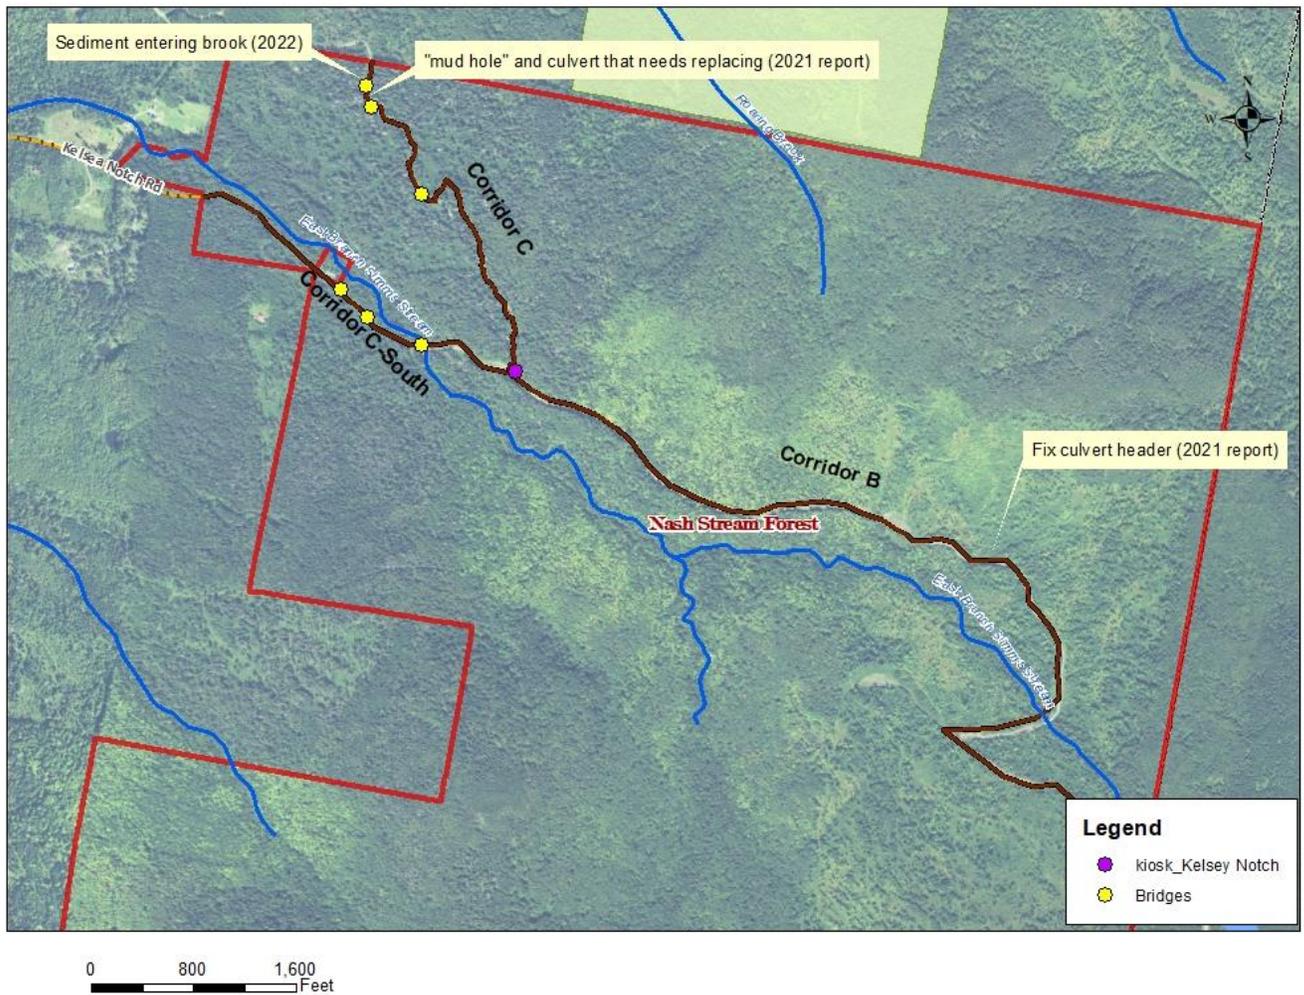
Figure 1- Map of the area showing the location of bridges, kiosks and trails labeled, and areas in need of repair.

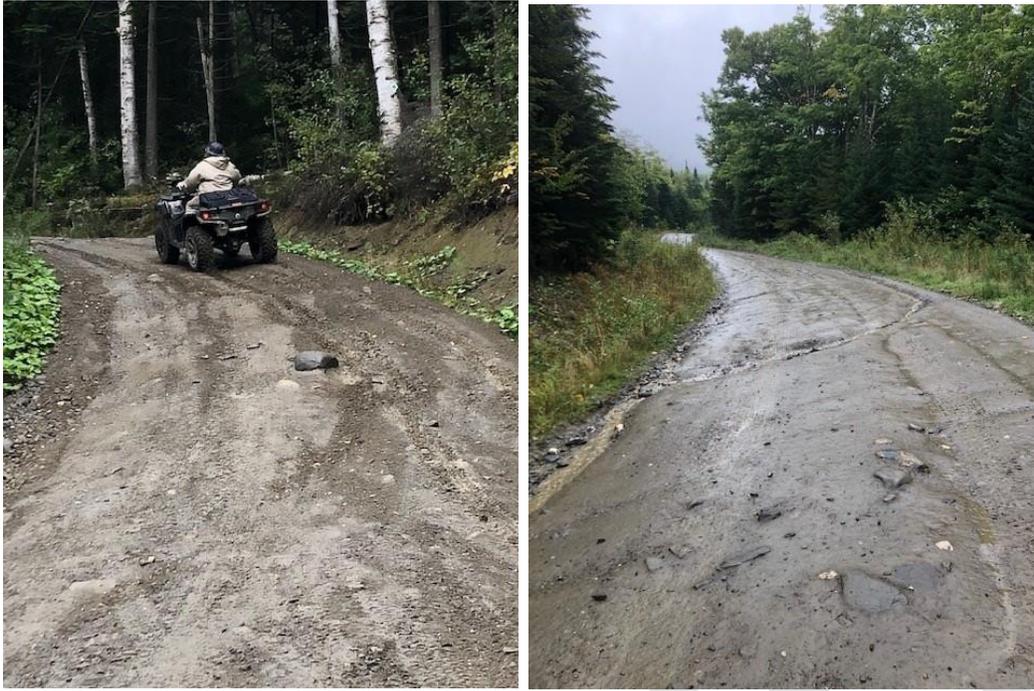
The trail was visited twice throughout the season by Forests and Lands staff and as well by Trails Bureau staff. Trails Bureau staff, checked the status of the trail at the beginning of the season and put the counters out on May 27, 2022. Forests and Lands staff noted that the trail was in rough condition this year compared to years past during the site visit on September 14, 2022.

*Figure 2- Photos from the September 14 visit*

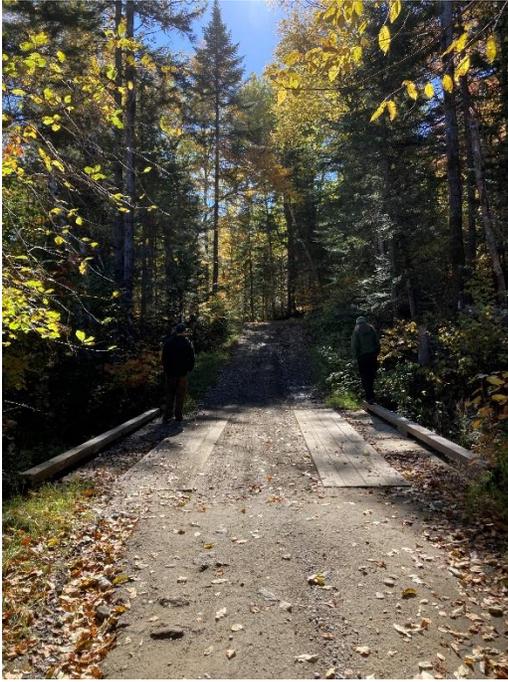
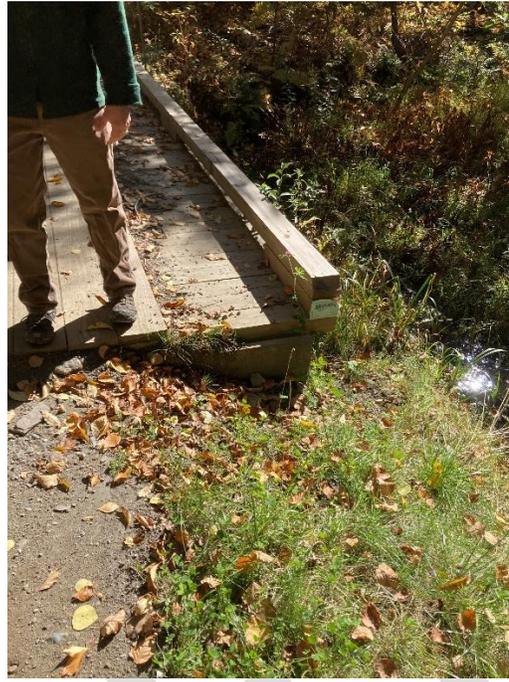
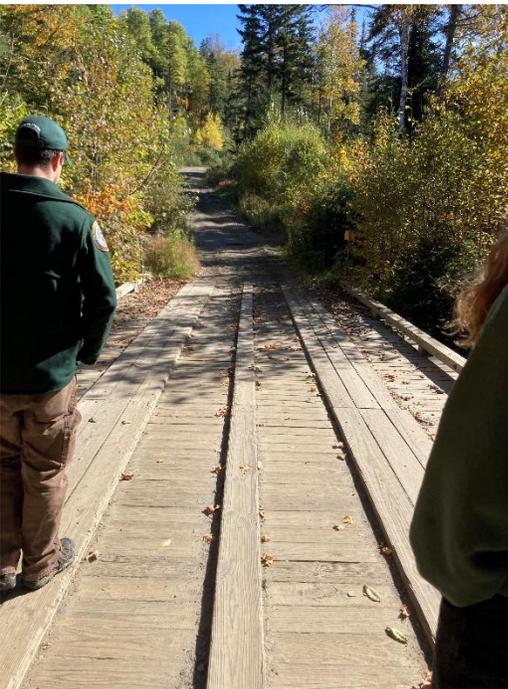
The monitoring began at the property line, reviewing Corridor C- South. There are two bridges on this section of trail soon after coming onto the property. Both bridges seemed to be in good condition. Then the monitoring crew looked at the large bridge over the East Branch of Simms Stream, which also seemed in good condition. There was no apparent sediment getting into the brooks that flowed underneath the bridges at these locations. Bridges appeared adequate to allow for movement of both aquatic and terrestrial organisms.

*Figure 3- Shows the condition of the bridges (top left- first bridge, top right- second bridge, bottom right- large bridge over East Branch of Simms Stream)*

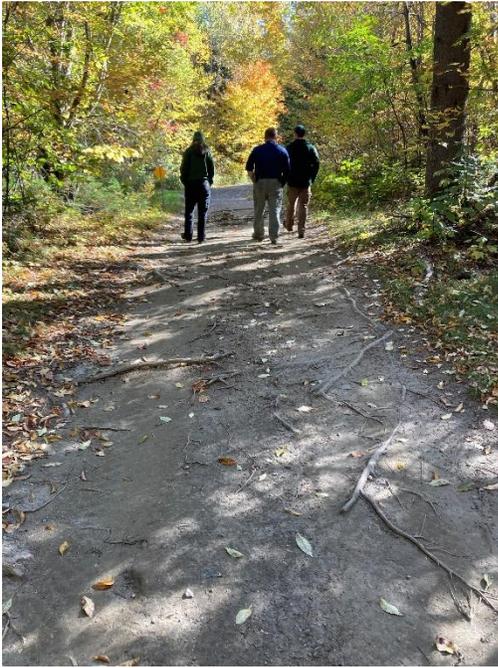
It was noted that the roots from the trees seemed to be protruding more than in years past on the flat section immediately west of the large bridge. (see figure 4)

*Figure 4- Shows the condition of the trail and the noted exposed roots.*

-Evaluate the exposed roots on trail (Figure 3) and see if this concern can be alleviated.

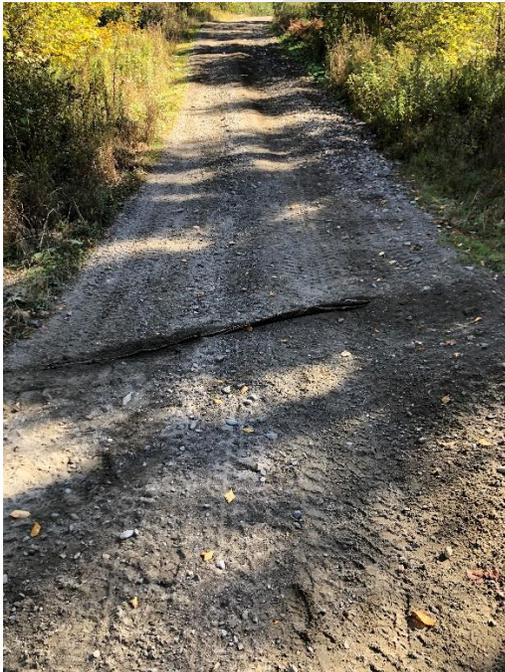
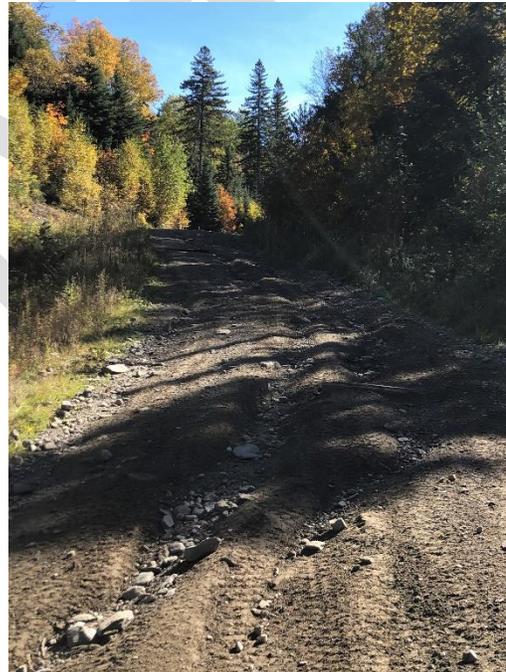
The hill leading up to the kiosk was a rougher than years past when more maintenance was completed. The rubber water diversion devices were completely filled in with material and were not functioning properly.

*Figure 5- Shows the condition of the trail on the steep hill leading to the kiosk and the rubber water devices.*

- Follow through with the 2021 recommendations
- Continue to monitor and treat the invasive species as needed. It may take many seasons to eradicate the *Phragmites australis* and it should be monitored during the growing season.
- Several of the rubber water diversion devices were in disrepair or breaking. Evaluate all devices and replace or repair the ones that are in need of attention.

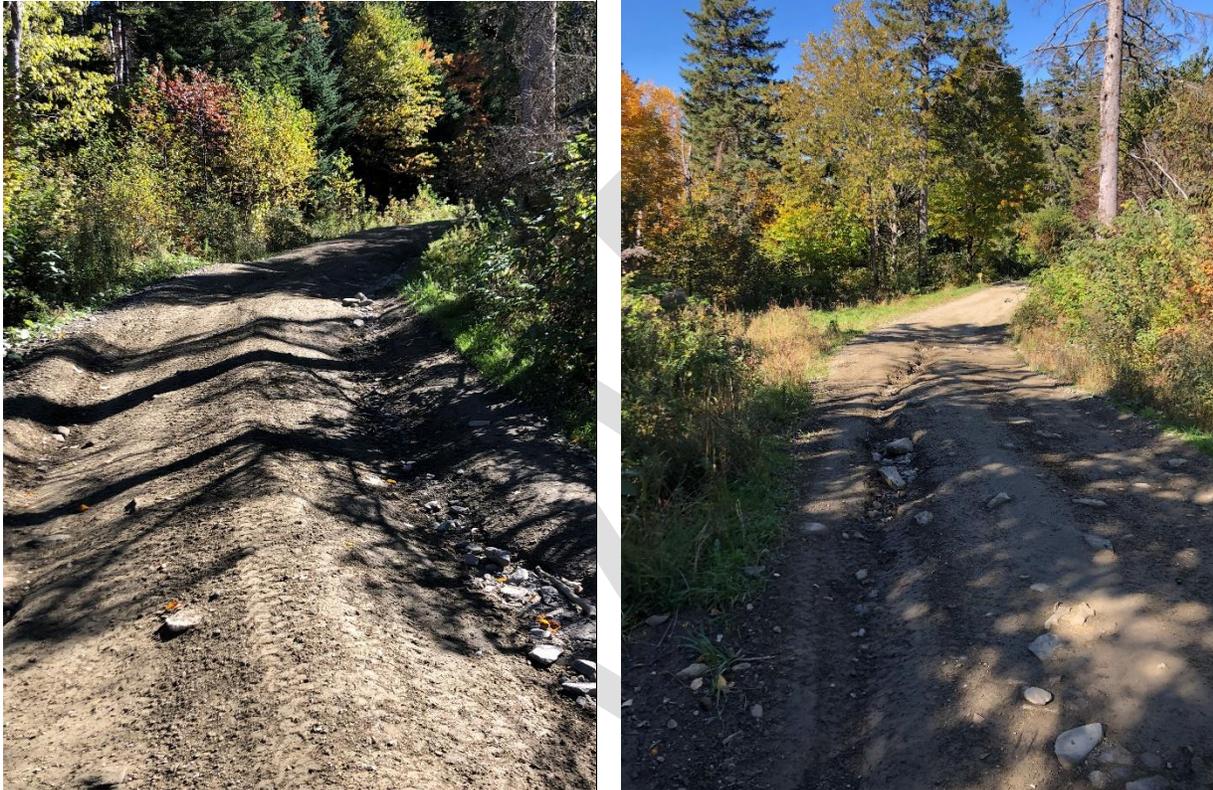
Heading toward Diamond Peaks (Corridor C), on foot monitoring continued toward the boundary line. This trail was very hard packed, despite having no maintenance throughout the year. There were some sections that had minor sedimentation, meaning there was evidence of sediment that had been washed away from trail but the trail was in fair/good condition.

*Figure 6- Shows condition of trail and some of the washing that had occurred.*

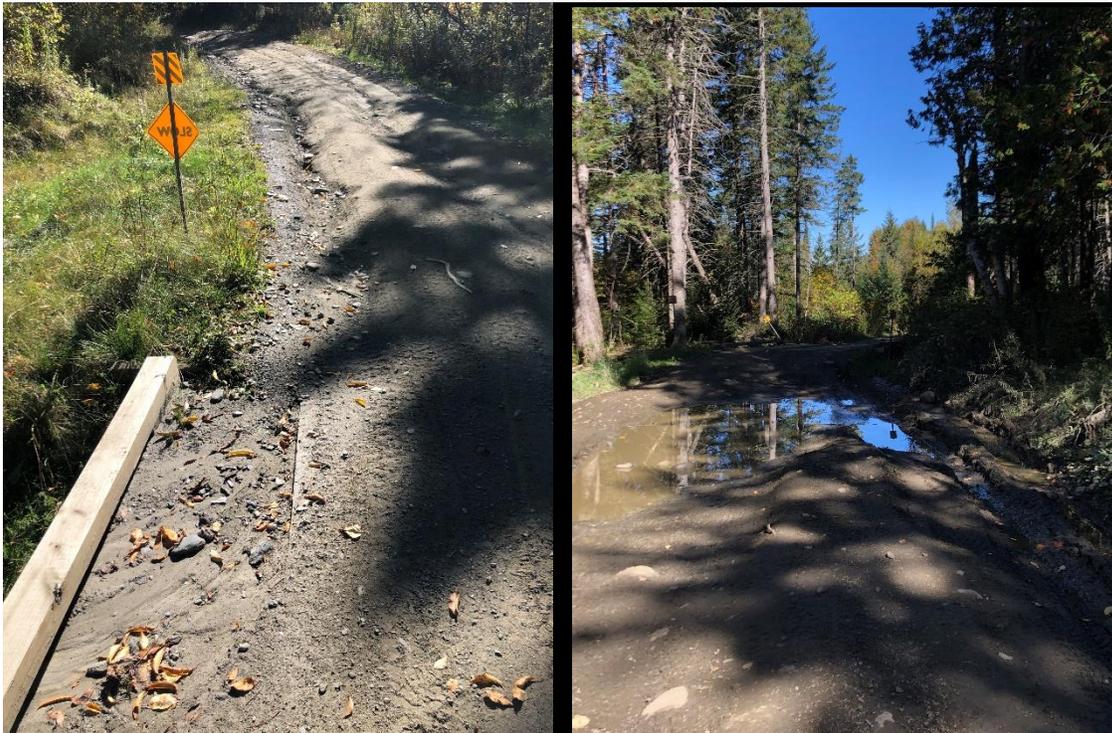
There was sediment observed entering into one of the brooks along Corridor C, on the last bridge before the property line. (Figure 7)

On the 2021 report, it was noted that there was a “mud hole” immediately south of the boundary line, but still on the property of Nash Stream Forest. Due to the lack of maintenance, this area remained and continued to be a settling area for water. (Figure 7)

*Figure 7- Shows sediment entering brook at bridge location and shows the “mud hole”*

- Fix the mud hole near the property line toward Diamond Peaks (Figure 4 from 2021 report).
- Place a culvert before the bridge at the end to address the sitting water near the mud hole (Figure 4 from 2021 report) .
- Fix culvert header where it is washing and slope the road away from the outlet of the culvert (Figure 6 from 2021 report).
- Continue to monitor and clean out the rubber water diversion devices that are in various locations on the trails.

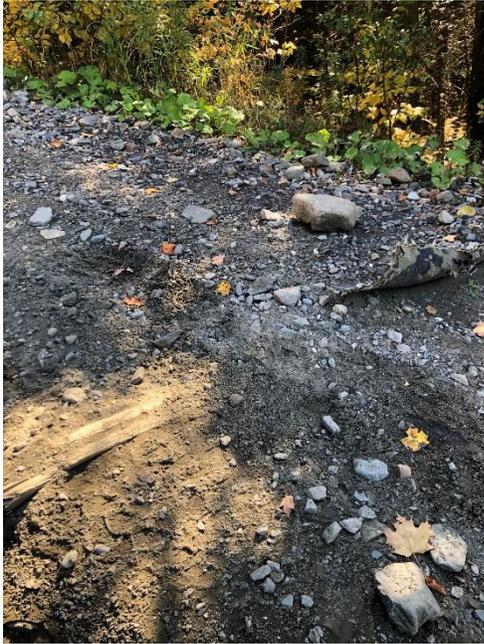
The hill leading from the kiosk toward Kelsey Notch (corridor B) was in poor condition due to lack of maintenance and amount of use. The rubber water devices were not working and some were broken. This hill was in very rough shape.

In 2021, it was noted that there was one location where some sediment was running down the trail and getting into the brook next to the rock/culvert, since there was no maintenance done on the trail this was still an issue in 2022.

*Figure 8- Depicting the rubber water diversion devices, where the rubber is completely missing.*

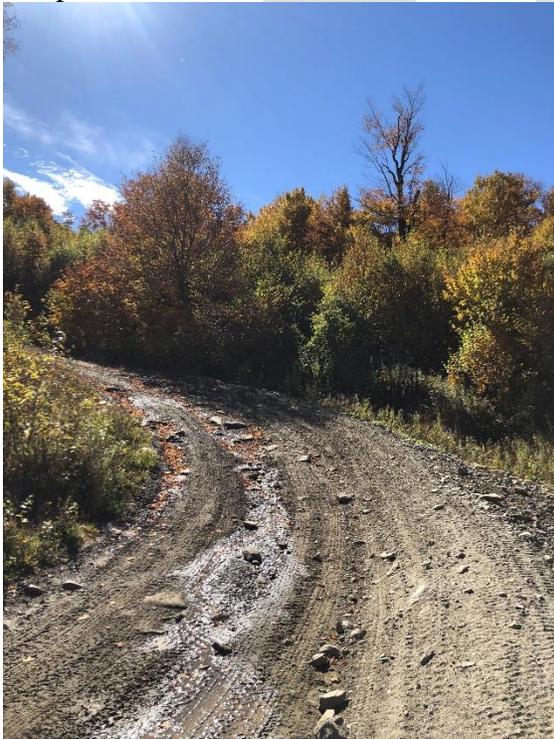
Each year, the sharp corner leading up to Kelsey Notch gets a significant berm. This happens from the dirt and rocks getting kicked out as the OHRVs turn and head up the hill, exacerbated with speed.

*Figure 9- Shows berm on corner of trail*

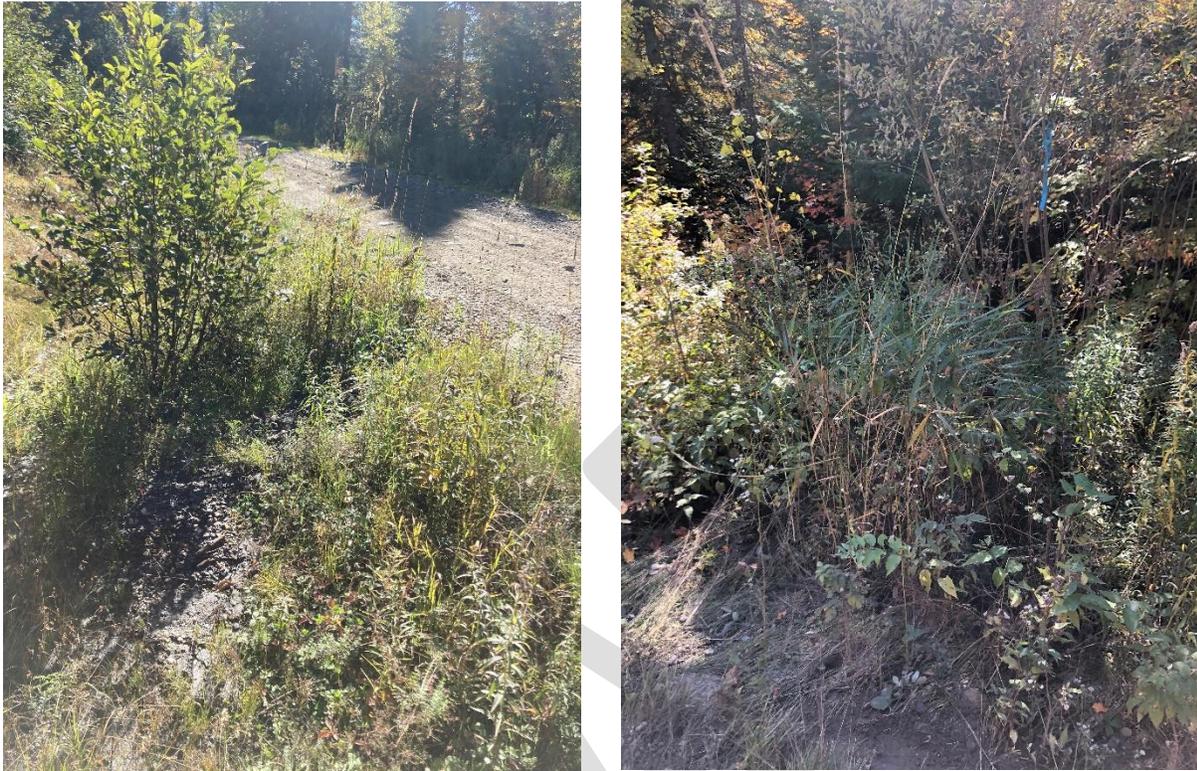
In 2020, we found a few patches of *Phragmites australis*. These areas were treated on September 3, 2021 with glyphosate by Fish and Game staff who are licensed pesticide applicators. During

our 2022 visit, we found no evidence of new *Phragmites australis* plants and no living plants. This will continue to be monitored each year, during the growing season by Forests and Lands and Fish and Game staff.

*Figure 10- Depicts the area where the Phragmites australis was previously found in 2021, but no plants were found in 2022.*
