P145 Line Rebuild – Asset Condition and OPGW Project

Planning Advisory Committee Meeting
January 20th, 2022

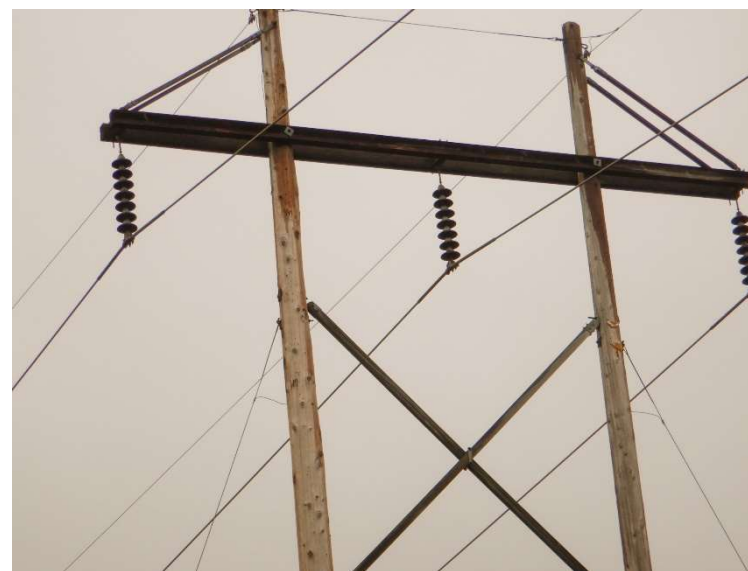
P145 Structure 104

- Line P145 is a 115-kV line spanning 12.5 miles between Merrimack Substation and Farmwood Substation in New Hampshire
- Originally constructed in 1966
- Existing conductor is 795 36/1 ACSR
- Existing static wires are two 3#6 Copperweld shield wires
- 165 structures, primarily single circuit wooden H-Frame structures

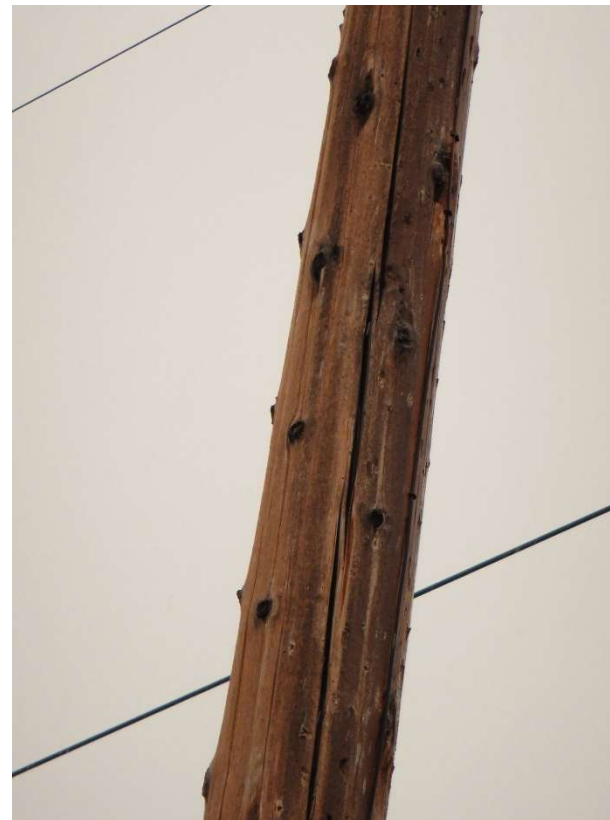
P145 Structure 73

- 25 structures need to be replaced based on recent visual inspections
 - C rated structures on EPRI rating scale
- Engineering analysis in preparation for OPGW installation identified additional structures which are loaded beyond their design capabilities
 - 98 structures found to exceed allowable loading based on the National Electrical Safety Code at the time of construction
 - 8 of these structures also failed recent visual inspections
- 13 additional structures exceed allowable loading with the OPGW added
- Age of structures (55 years) and wood deterioration must also be considered
- In total, 128 (78% of the structures on the line) need to be replaced due to structural overloads, degradation, or both

- Rebuild the P145 line (preferred solution)
 - Rebuild the P145 line with 154 new weathering steel structures, reusing 6 existing steel structures and permanently removing 5 structures
 - Replace existing 795 ACSR 36/1 with Eversource-standard 1272 ACSS 54/19 conductor
 - Replace obsolete and degrading 3#6 Copperweld with 48 fiber OPGW
- Replace only high priority asset condition structures (Not preferred)
 - Replace only the priority C structures
 - Remaining structures pose a barrier to replacing conductor and shield wire due to increased loading, clearance, and uplift concerns
 - Inability to replace the conductor and shield wire fails to address the asset condition and operational concerns of aging and obsolete copper materials
