Re: Public Service of New Hampshire dba Eversource Energy
US Forest Service Fall Small Projects Day Meeting Application
X-178-2 115kV Transmission Line Rebuild Project Summary
Woodstock, Lincoln and Easton, New Hampshire

As requested in advance of the fall 2024 Small Projects Day (SPD) meeting, this letter is being provided as a Project Summary of the proposed X178-2 Transmission Line Rebuild Project which is located within the White Mountain National Forest (WMNF). Eversource met with you virtually on November 2, 2023 to discuss the upcoming project and a follow up project proposal was submitted to you on February 24, 2024. A follow up meeting between Eversource, GZA and the US Forest Service (USFS) was held virtually on March 7, 2024. As we discussed, Eversource is proposing to rebuild the 115kV X178 Transmission Line which crosses through portions of Campton, Thornton, Woodstock, Easton, Lincoln, Sugar Hill, Bethlehem, Dalton and Whitefield NH between the Beebe River Substation and Whitefield Substation for approximately 49 miles (see Table 1). In total, the proposed project will replace 593 existing wooden utility poles (i.e. structures) with steel pole equivalents. Access to

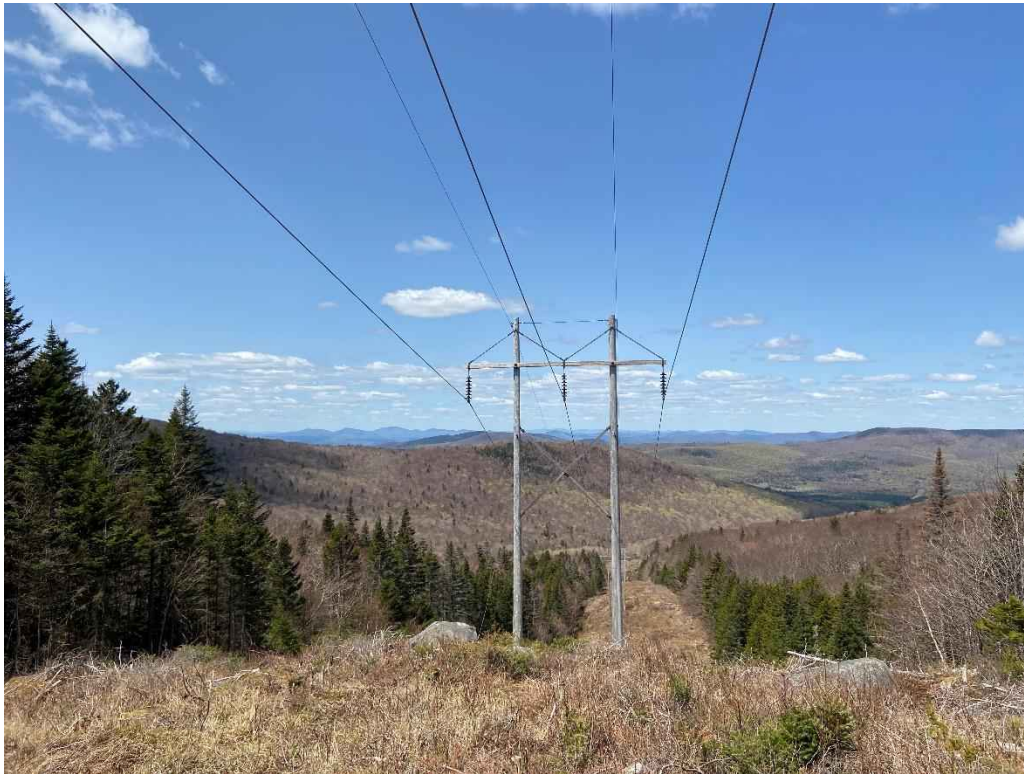
Looking west at existing Structure 267 in Easton

A portion of the Appalachian Trail (Kinsman Ridge Trail) passes through the existing X178 Transmission Line ROW by existing Structure 259. Existing Structure 259 is a three-pole wooden structure and will be replaced in-kind with a three-pole weathered steel structure. Therefore, it is not anticipated the pole replacement will have a negative aesthetic impact on the Appalachian Trail in the long term. During active construction, it is anticipated there will be construction equipment in and around the Kinsman Ridge Trail and hikers may need to be rerouted around the construction area.

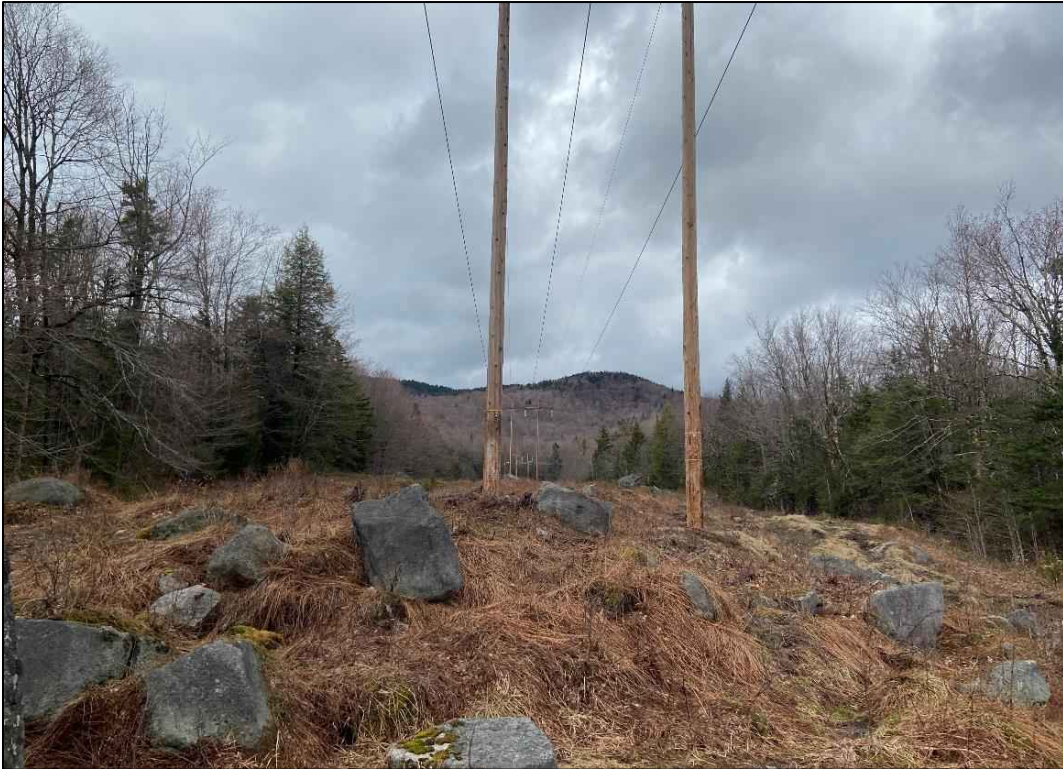
Photograph No. 37: Looking northwesterly at proposed work pad location for Structure 215.

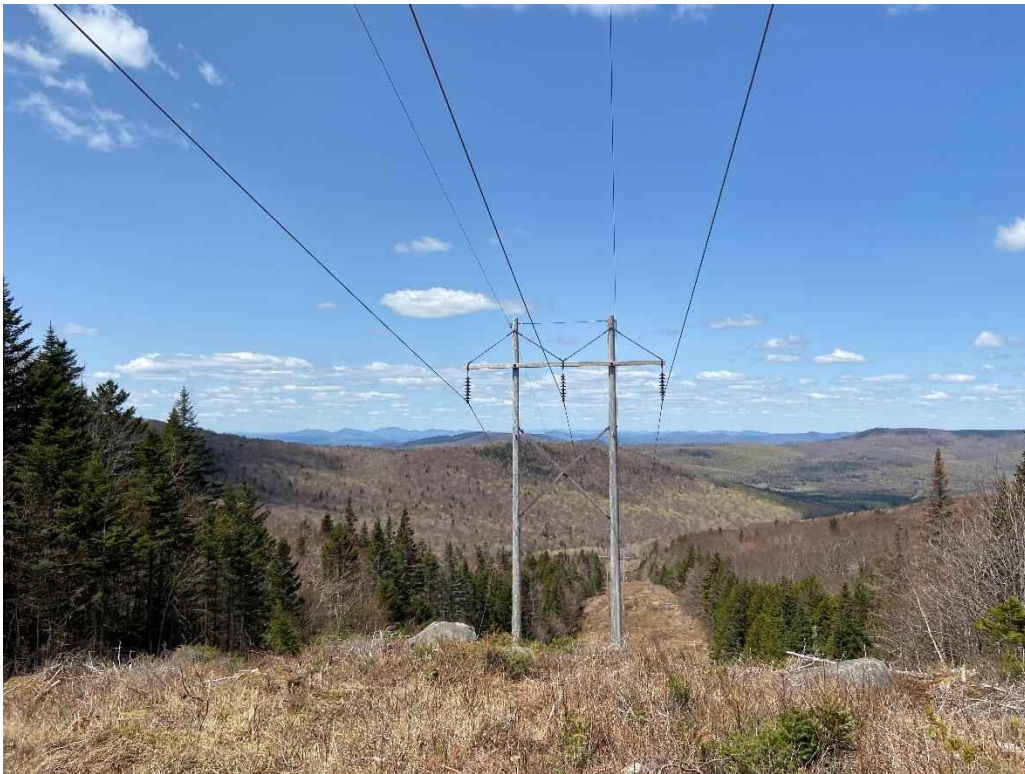
Photograph No. 106: Looking westerly at proposed work pad location for Structure 267.

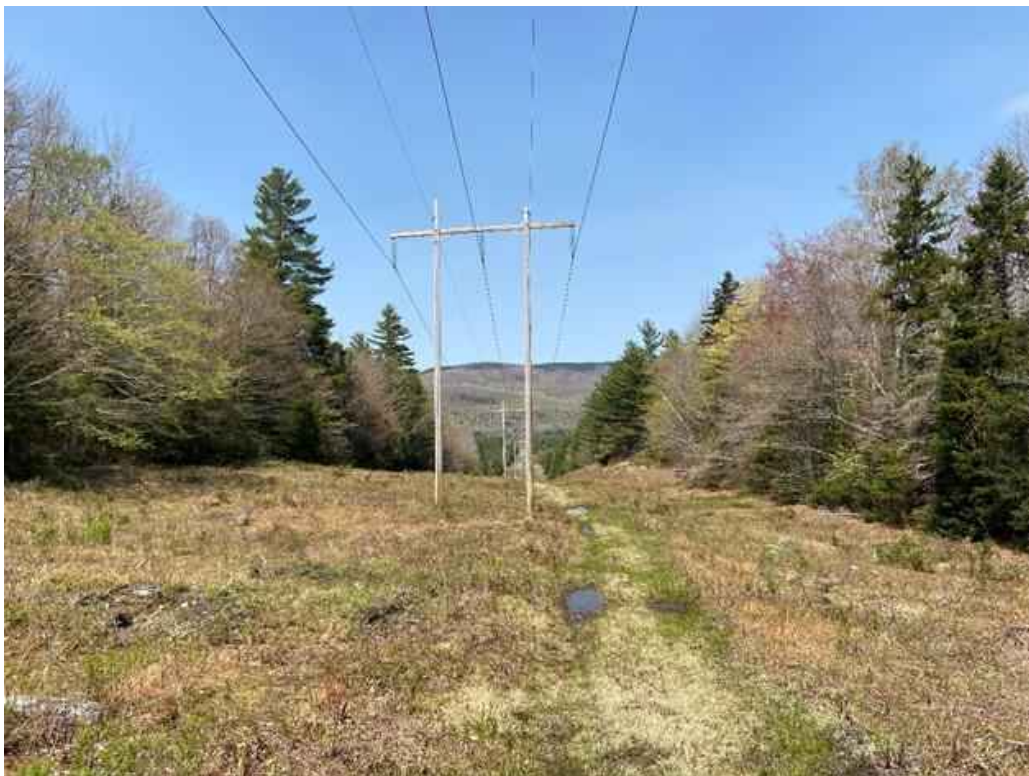
Photograph No. 130: Looking westerly at proposed work pad location for Structure 289 to be replaced within Wetland ET-48.

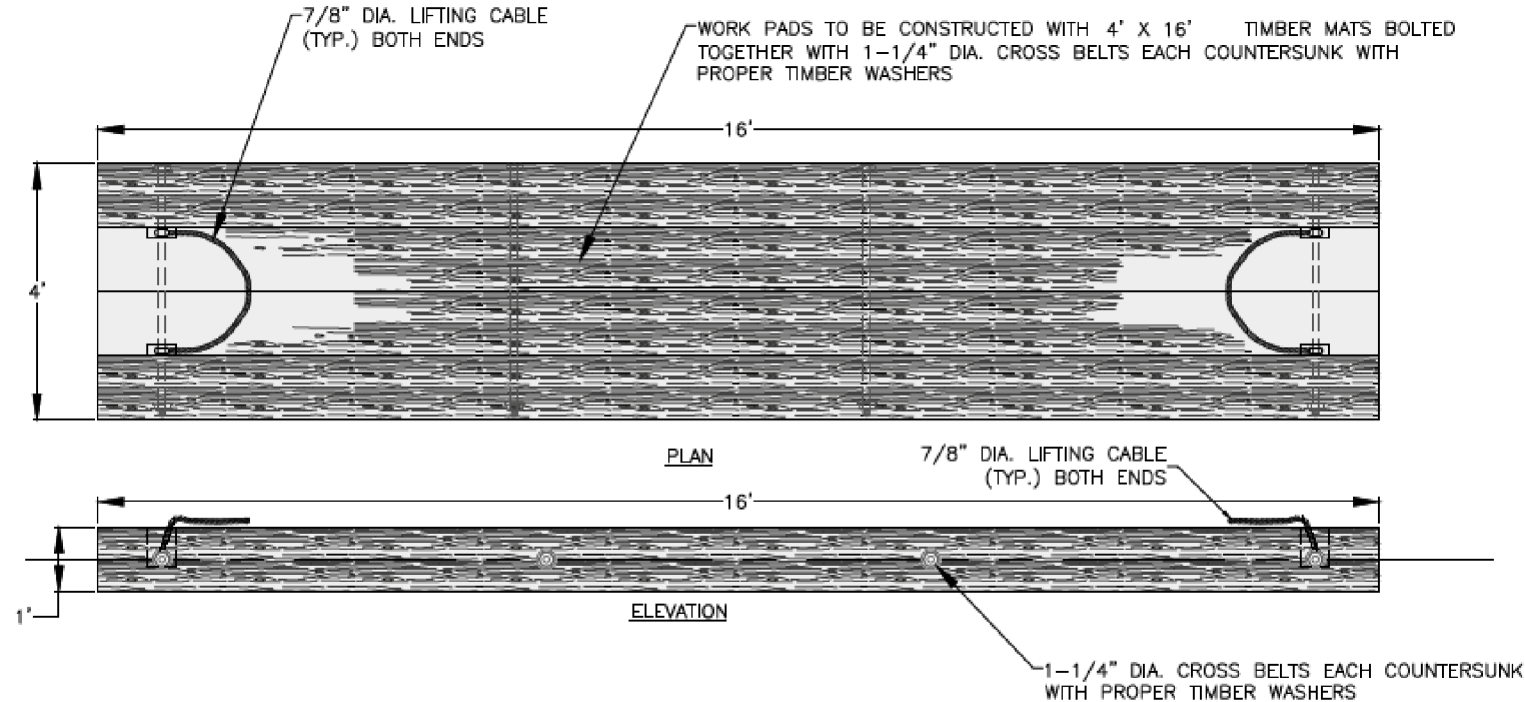
TYPICAL TIMBER MAT DETAIL
NOT TO SCALE
