November 12, 2024
File No. 04.0191410.39

Re: Revised Wetlands Conditional Use Permit Application
Eversource Energy
X178-2 Transmission Line Structure Rebuild & OPWG Project
Easton, New Hampshire

PHOTO LOG
X178 Transmission Line Rebuild & OPGW Project
Easton, New Hampshire
Photos Taken: Drone Photos October 2022, Ground Photos December 8, 13, 14, 2022, and May 9, 10, 2023

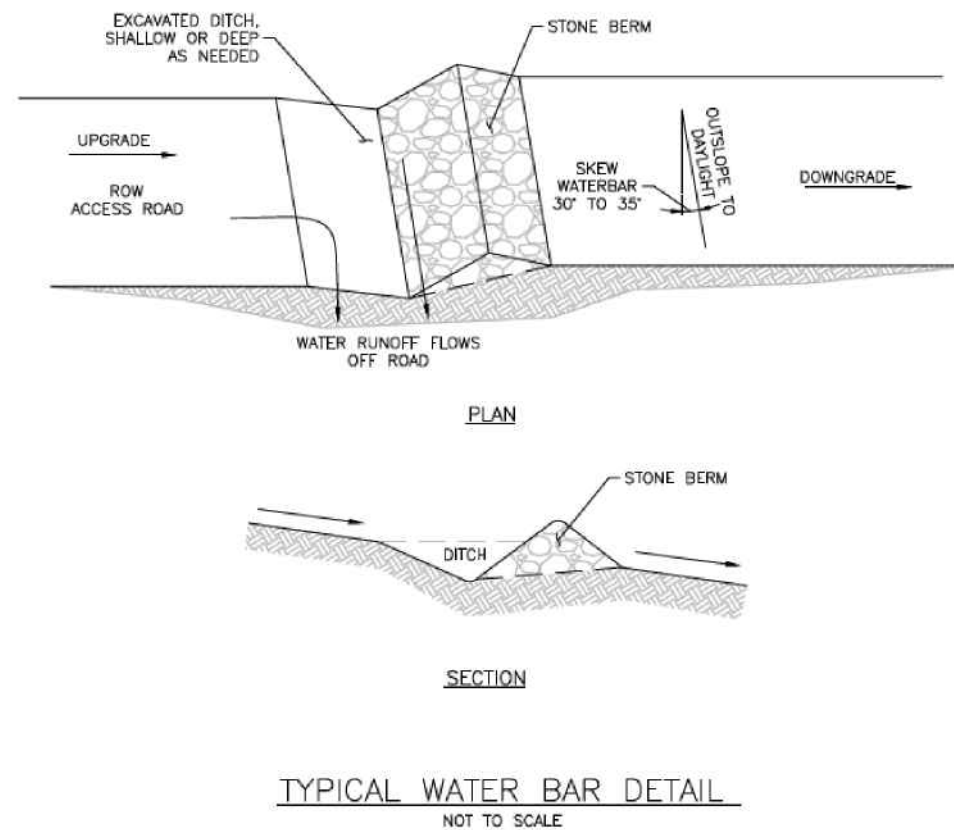
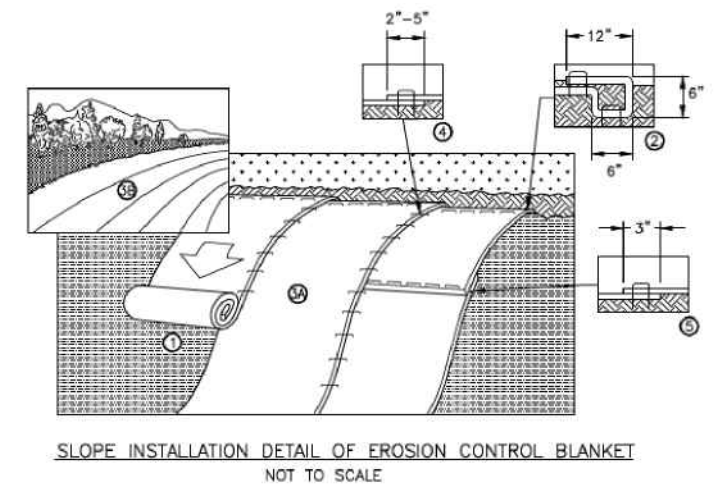
1. EROSION CONTROL BLANKET SHOULD BE INSTALLED VERTICALLY DOWNSLOPE.
2. STAKES/STAPLES SHOULD BE PLACED NO MORE THAN 3 FT. APART VERTICALLY AND 1 FT. APART HORIZONTALLY.
3. SLOPE SURFACES SHOULD BE FREE OF DEBRIS, INCLUDING STICKS, ROCKS AND OTHER OBSTRUCTIONS.
4. BLANKETS SHOULD BE ROLLED OUT LOOSELY AND STAKED/STAPLED TO MAINTAIN DIRECT SOIL CONTACT. DO NOT STRETCH THE BLANKETS.
5. DESIGNER/ENGINEER SHALL CHOOSE THE TYPE OF BLANKET OR MATTING DEPENDING ON SPECIFIC OBJECTIVES AND SITE CONDITIONS.

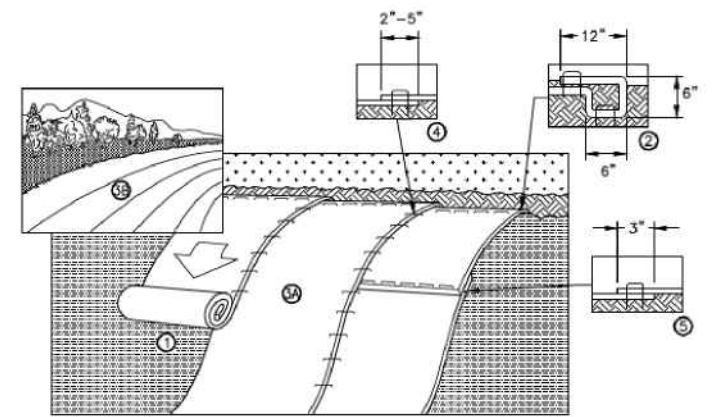
1. EROSION CONTROL BLANKET SHOULD BE INSTALLED VERTICALLY DOWNSLOPE.
2. STAKES/STAPLES SHOULD BE PLACED NO MORE THAN 3 FT. APART VERTICALLY AND 1 FT. APART HORIZONTALLY.
3. SLOPE SURFACES SHOULD BE FREE OF DEBRIS, INCLUDING STICKS, ROCKS AND OTHER OBSTRUCTIONS.
4. BLANKETS SHOULD BE ROLLED OUT LOOSELY AND STAKED/STAPLED TO MAINTAIN DIRECT SOIL CONTACT. DO NOT STRETCH THE BLANKETS.
5. DESIGNER/ENGINEER SHALL CHOOSE THE TYPE OF BLANKET OR MATTING DEPENDING ON SPECIFIC OBJECTIVES AND SITE CONDITIONS.
