Documentation of Eversource “Asset Condition” projects failure to use Best Management Practices as defined in ‘Best Management Practices Manual, Utility Maintenance in and Adjacent to Wetlands and Waterbodies in New Hampshire.’

(Above: 391/373, 1/2/2024) All photos are of Eversource “Asset Condition” projects.

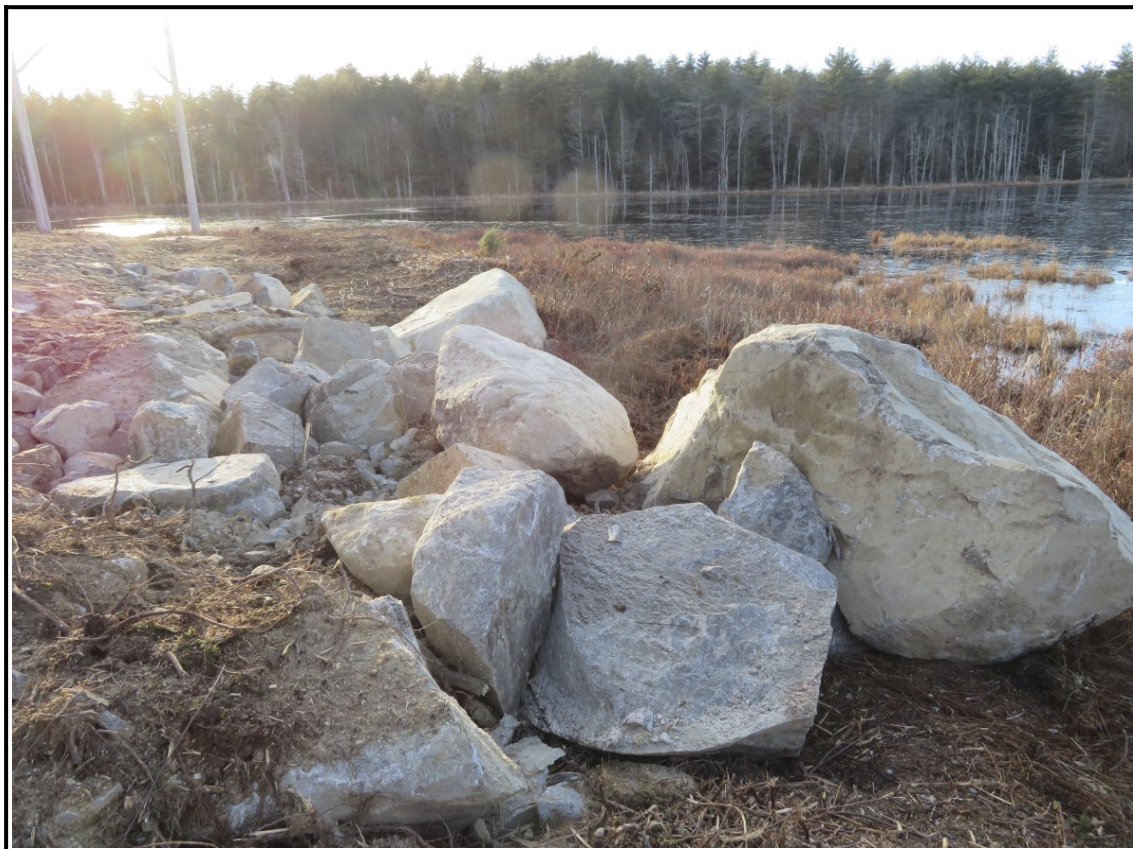
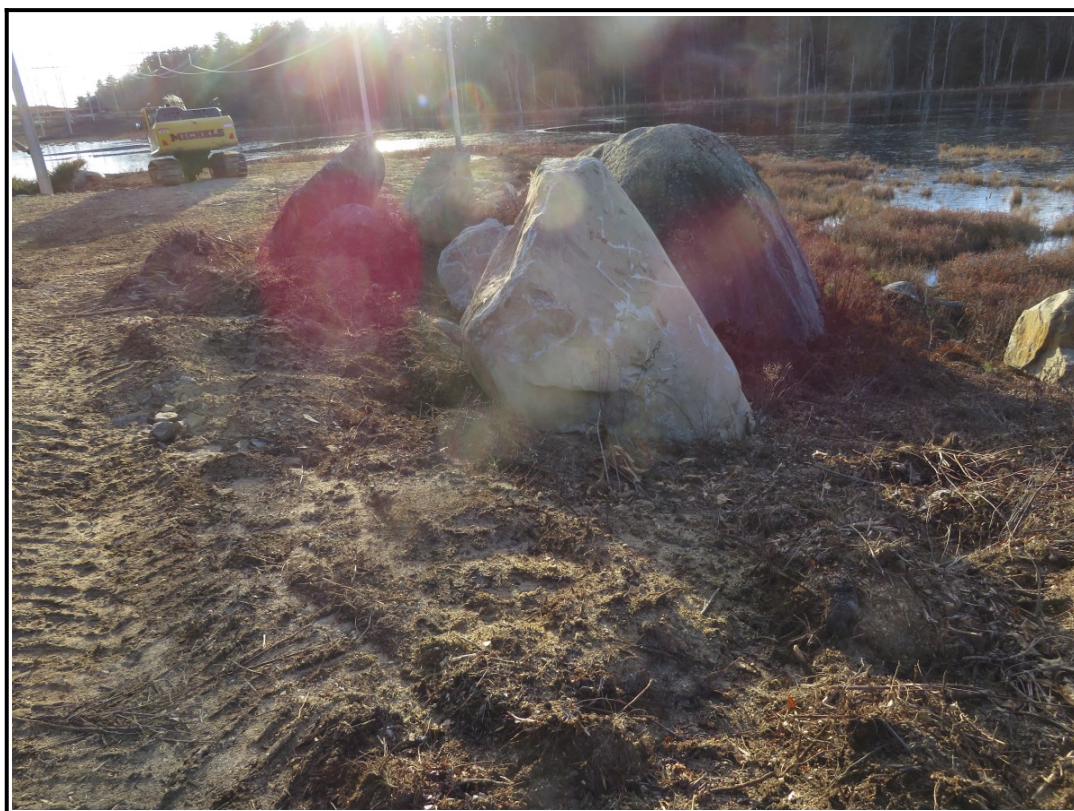
(Above and below: 391/373 1/2/2024)

“2.6 Operating Adjacent to Wetlands and Waterbodies

Work adjacent to wetlands and waterbodies, but not necessarily in wetlands and waterbodies, can present potential environmental impacts. Care must be taken when working in these areas in order to protect these existing resource buffers. To minimize erosion potential, preserve low-growing vegetation adjacent to wetlands or waterbodies to the fullest extent possible.

Stumps and rocks must not be removed unless required for safety reasons...”

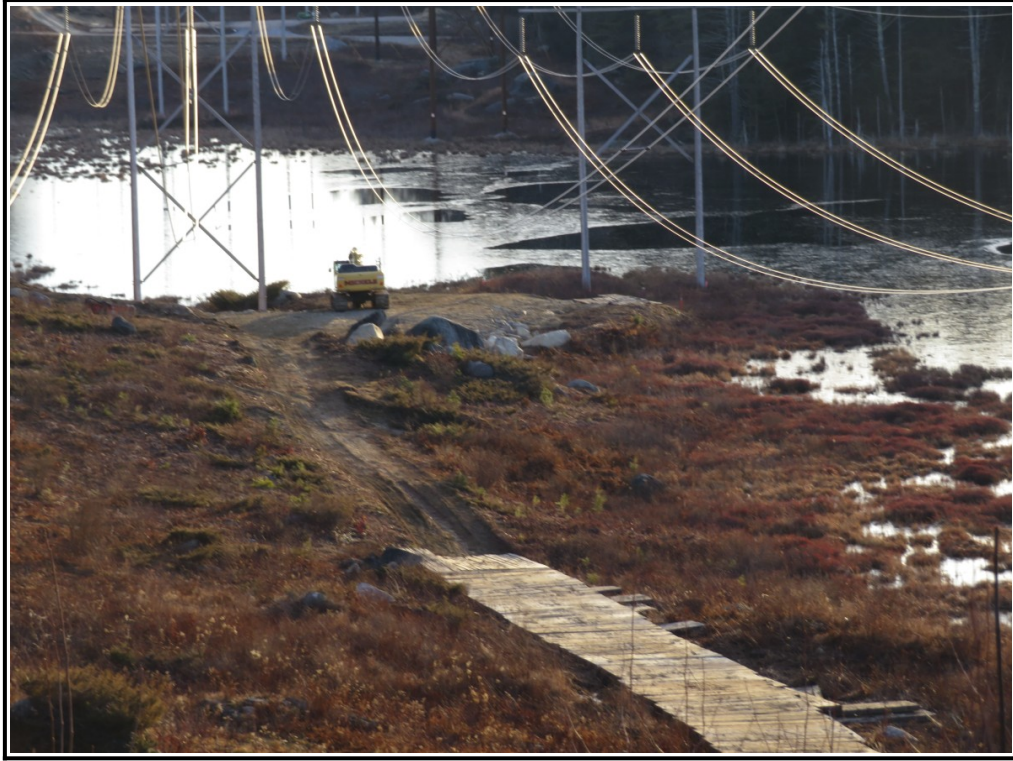
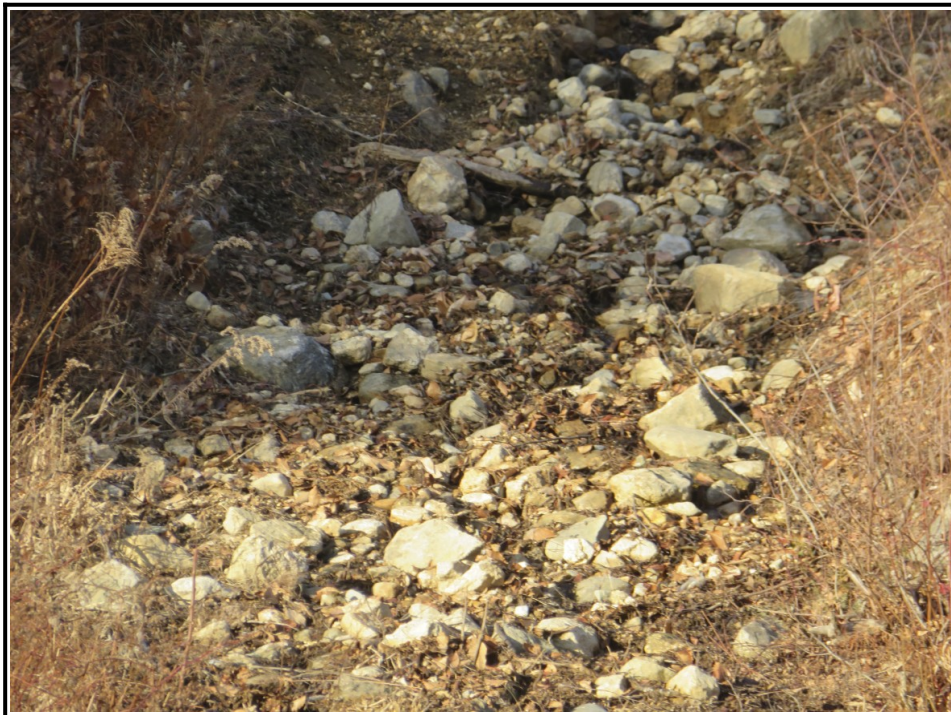
“Install temporary erosion controls immediately prior to initial disturbance of the soil. Temporary erosion controls must be properly maintained throughout construction, on a daily basis and reinstalled as necessary until replaced by permanent erosion controls or restoration is complete.”
(Above and below: 391/373 1/2/2024)

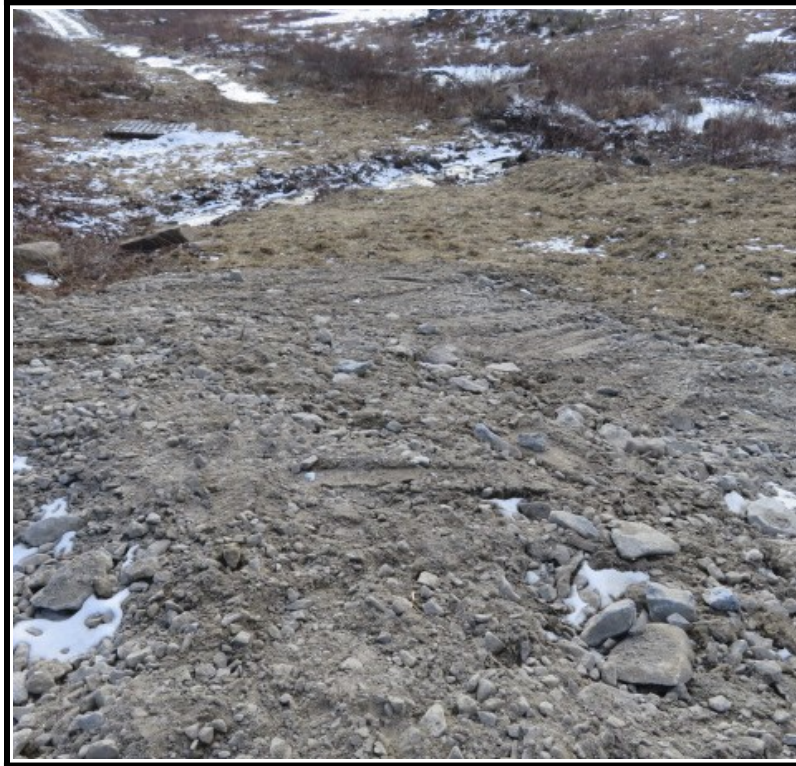
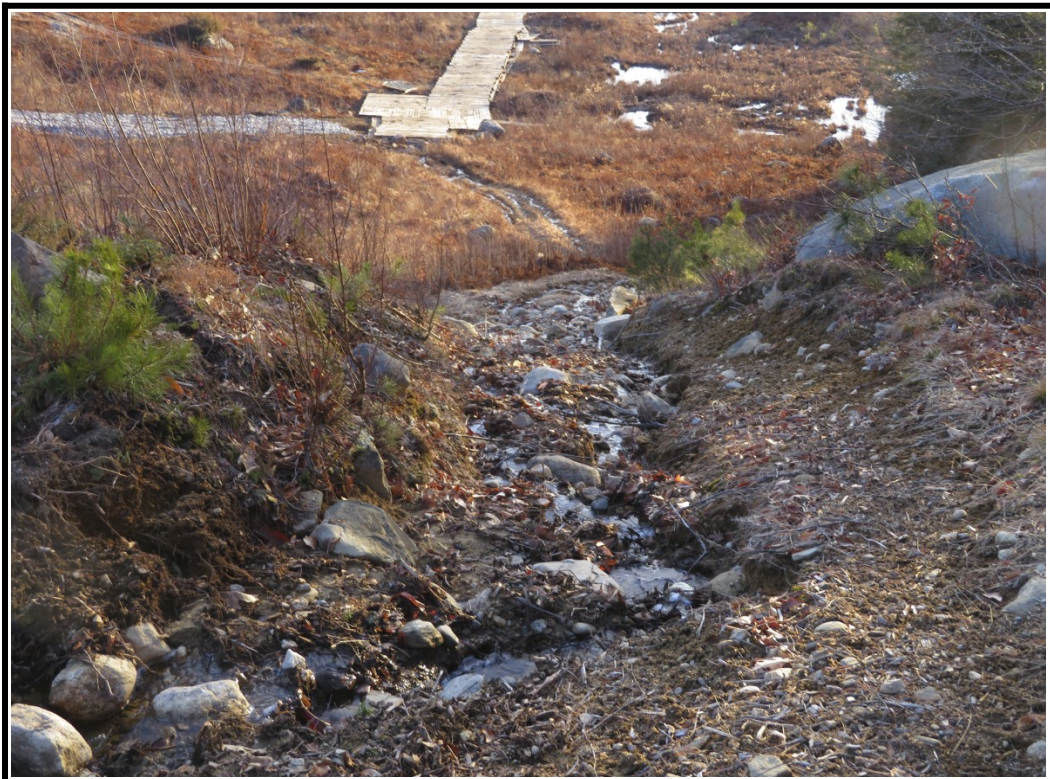
If exposed soils present sedimentation issues to adjacent wetlands and waterbodies, provide permanent soil protection. On steep slopes, install erosion control blankets as needed. “
(Below: 391/373 1/2/2024), 2/18/2024)

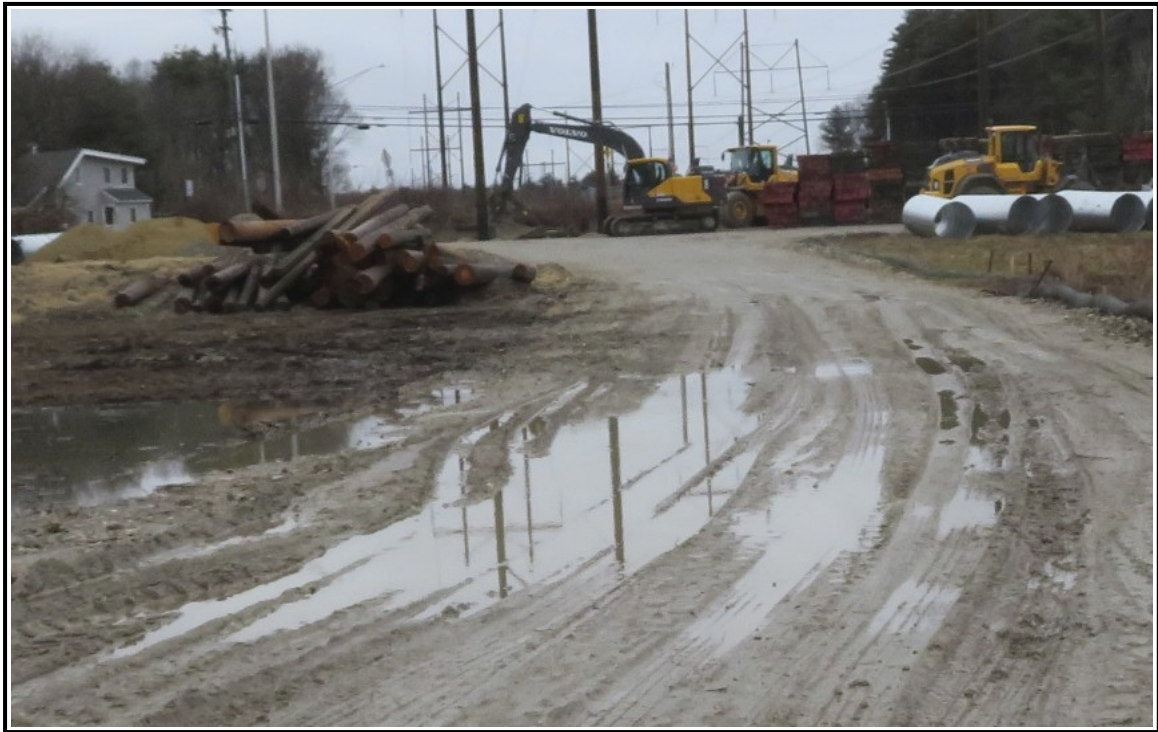
(Below: 391/373 1/2/24)

A temporary stabilized construction exit consists of a pad of stone aggregate placed on a geotextile filter fabric, located at any point where traffic will be leaving a construction site to an existing access road way or other paved surface. Its purpose is to reduce or eliminate the tracking of sediment onto public roads by construction vehicles. This helps protect receiving waters from sediment carried by stormwater runoff from public roads.

The minimum size stone used should be three-inch crushed stone.

The minimum length of the pad should be 75 feet, except that the minimum length may be reduced to 50 feet if a three- to six-inch high berm is installed at the exit of the project site.

The minimum depth of the pad should be at least six inches thick.

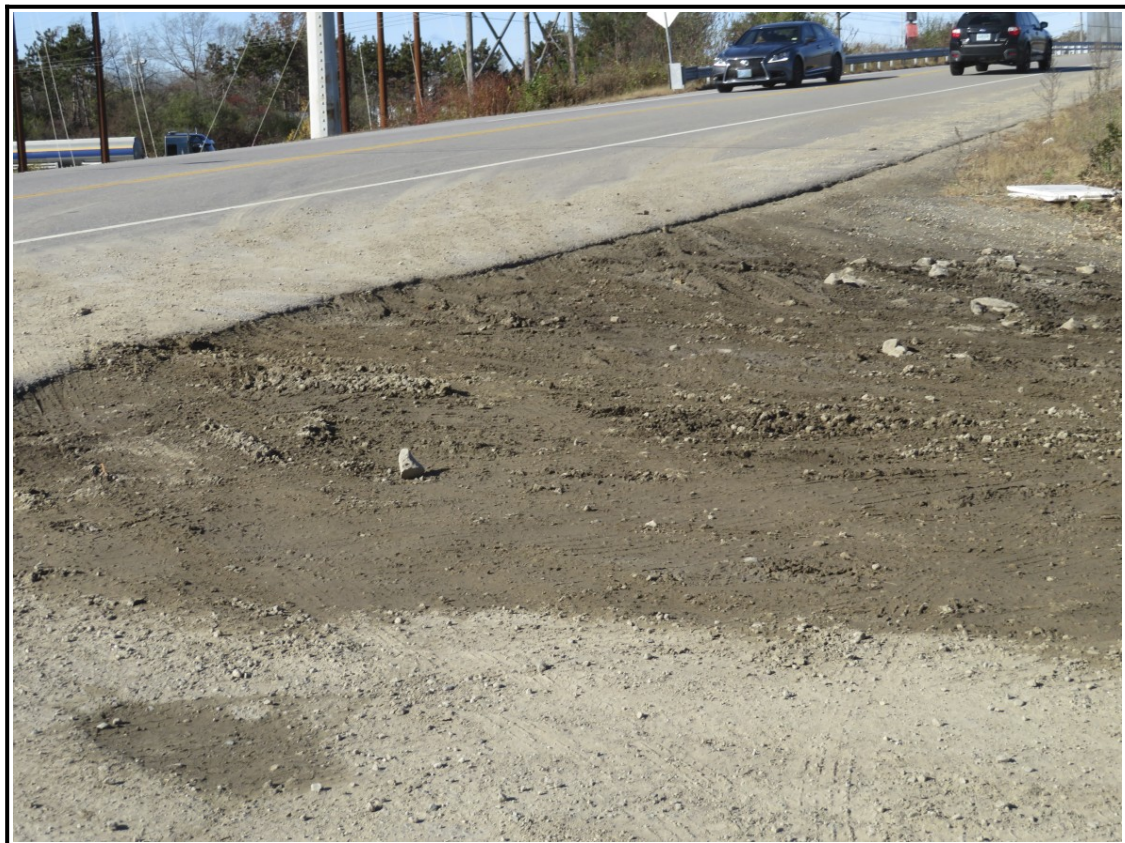
(Below: U-181 U-194)

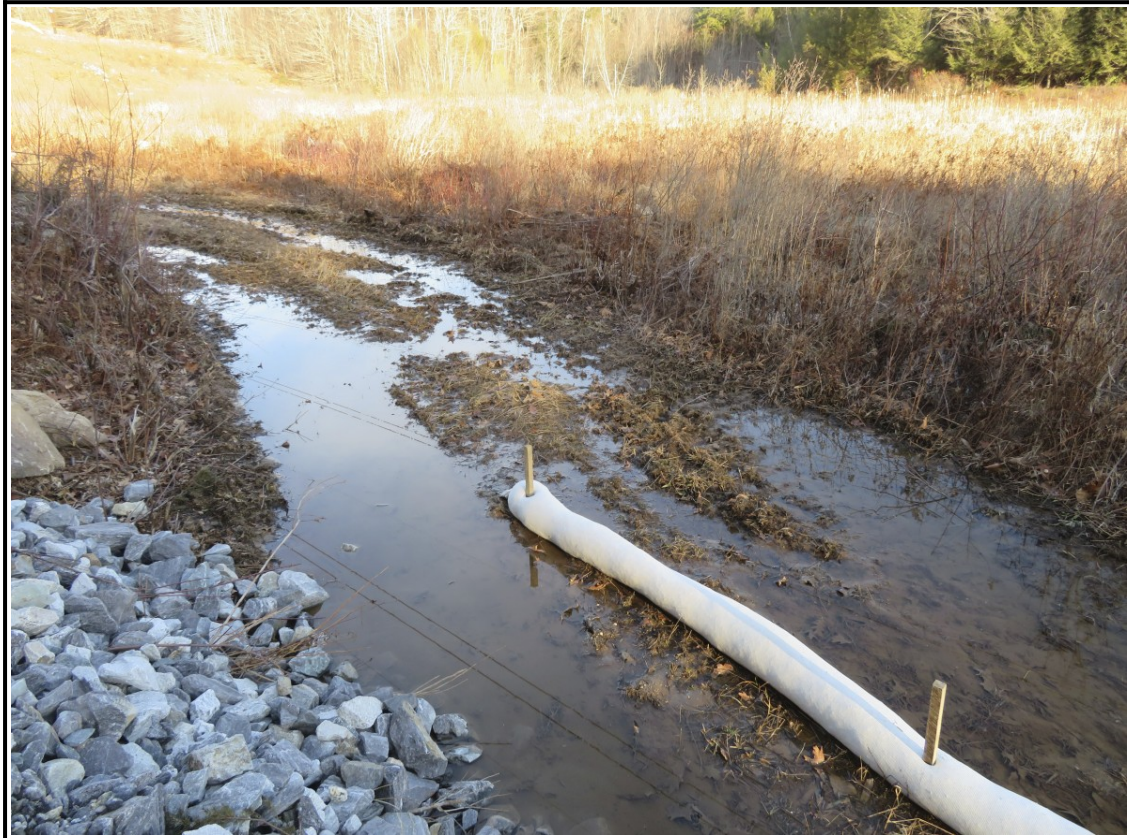
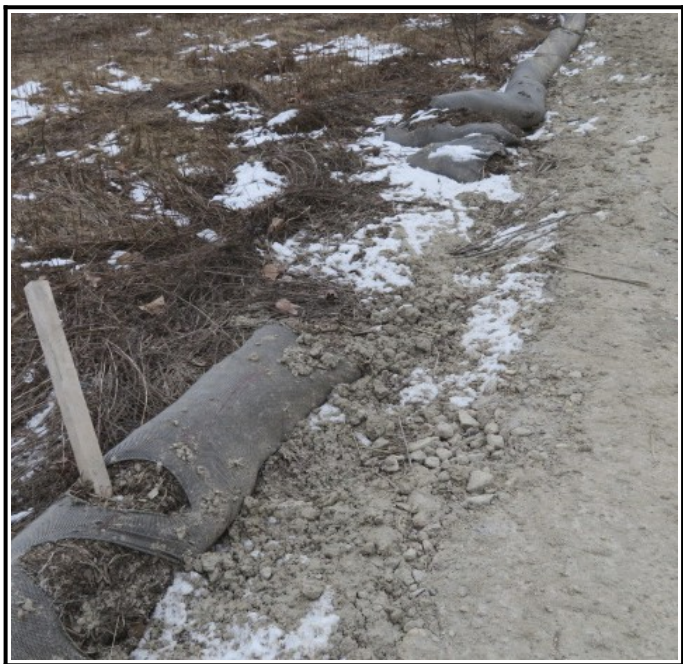
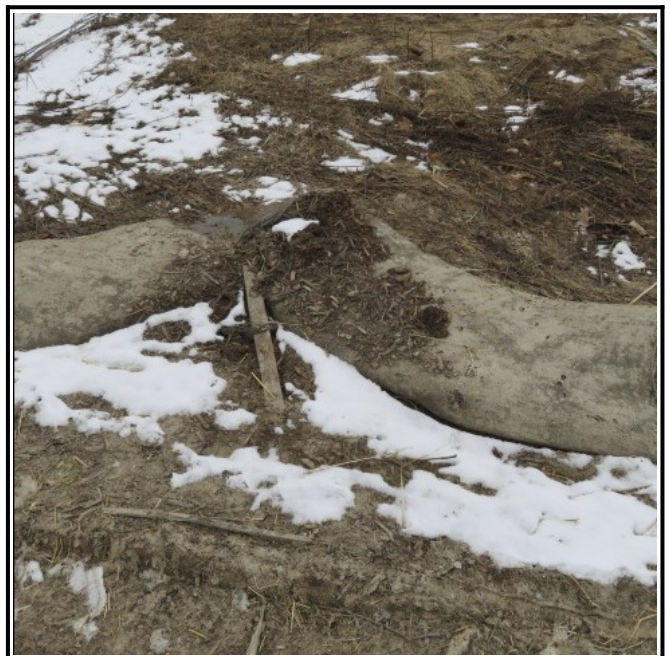
(Above: 1/2/24 391/373, Below: E-194/U-181, 2/25/2024)

For slope stabilization, it is critical that coir logs are installed perpendicular to soil movement and parallel to the slope contour.

Coir logs, especially if used in slope stabilization, are not effective unless entrenched. Construct trenches half the diameter of the log in which to place the roll. Install rolls from the bottom of the slope and work up.

Lay the coir log along the trench, snugly fitting it against the soil. Ensure no gaps exist between the soil and the fiber roll.

Install stakes at least every three feet apart along the length of the roll. Additional stakes may be driven on the downslope side of the trenches on highly erosive or very steep slopes. Consider using coir logs where slopes are susceptible to sheet and rill erosion, to freeze and thaw activity, or where slopes are difficult to vegetate because of soil movement.”

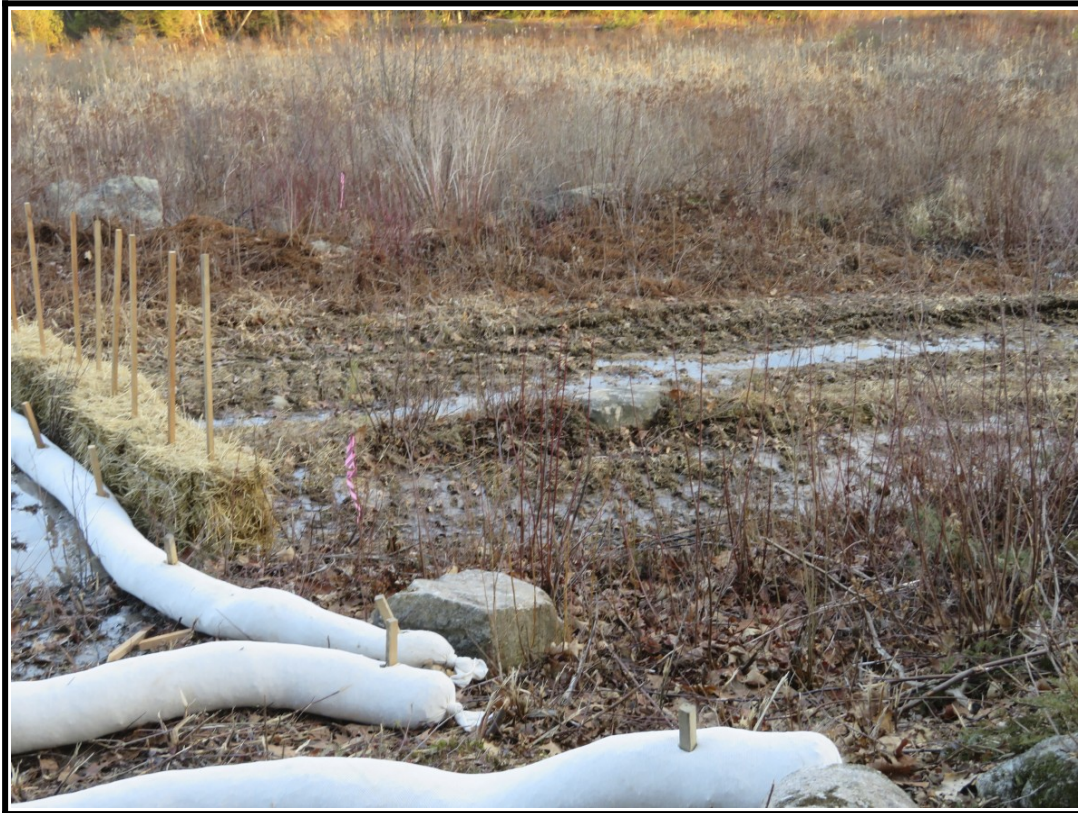
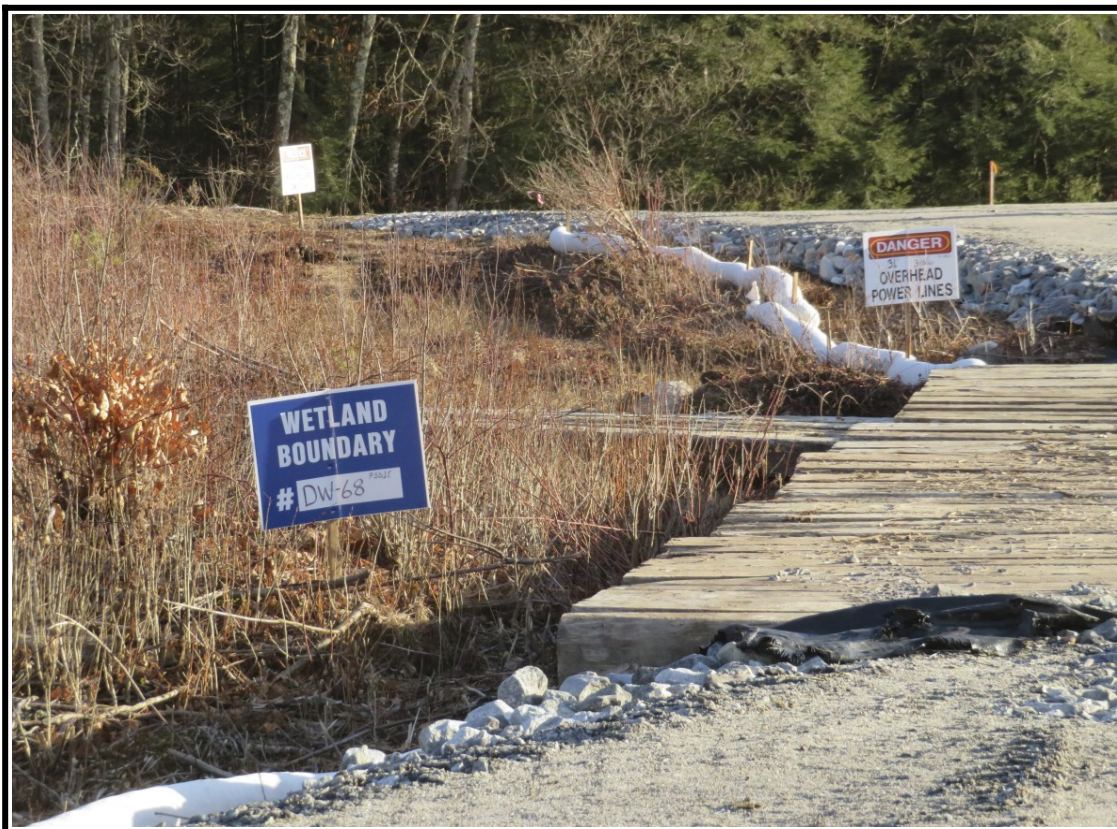
(Above and below: 1/2/24 391/373)

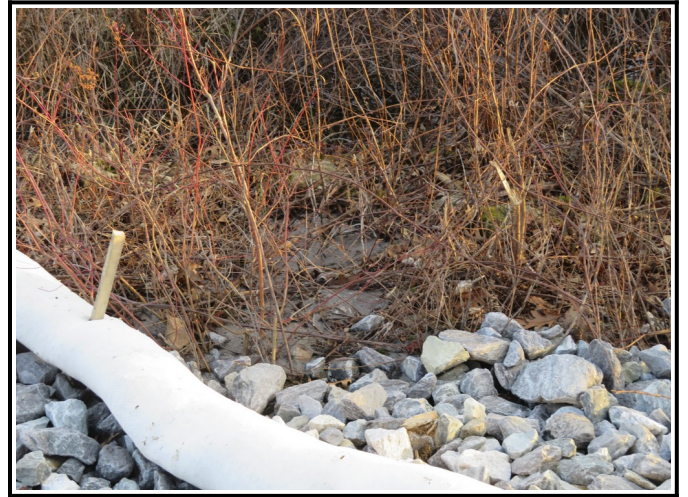
No photos of silt fence available.
Below: 373 and 319 easement, silt, no silt barrier

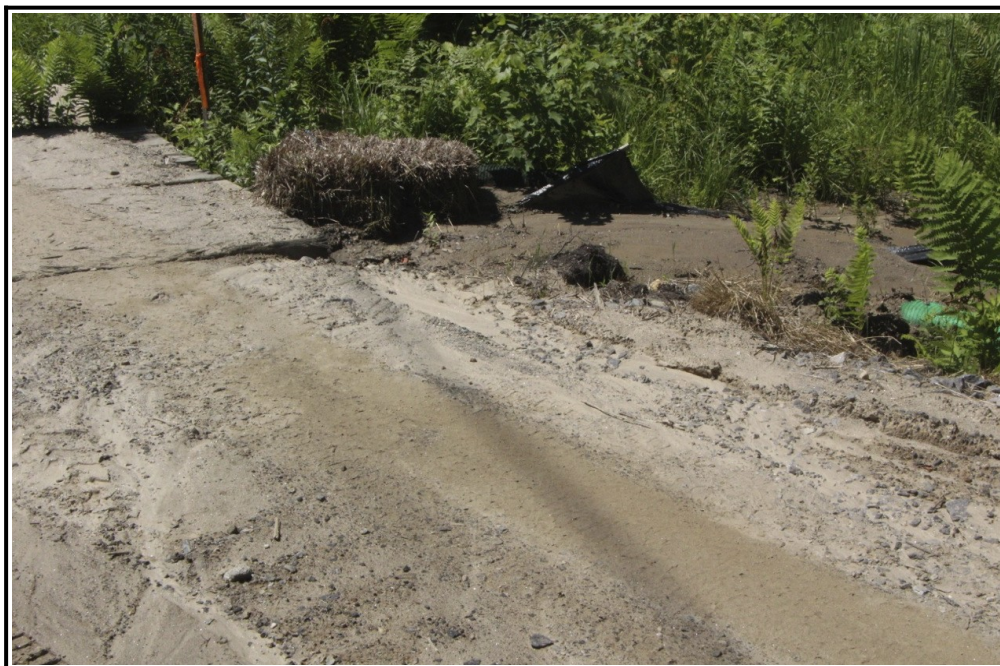
Below: A-111 easement. Silt, no fence.

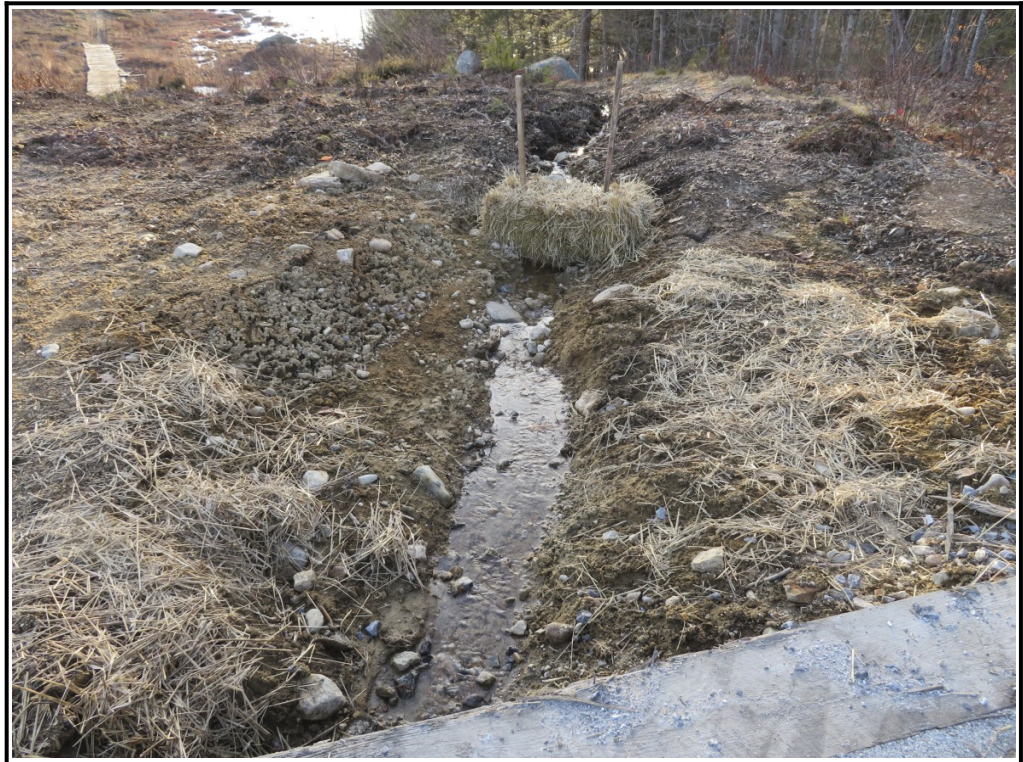
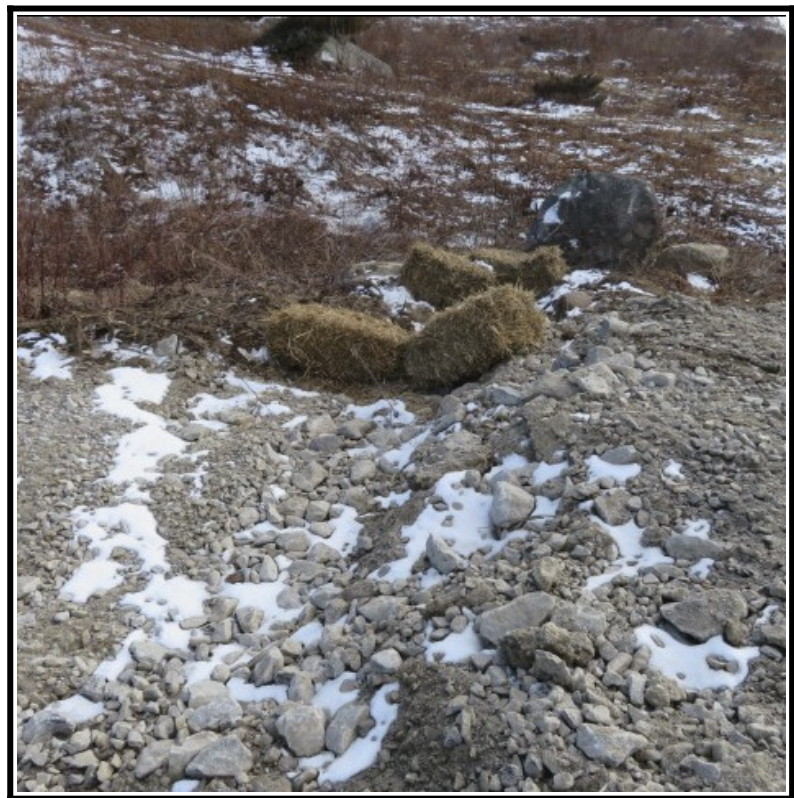
(Above: 1/2/24, 2/18/2024; 391/373) Straw bales installed in swale, not “embedded within the concentrated flow path”. No erosion matting.

“Do not install straw or hay bale barriers across streams, channels, swales, ditches or other drainage ways, or areas with concentrated flows. Such barriers are not capable of effectively filtering the high rates and volumes of water associated with channelized flow. However, they may be used for check dams in applications where installation access or other conditions prevent the use of preferred materials such as stone. In such cases, embed the straw or hay bales within the concentrated flow path; otherwise, they are subject to undercutting and end cutting. This frequently not only results in the bypass of sediment laden-water, but also in the complete failure of the barrier. Such failures typically release sediment accumulation on the upgradient side of the barrier and severe erosion of the channel both upstream and downstream of the device. Under no circumstances should sediment barriers be constructed in live streams or in swales where there is a possibility of a washout.”

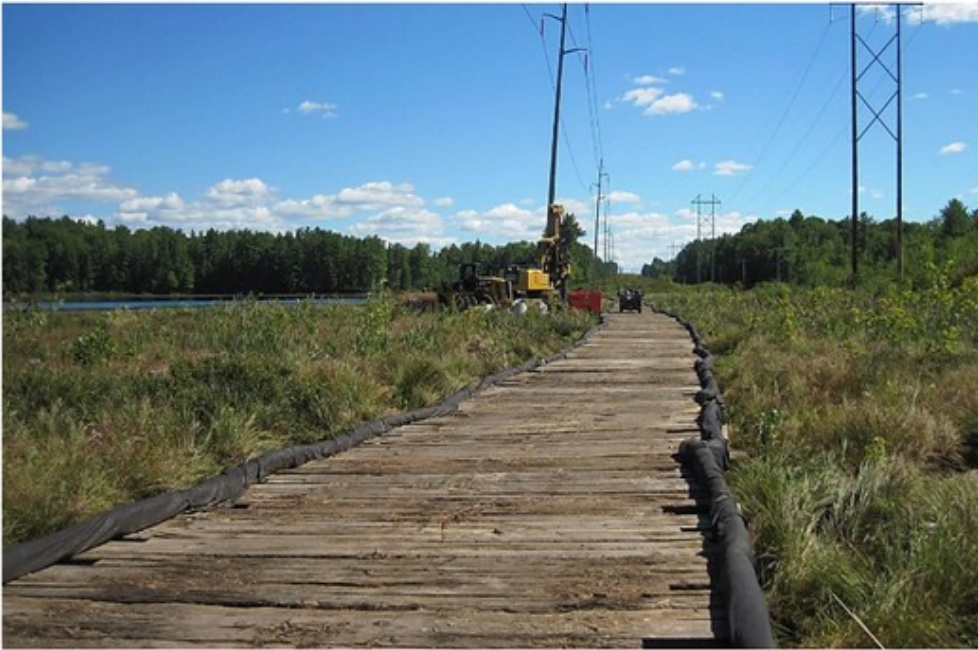
*(Right: 391/373:
2/12/2024) No coir
no silt barriers, mats
uncleaned and
extended in width
by improper
placement of lower
matting/support.*

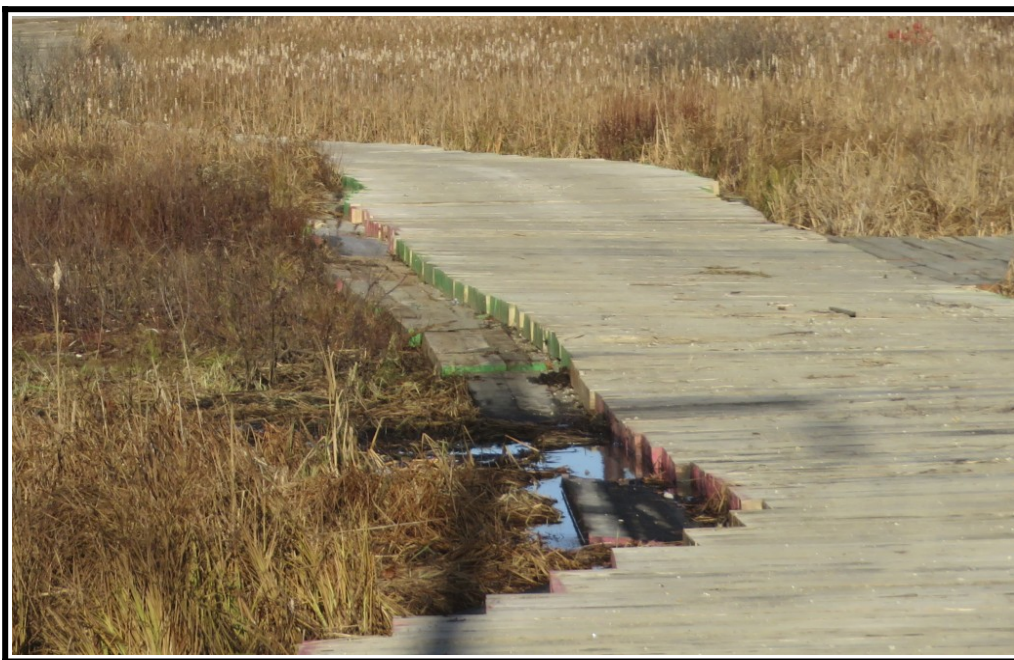
Below: U-181/E-194 12/2/2023) Wetlands impacts extended by lower layer.

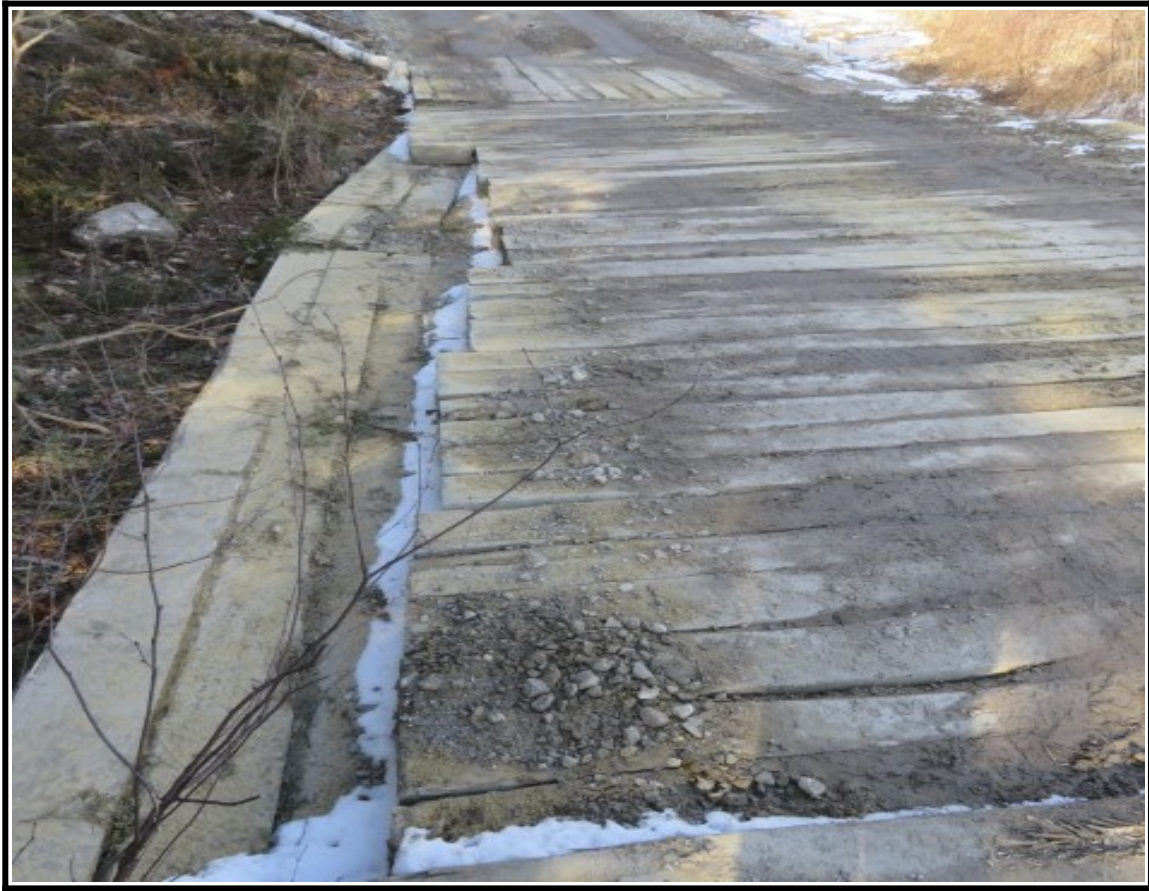
(Right: U-181/E-194
12/2/2024)
Silty gravel dump above
wetland.

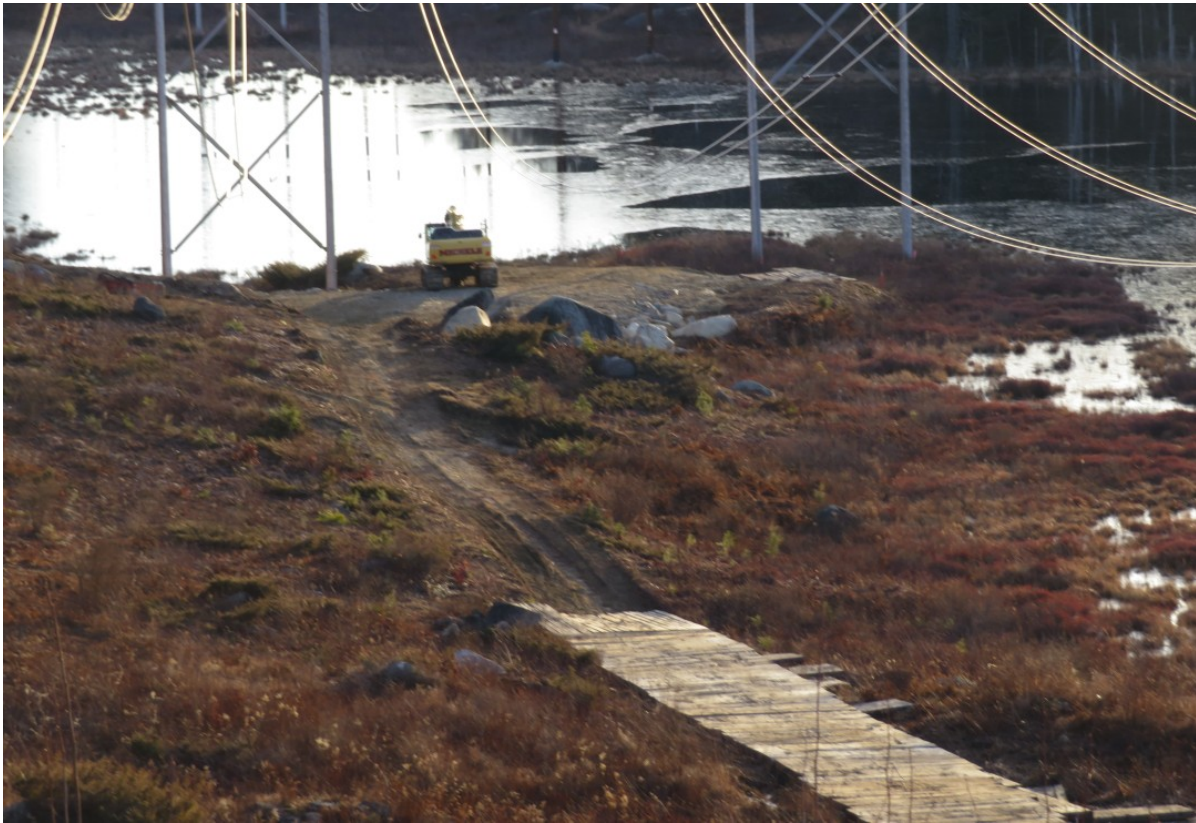
Below: 1/2/24, easement with lines 373 and 391, wetland with no matting, coir coils, hay bales, protection of any kind. The equipment used to construct this area was working for a month prior to the photos of the matting being placed.

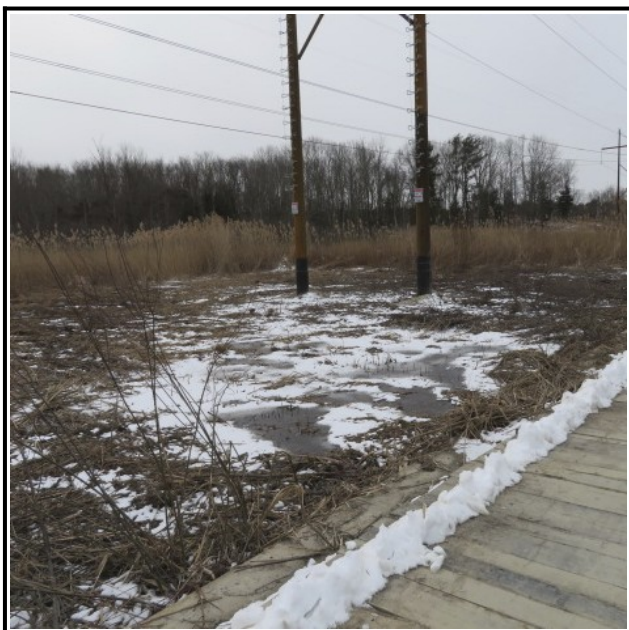
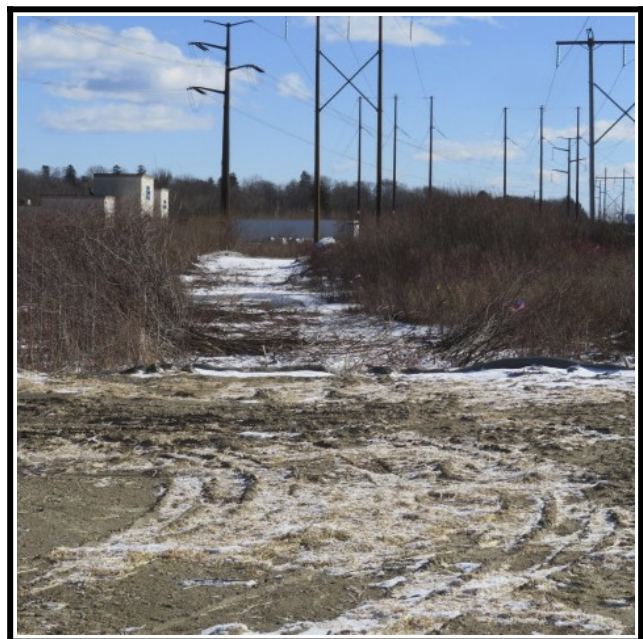
Below left U-181/E-194, 2/18/2024, partial mat removal in an area colonized by invasive phragmites. No proof that any of the above measures were carried out.

“If construction mats are used ensure they are free of invasives (particular consideration if using timber mats) before arriving on site and clean as with other equipment when moving. Properly treat or dispose of invasive species, or any materials that may harbor invasive species...

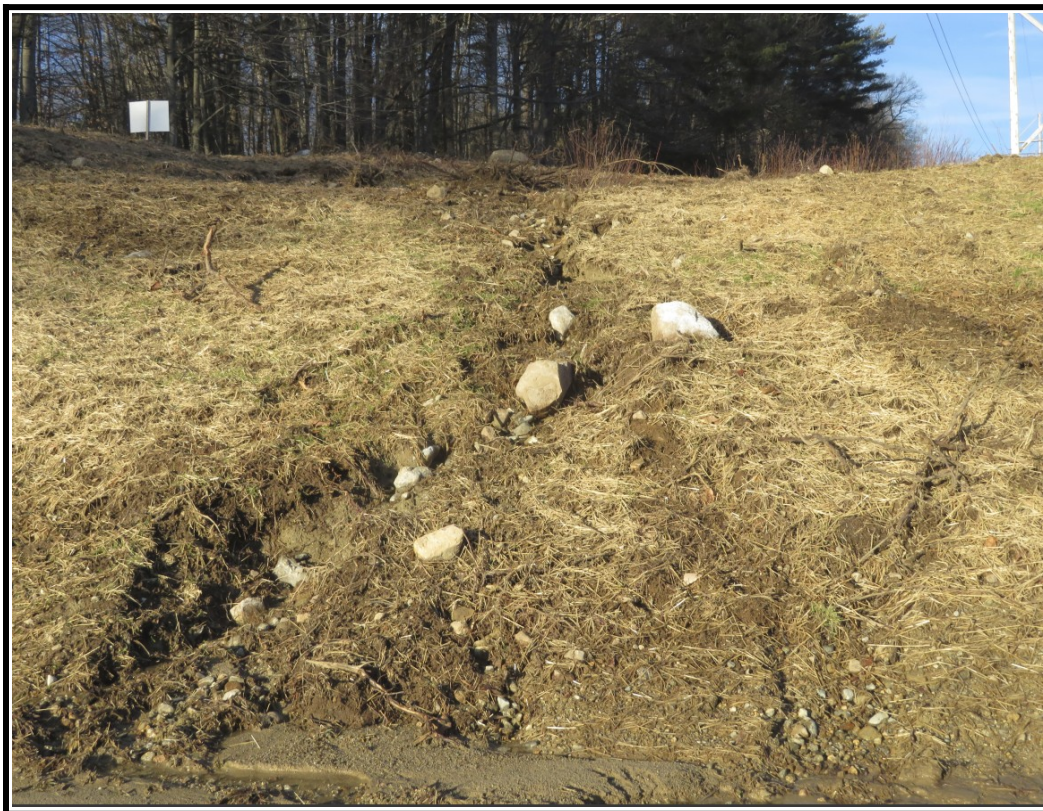
(1/2/24, 373/391) No erosion control blankets, glacial erratic dump pile.

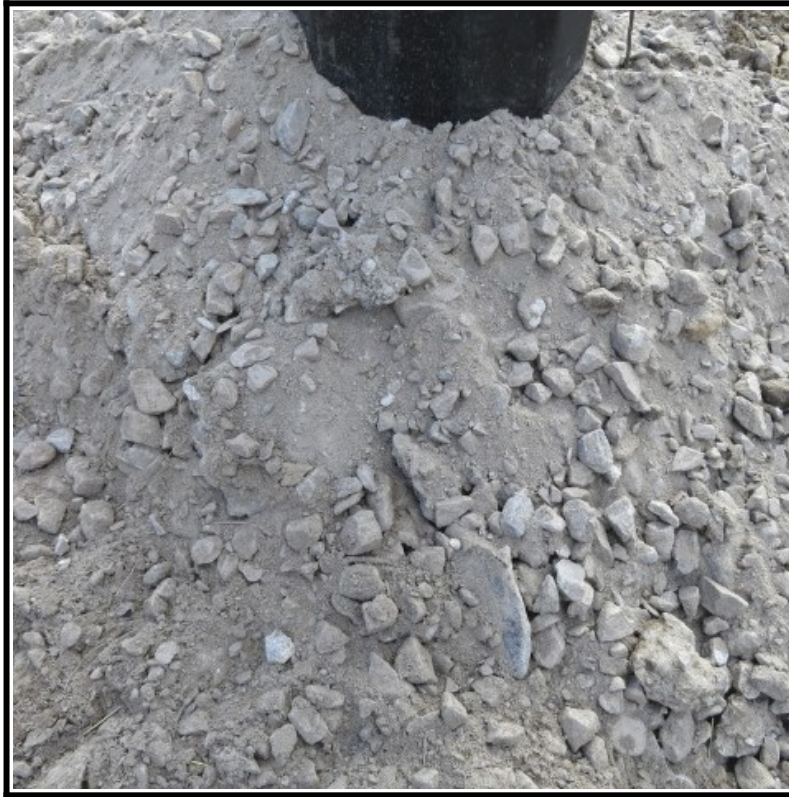
Below: 307/391, 2/12/2024

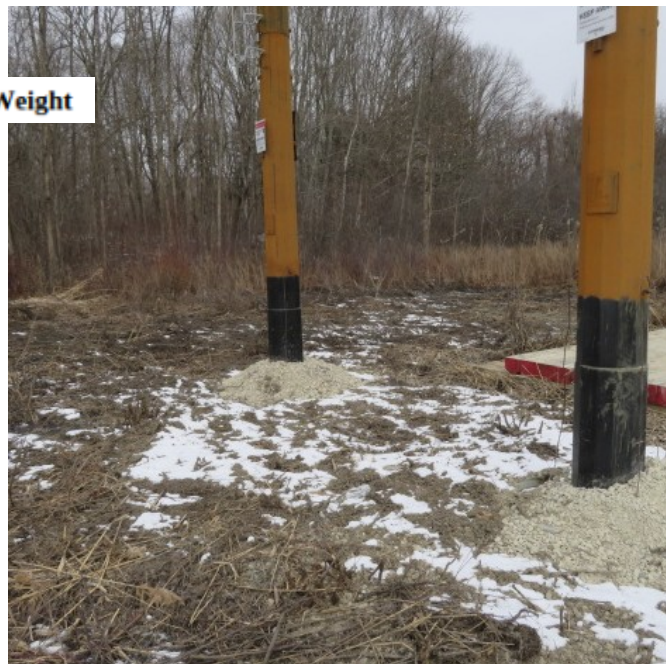
* Fraction passing the # 4 sieve 2/12/2024 E-194

Has DES sampled the fill used on any of the Asset Condition projects to see if it meets standards or if it is high in silt?
