Eversource 345-kV Structure Replacement Projects (2021-2022)

Planning Advisory Committee Meeting

January 21st, 2021

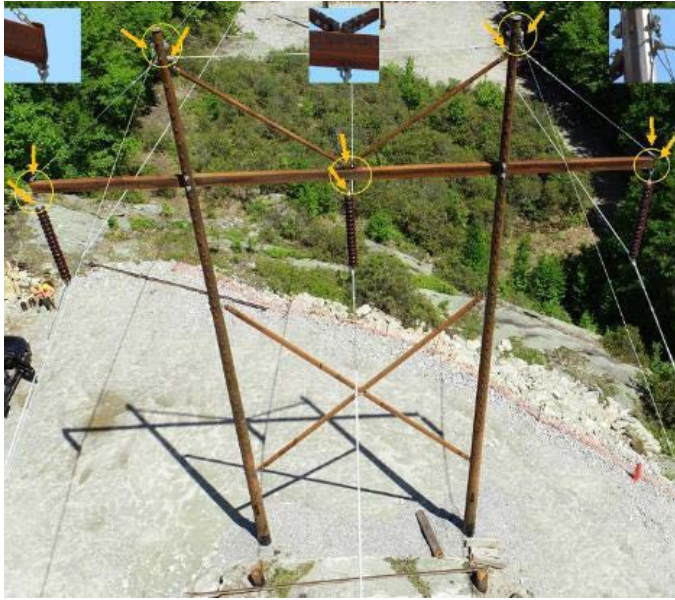
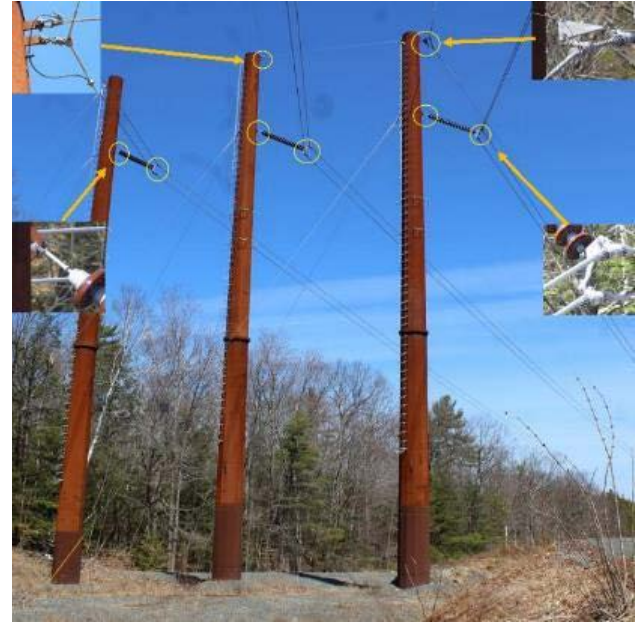
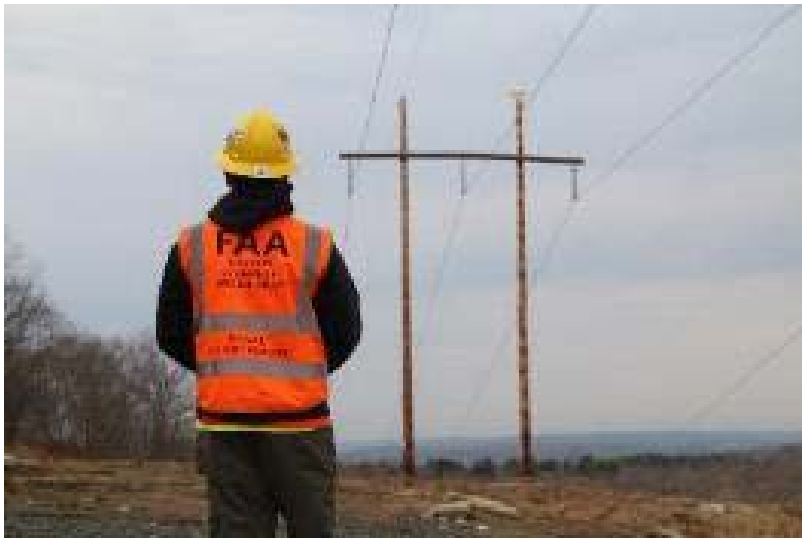
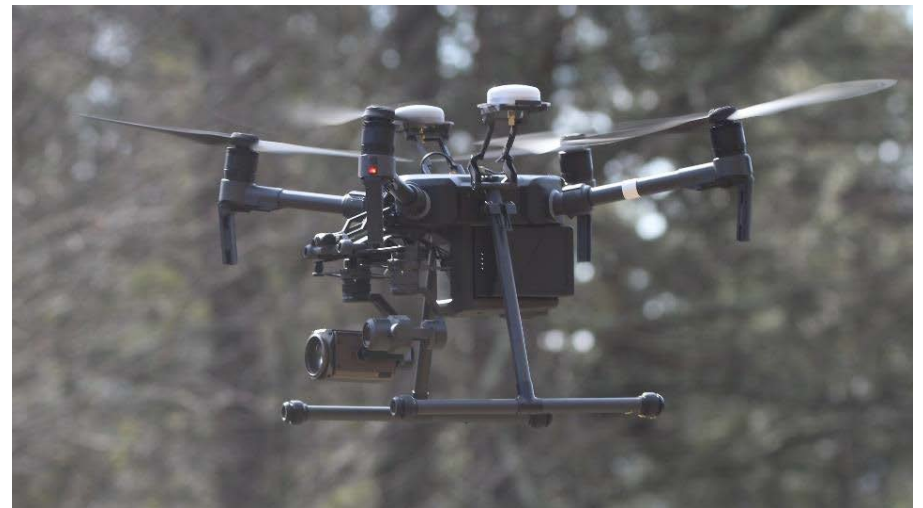
Drone Inspections

- Current Inspection Standard utilizes ***Comprehensive Drone Inspection*** as Primary Means of Inspection
 - Combines foot patrol and aerial inspection details in one inspection
 - 2-in-1 inspection is more efficient when considering overall duration and frequency of inspectors in ROW easements during two separate inspections
 - High-definition cameras on drones allow for inspectors to see possible damage from all angles and take better photos
 - 345-kV system is inspected on an annual basis
- Items Reviewed – Wood Structures
 - Significant woodpecker damage
 - Severe checking/splits/cracking
 - Insect damage
 - Rot or decay
 - Severe fracturing, buckling, leaning
 - Compression breaks
 - Fire damage
 - Damage/Vandalism
 - Hardware/Insulator damage
