New Hampshire Asset Condition Structure Replacements – Line S153

Planning Advisory Committee Meeting

July 23, 2025

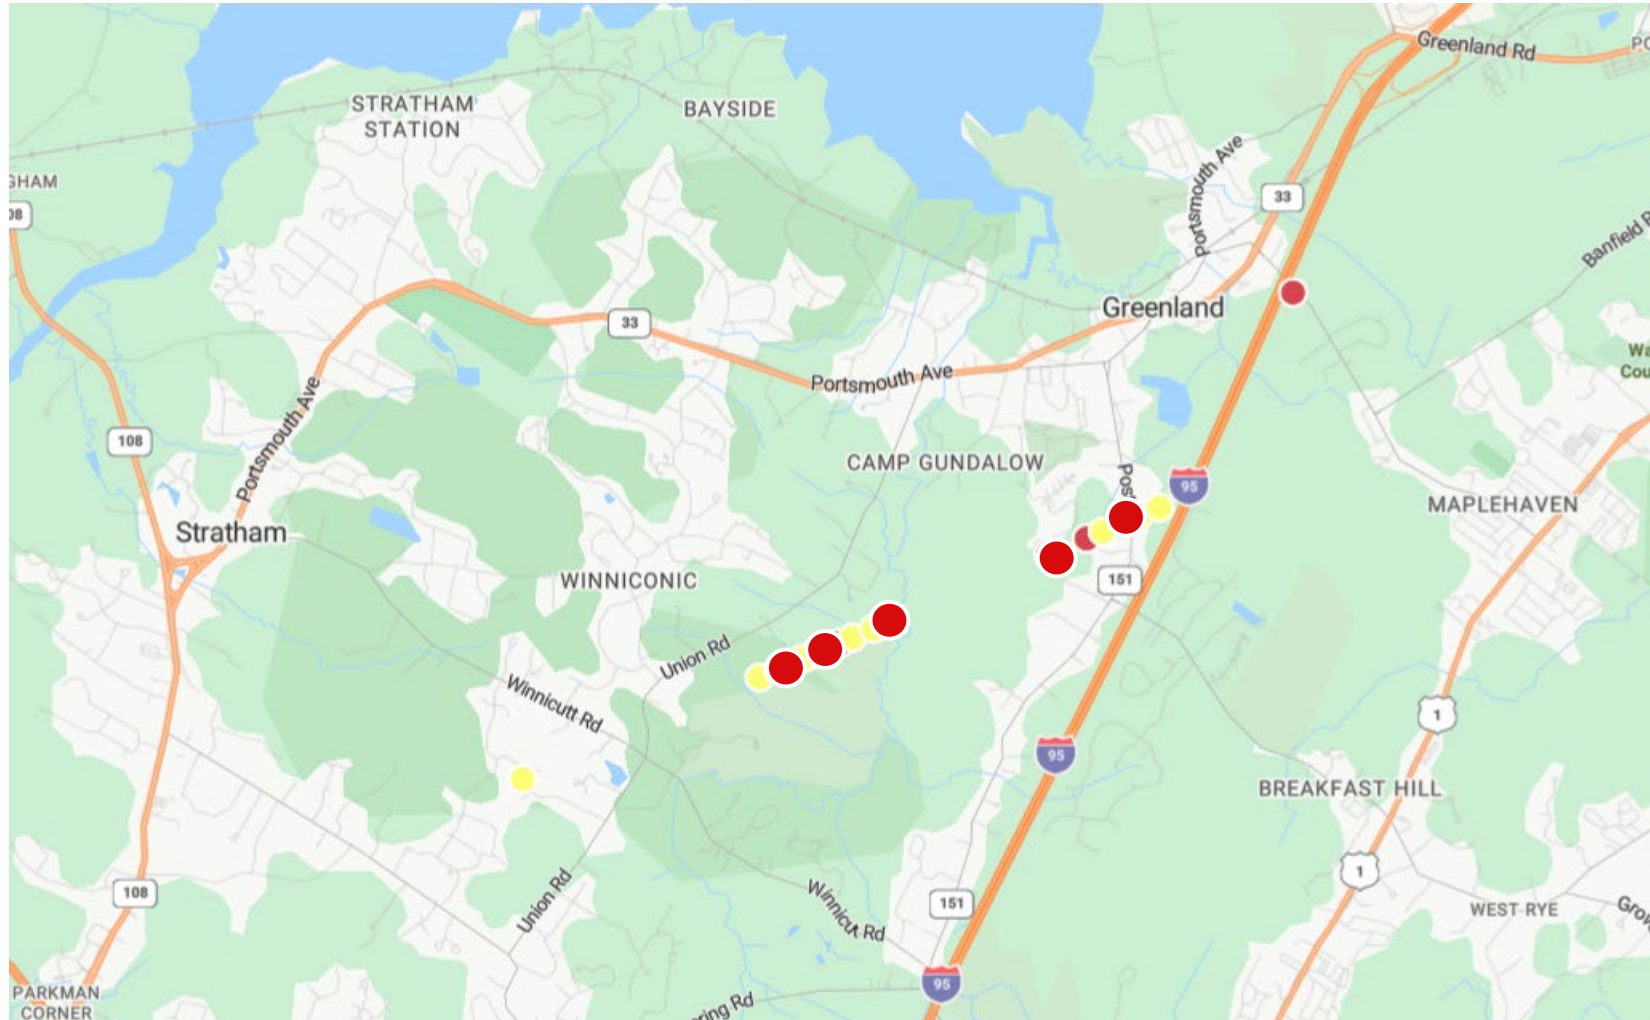
Structure Concerns – Map (Line S153)

- Category B structures are in close proximity to the work sites that will be required to replace the Category C structures

- Category C structures
- Proximity structures
