New Hampshire Line X-178 Rebuild

Planning Advisory Committee Meeting

Commentary, March 17, 2024

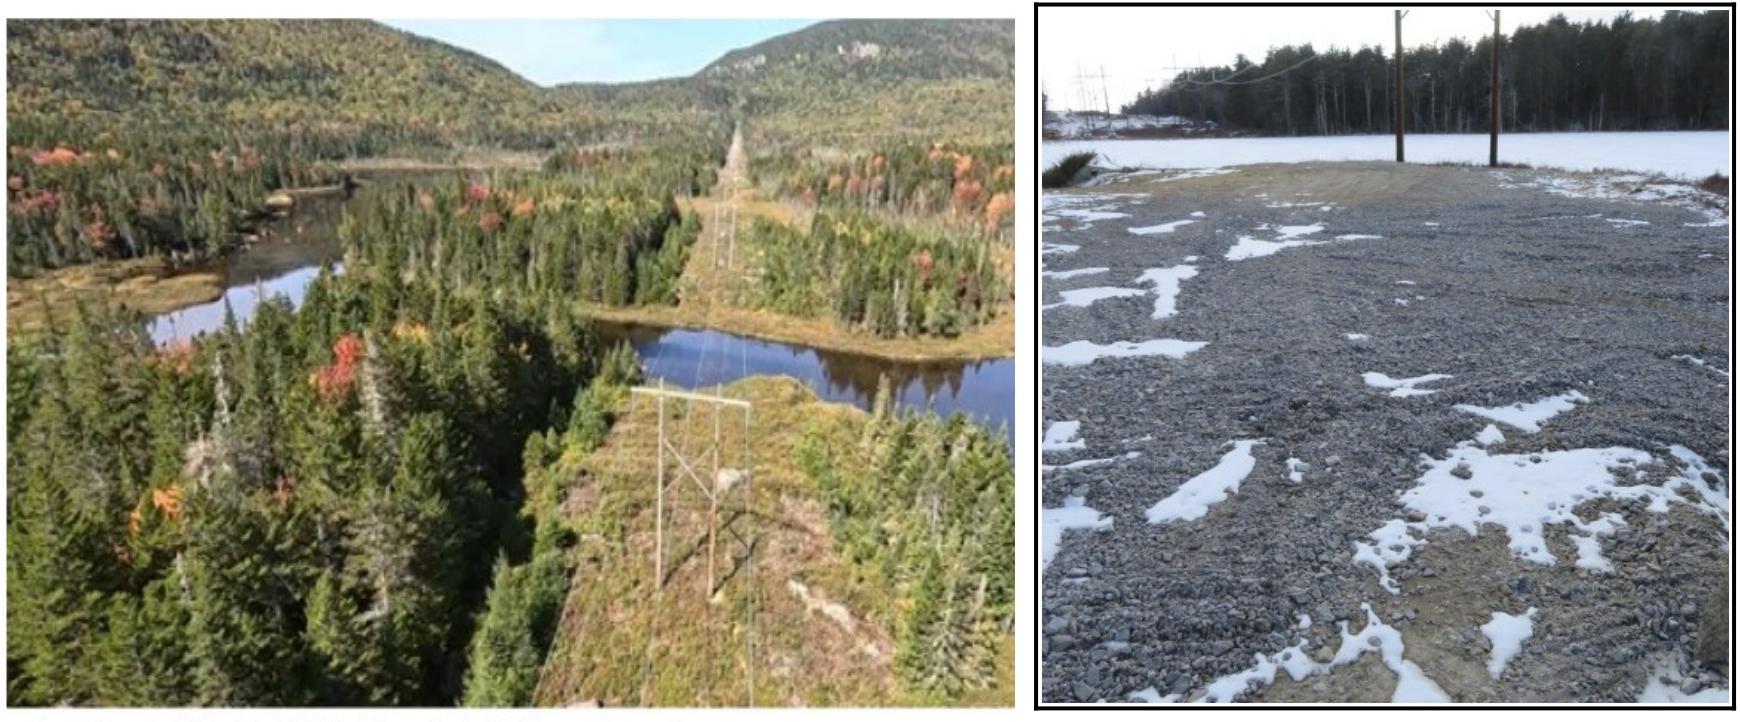
Bog Pond within the White Mountain National Forest

Bog Pond permanent construction pad, 2026?

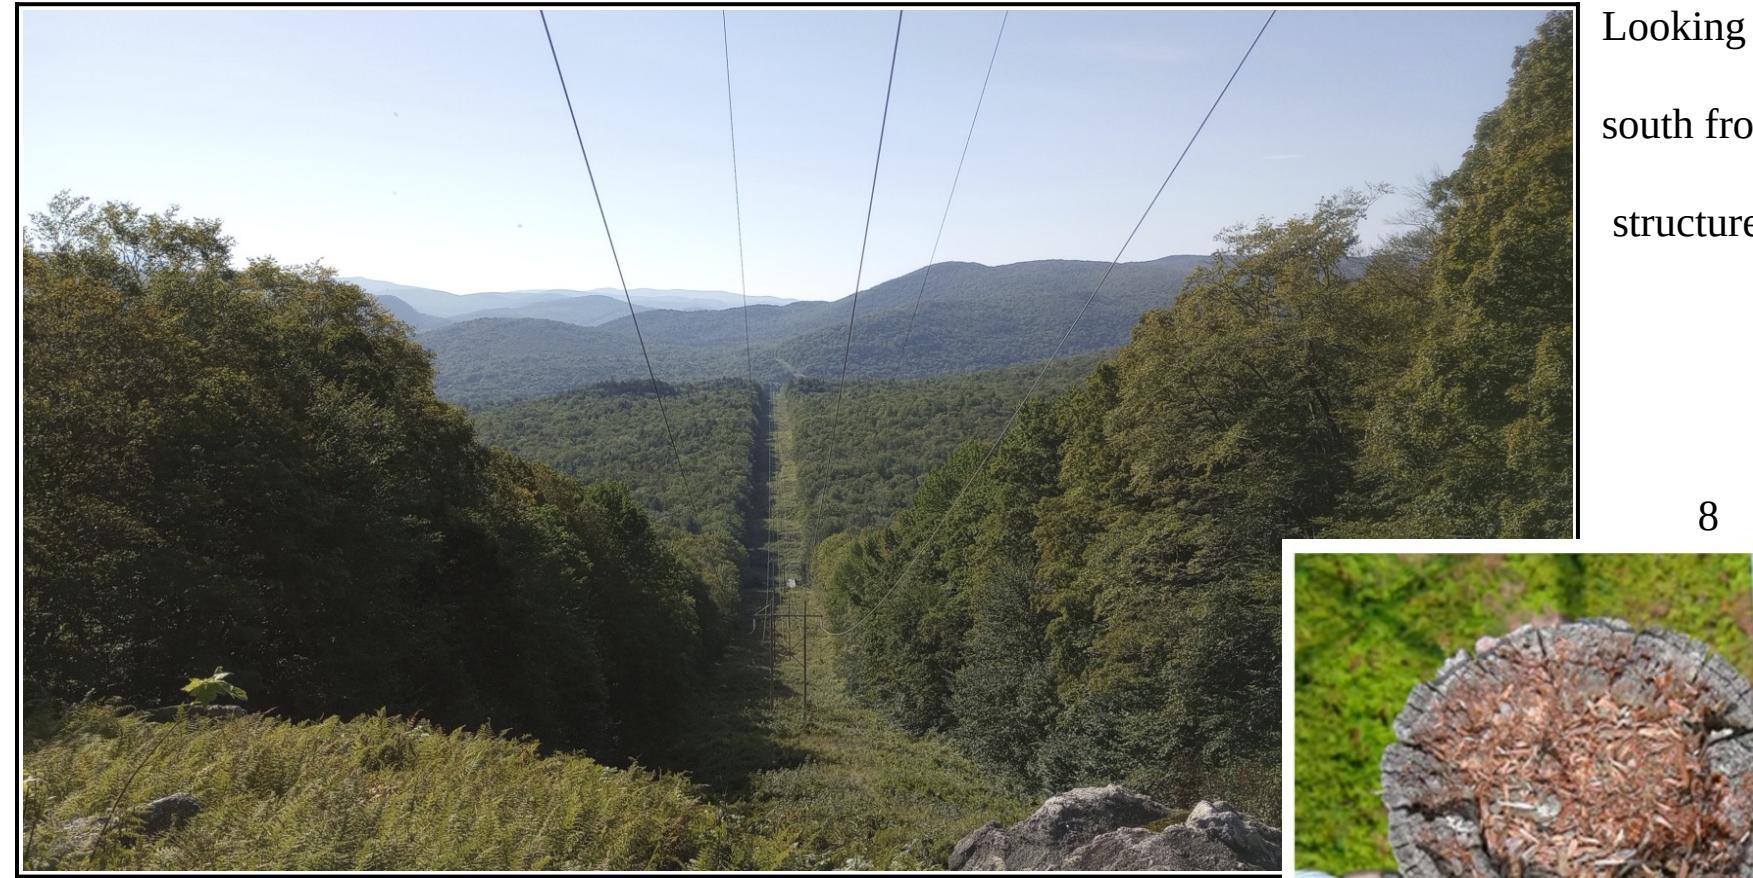
Structure 212 - Pole Top Rot & Rusted Hardware

Eversource claims it needs to build a permanent road and construction pads here, in White Mountain National Forest, to access structure 212. Rusted hardware can be replaced. Why was this pole not covered when structures 214 and 216 had insulators and crossbar replaced, via helicopter, in 2016?
