1/18/24kris pastoriza questions to Eversource about structures 424, 212 and 356 and a repeatedrequest for the locations of the Category C poles.

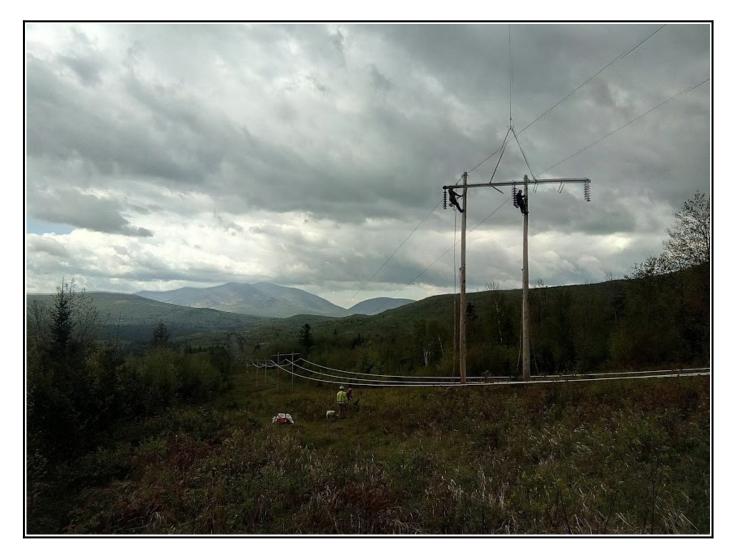
Crossbar and insulator replacement, X-178 line. Why didn't Eversource replace the 56 (in 2018) or 43 (now) Category C poles that needed replacement while it was doing this work? Was it waiting for them to become Category D? Have 13 of those poles/structures been replaced since 2018, as Category D poles?

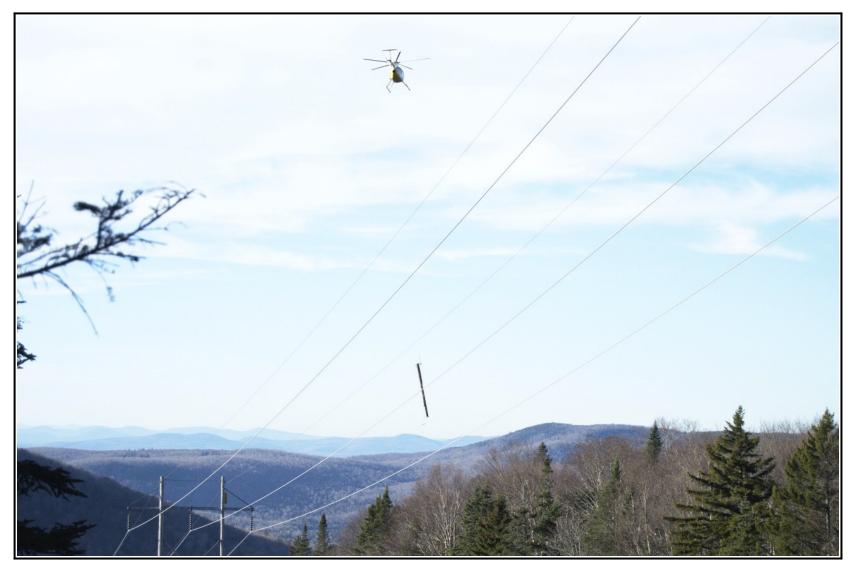
(11/10/2015)

Pole removal, X-178, White Mountain National Forest:
