Comment on ACCC type conductors and ice load, SEC 2024-02 and DE-24-087

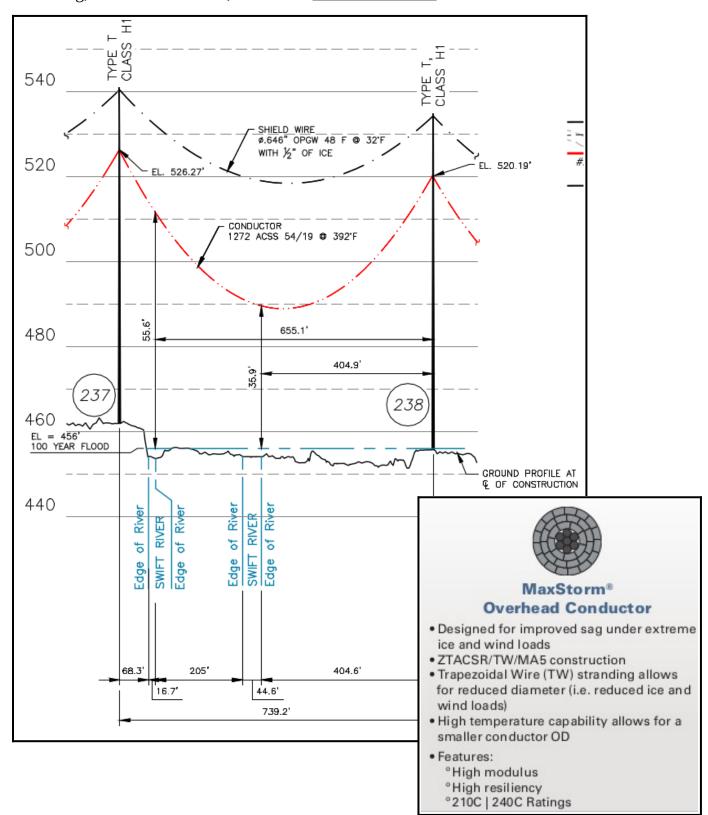
Below: Eversource's <u>proposed</u> 2,200 amp 1272 ACSS at 739' has 35' sag at 392 F, its condition of maximum sag, 20' more than the 1,026 ACCC <u>with ½" radial ice</u>.

Newer ACCC type conductors designed for ice loads may have even less sag. For example (above right) MaxStorm Overhead Conductor; "Trapezoidal Wire (TW) stranding allows for reduced diameter (i.e. reduced ice and wind loads.)"

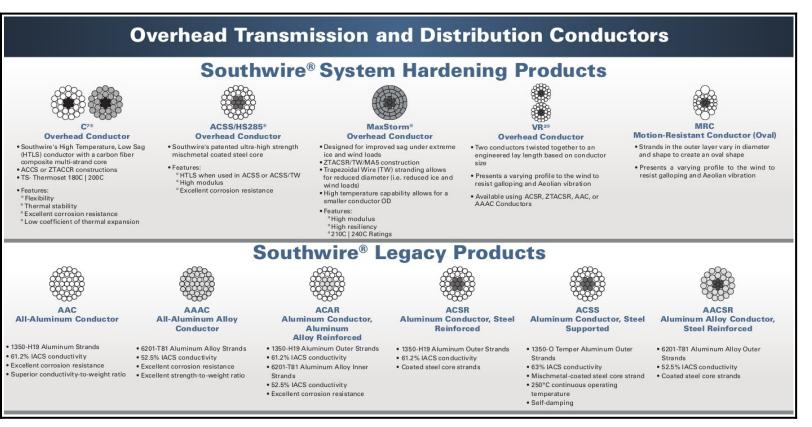
Note that Southwire lists ACSS in its "Legacy" category, along with ASCR.

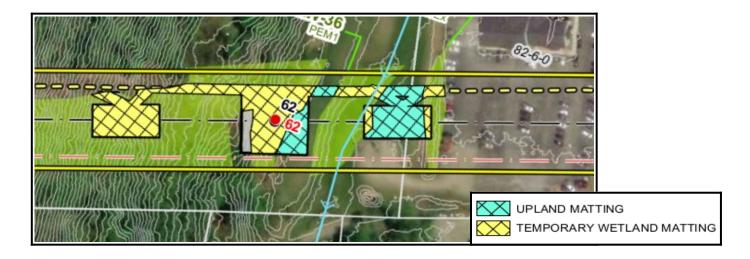
Loggers can fell and limb large trees with a tracked feller-buncher but Eversource claims it cannot set light-duty poles without a road and 100' x 100' construction pads. The plans for this area show wetland and uplands matting placed where the road and part of the lower construction pad are, so why has Eversource been allowed to excavate wetlands when it is required to place matting on the wetlands to protect them? Why has it built what appear to be two construction "pads" into the steep slope above structure 62 rather than laid wetlands/upland matting around it?

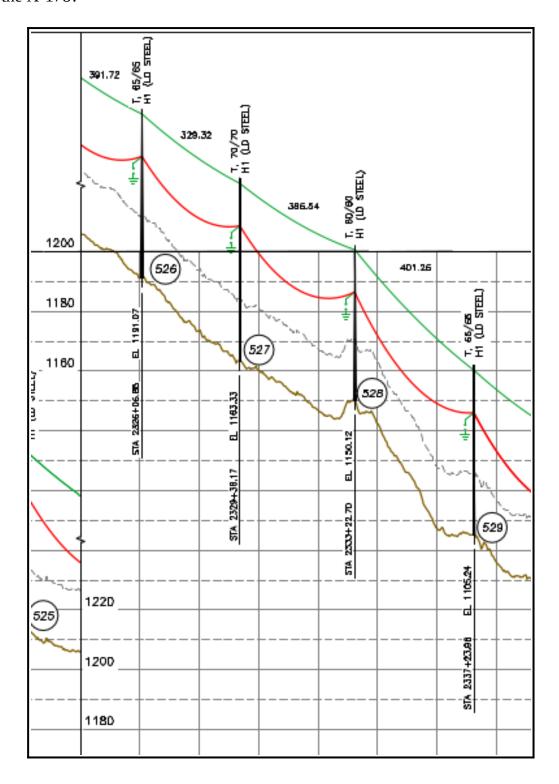
Should we assume Eversource is exceeding Code clearances and increasing structure heights here far beyond what is required to carry its high sag conductor, as it plans to do on the 49 miles of the X-178?
