THE STATE OF NEW HAMPSHIRE  
BEFORE THE  
NEW HAMPSHIRE SITE EVALUATION COMMITTEE

DOCKET NO. 2024-02

PETITION REQUESTING JURISDICTION AND OVERSIGHT OF  
EVERSOURCE PROPOSED X-178 TRANSMISSION LINE  
REPLACEMENT PROJECT

**Public Service Company of New Hampshire Responses to  
Technical Session Data Requests**

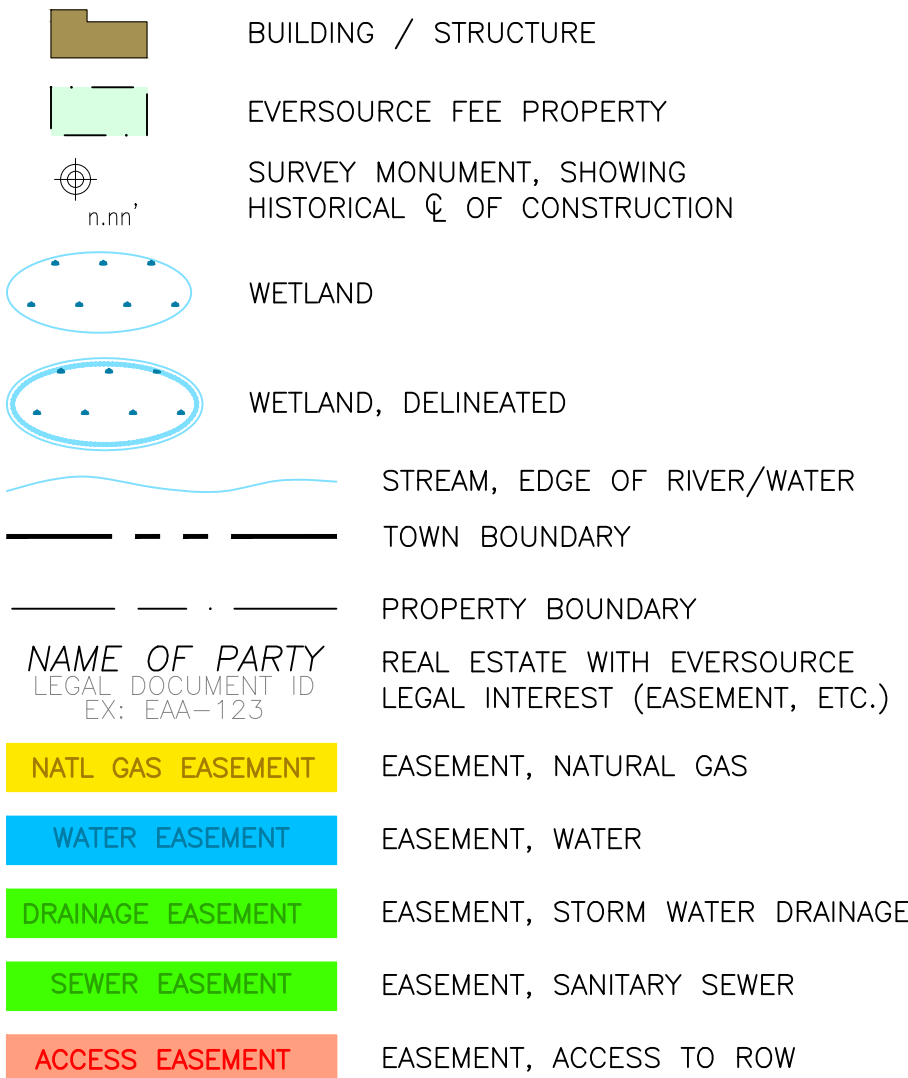
LEGEND PROFILE VIEW:

1. LINE X178 IS A 47 MILE SINGLE CIRCUIT 115kV OVERHEAD TRANSMISSION LINE CONDUCTORS ARE 1272 KCMIL 54/19 ACSS, SAGGED FOR A MAXIMUM DESIGN TENSION OF 10,000 POUNDS UNDER NESC 2017 EDITION RULE 250B HEAVY FINAL CREEP LOAD CONDITION, UNLESS NOTED OTHERWISE.
2. OVERHEAD GROUND WIRES ARE 0.646" 48 FIBER SAGGED FOR A MAXIMUM DESIGN TENSION OF 5,500 POUNDS AT NESC HEAVY FINAL CREEP CONDITION, UNLESS NOTED OTHERWISE.
3. WIRE SAGS ARE DEPICTED IN PROFILE VIEWS AS FOLLOWS:
  - 4.1. CONDUCTORS AT 392°F
  - 4.2. GROUND WIRES AT -20°F
5. SURVEY INFORMATION
  - 5.1. HORIZONTAL DATUM: NORTH AMERICAN DATUM OF 1983 (NAD83) NEW HAMPSHIRE STATE PLANE COORDINATE SYSTEM, US SURVEY FOOT
  - 5.2. VERTICAL DATUM: NORTH AMERICAN VERTICAL DATUM OF 1988 (NAVD 88)

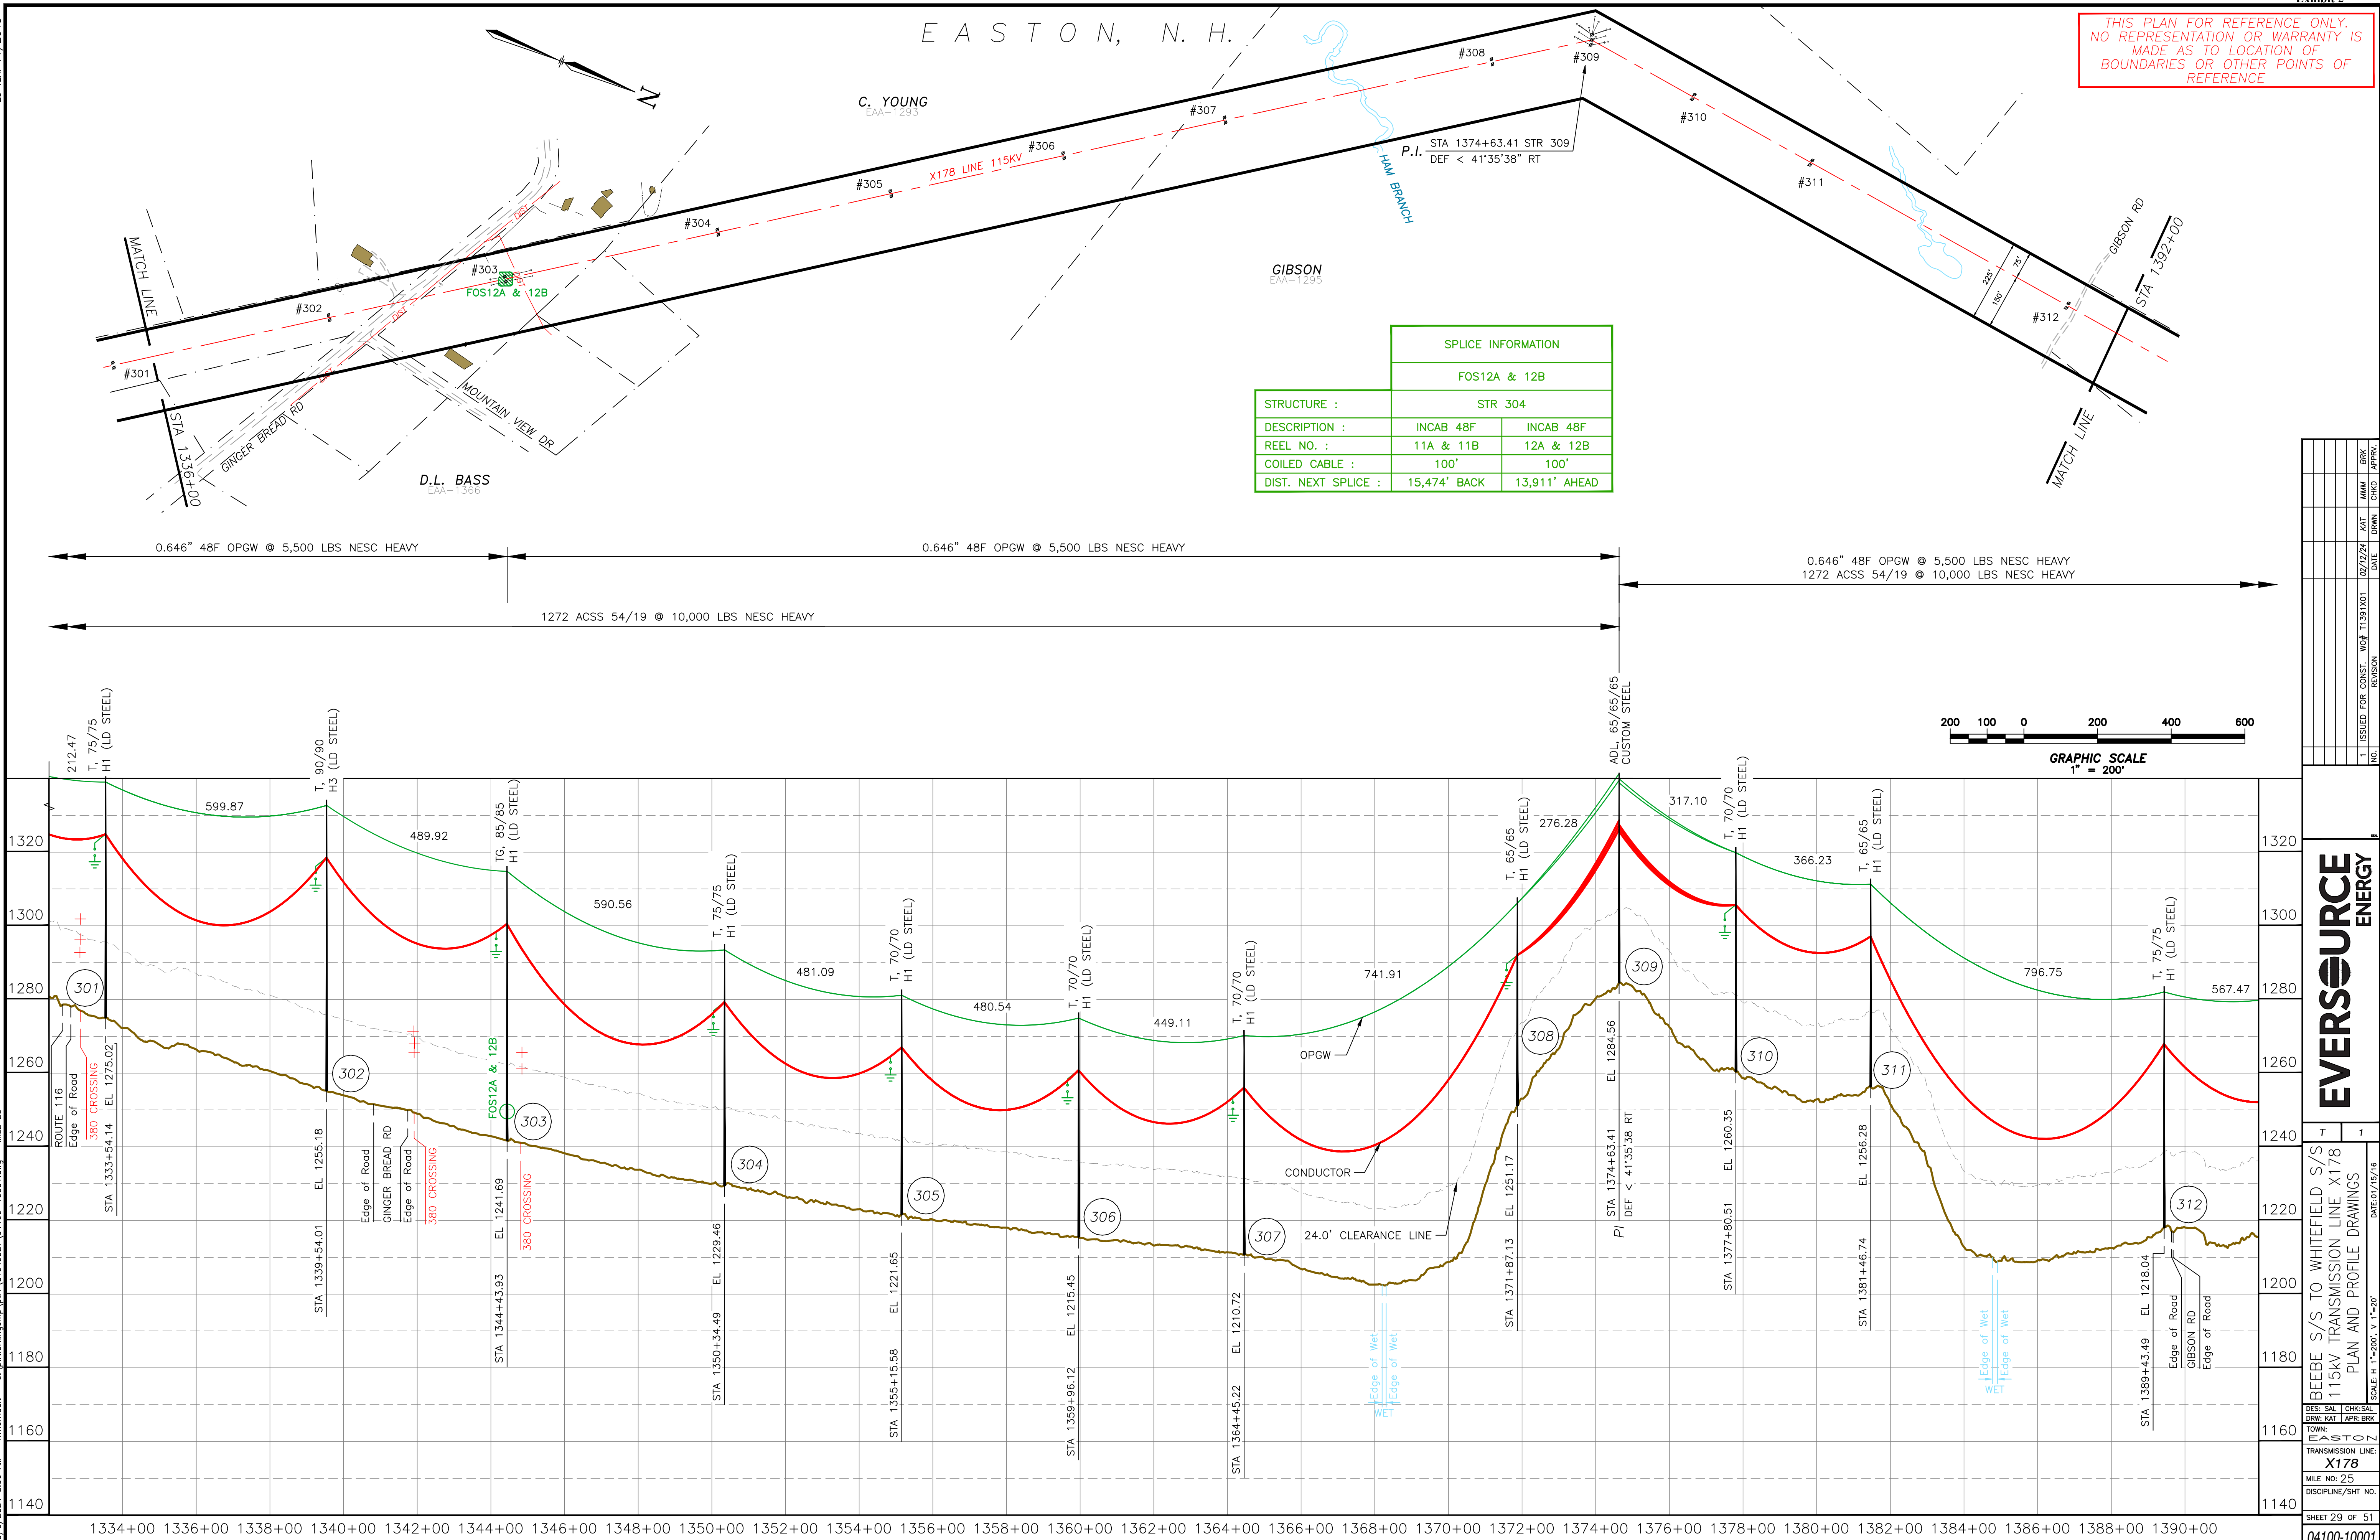
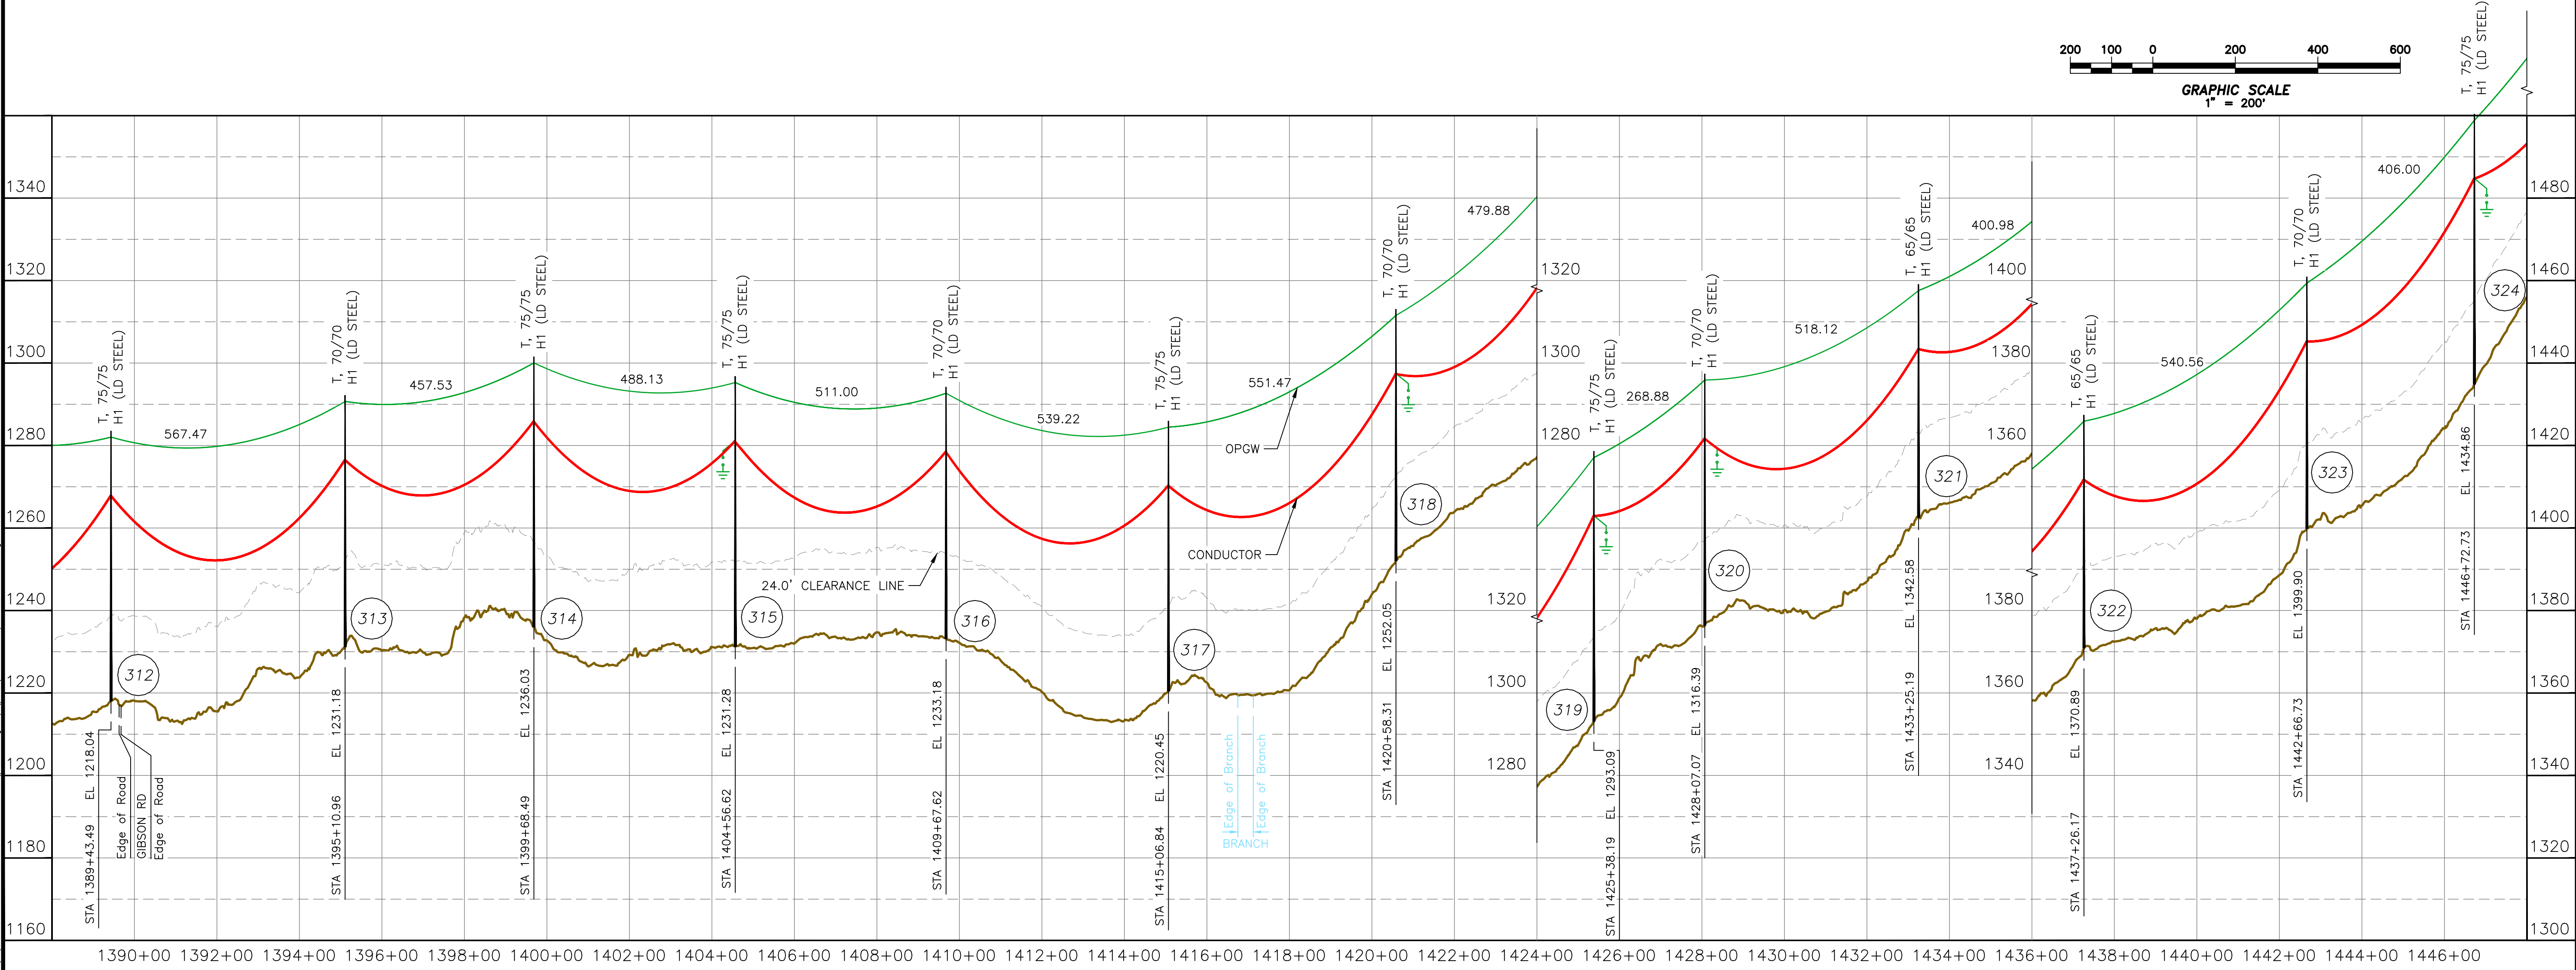
DES: S/S TO WHITEFIELD S/S  
115kV TRANSMISSION LINE X178  
PLAN AND PROFILE DRAWINGS  
TOWN: EASTON  
TRANSMISSION LINE: X178  
MILE NO: 26  
DISCIPLINE/SHT NO.  
SHEET 30 OF 51  
04100-10001

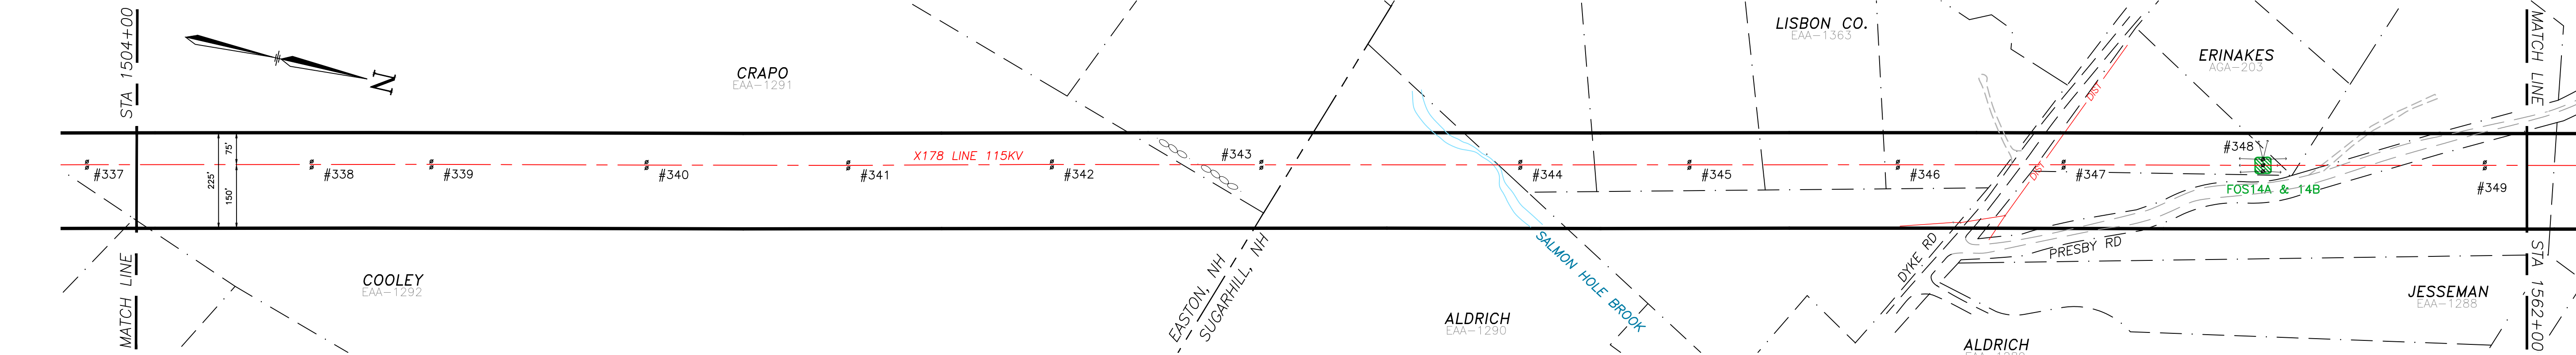
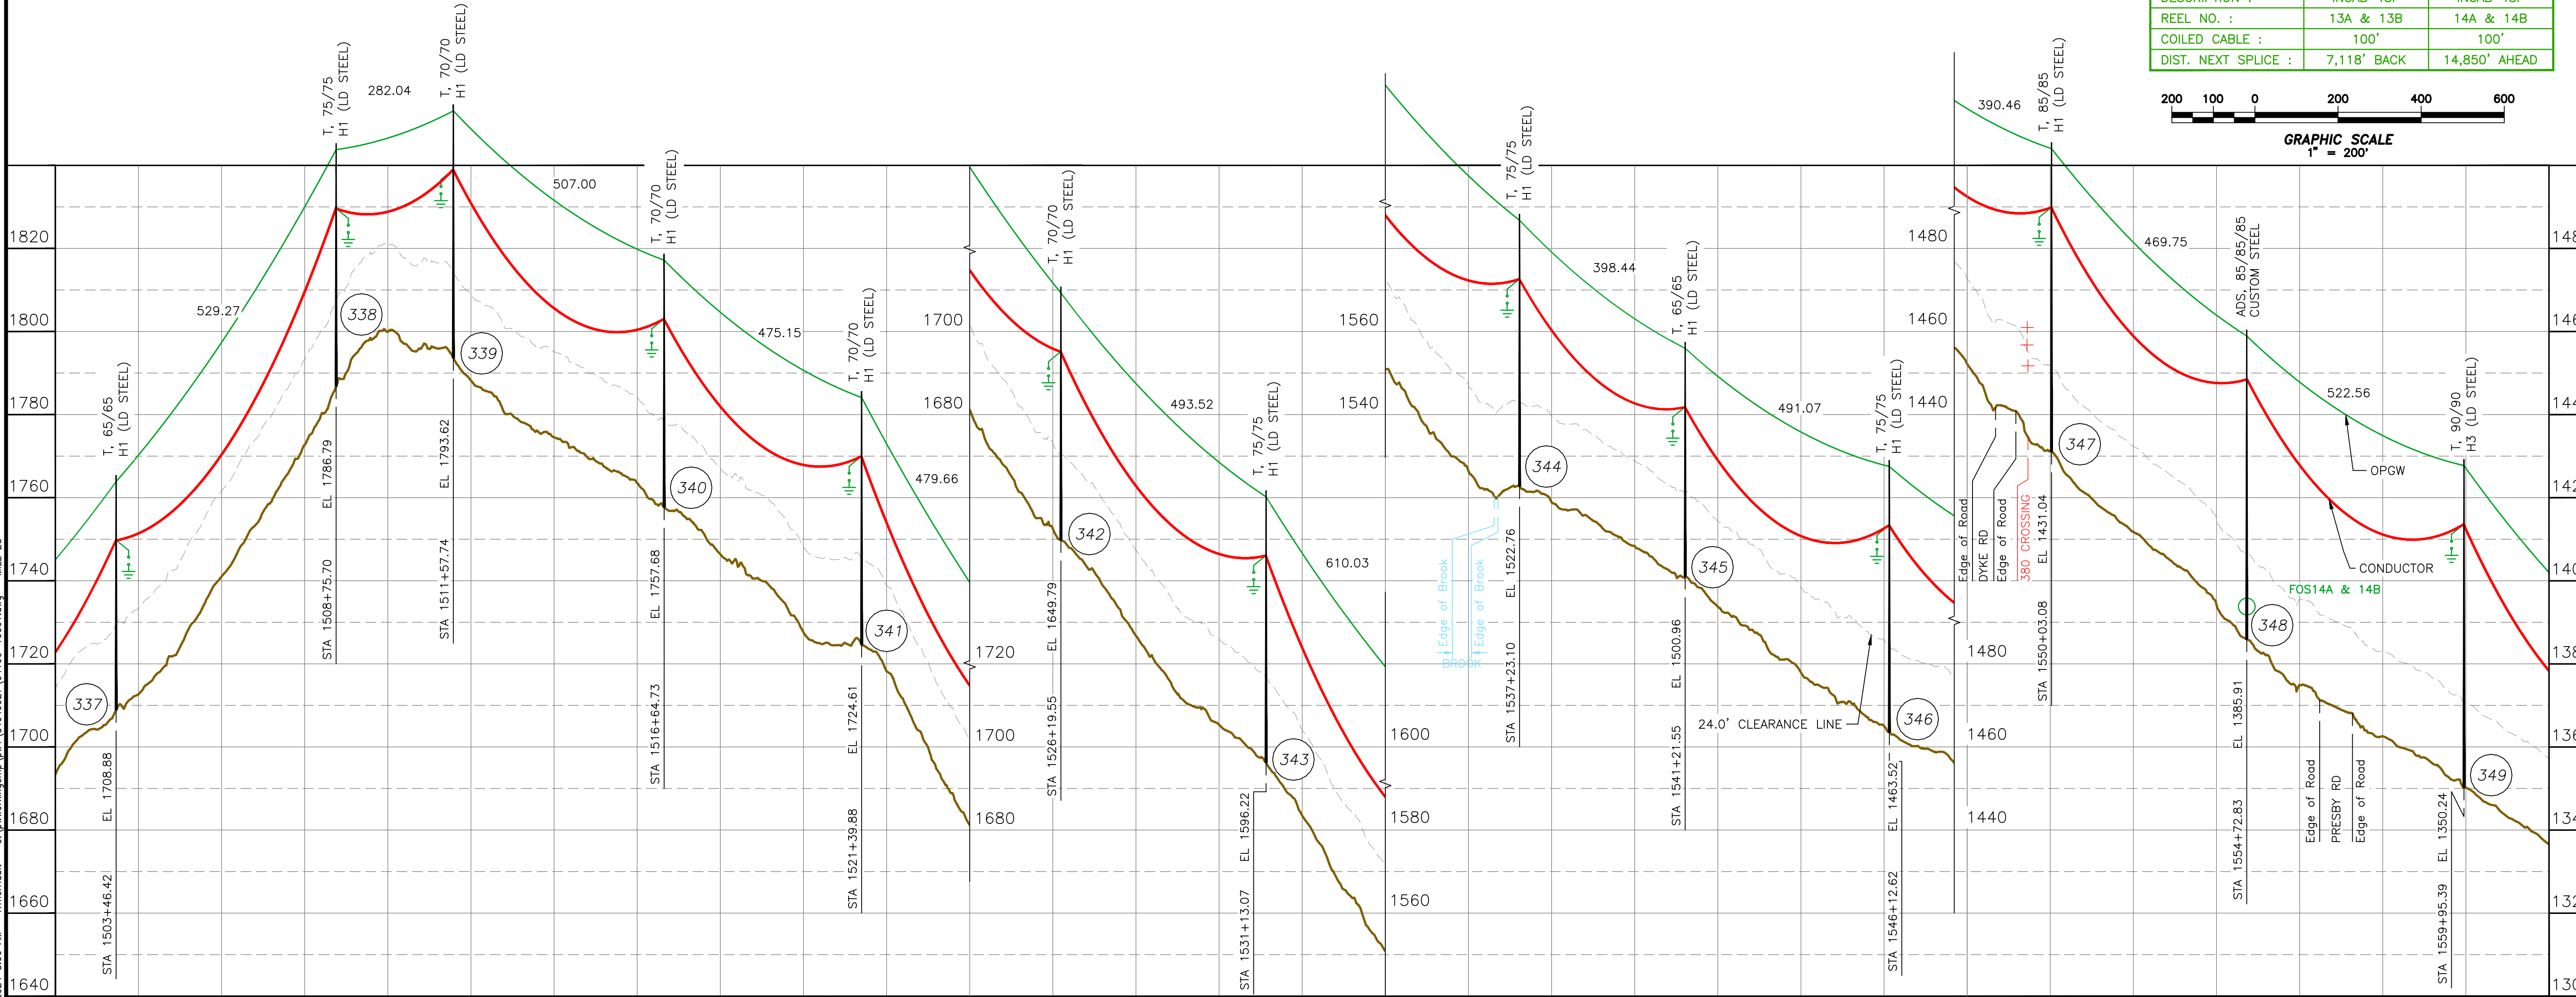
0.646" 48F OPGW @ 5,500 LBS NESC HEAVY  
1272 ACSS 54/19 @ 10,000 LBS NESC HEAVY

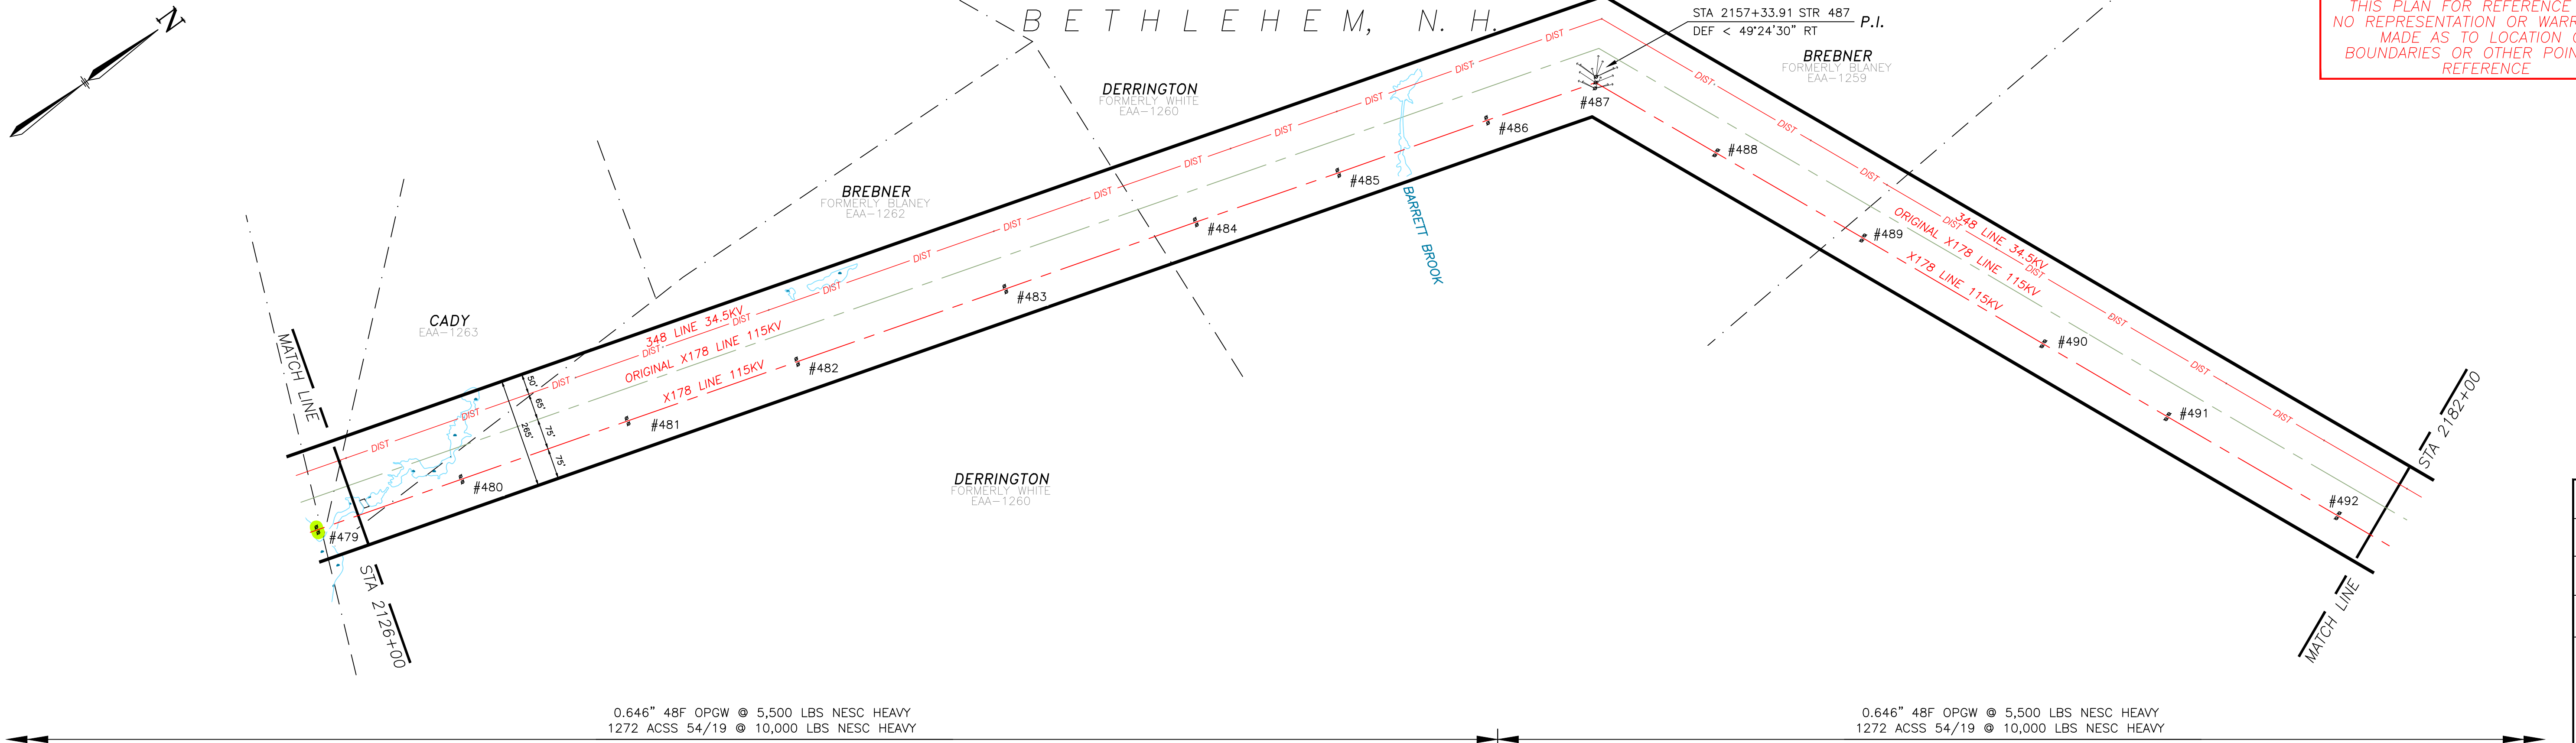
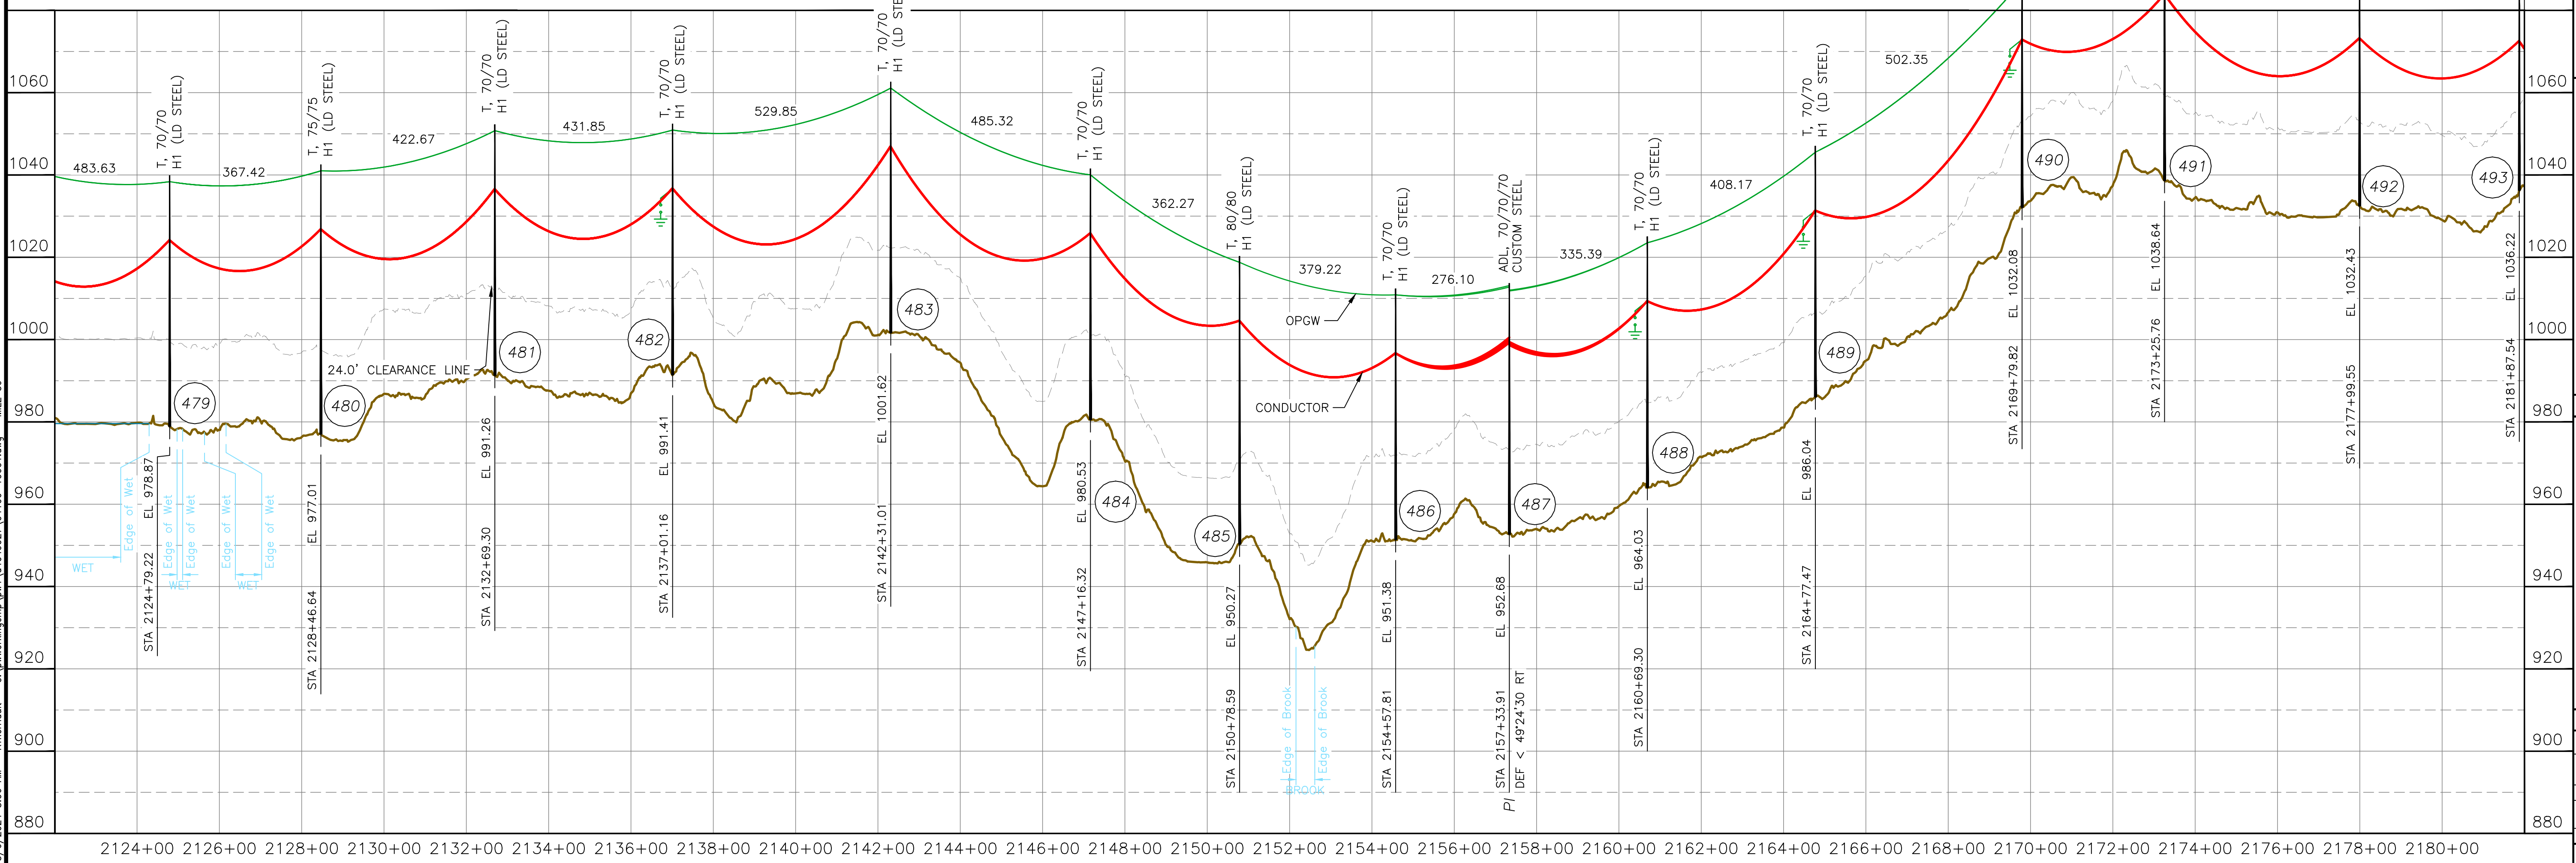
0.646" 48F OPGW @ 5,500 LBS NESC HEAVY  
1272 ACSS 54/19 @ 10,000 LBS NESC HEAVY

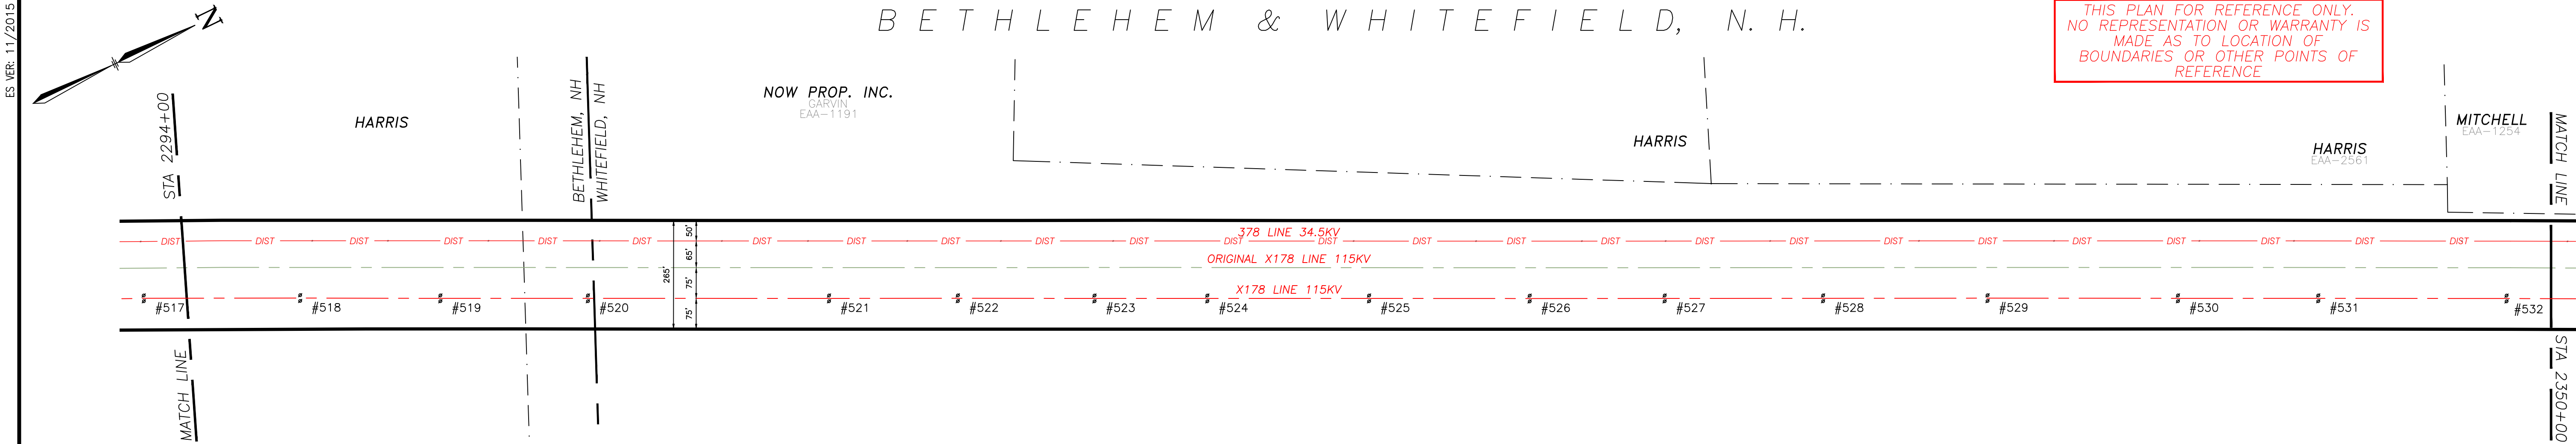
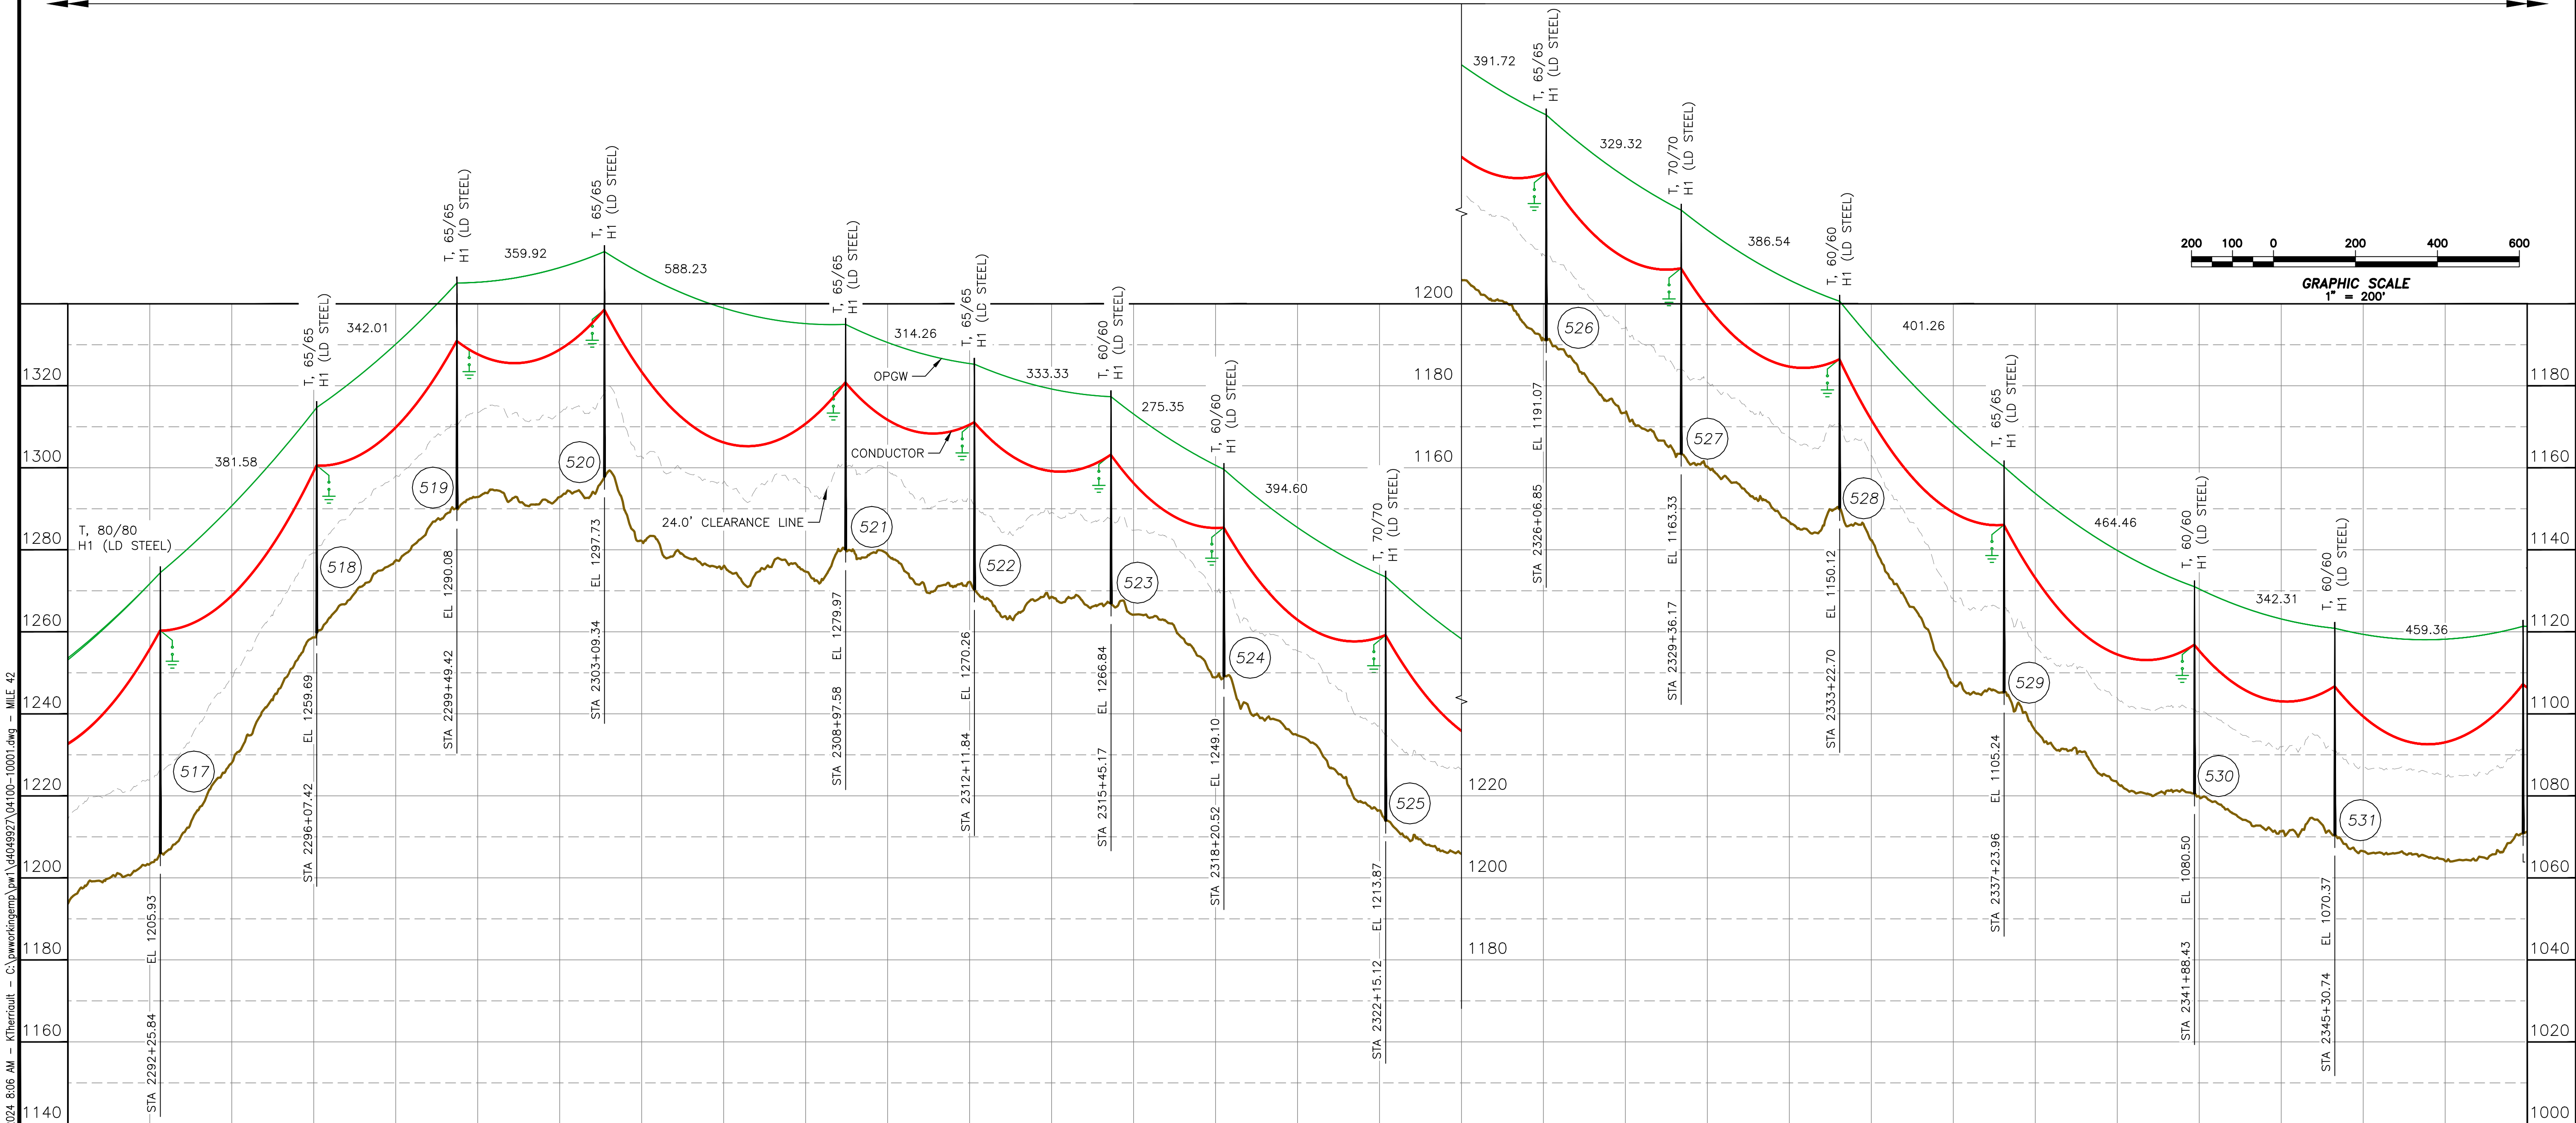
0.646" 48F OPGW @ 5,500 LBS NESC HEAVY  
1272 ACSS 54/19 @ 10,000 NESC HEAVY
