New Hampshire Asset Condition Structure Replacements – Lines 373, 385, 391

Planning Advisory Committee Meeting June 16, 2025

Introduction

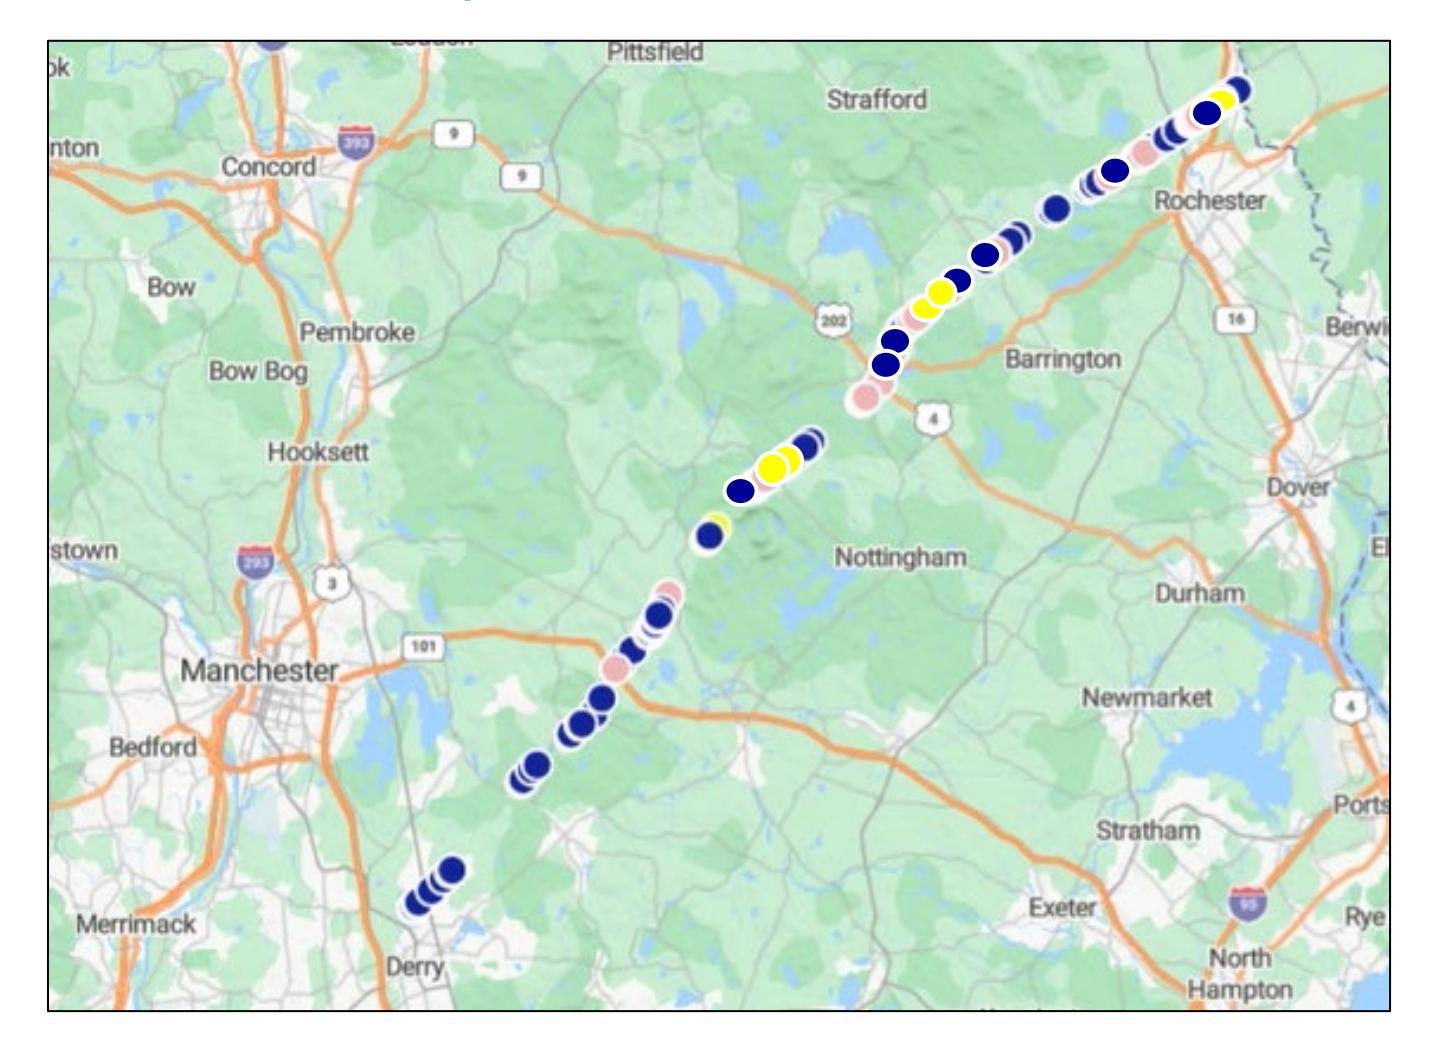
Project Needs and Drivers Structure Concerns - Map

Category C structures
 Proximity structures
 Last remaining wood structures
