E115 Transmission Line Rebuild and Optical Ground Wire Replacement Project Eversource Energy

New Hampton, Bridgewater, Bristol, Ashland, and Holderness New Hampshire

NHDES Alteration of Terrain Permit Application

March 1, 2022 GZA File No. 04.0190999.72

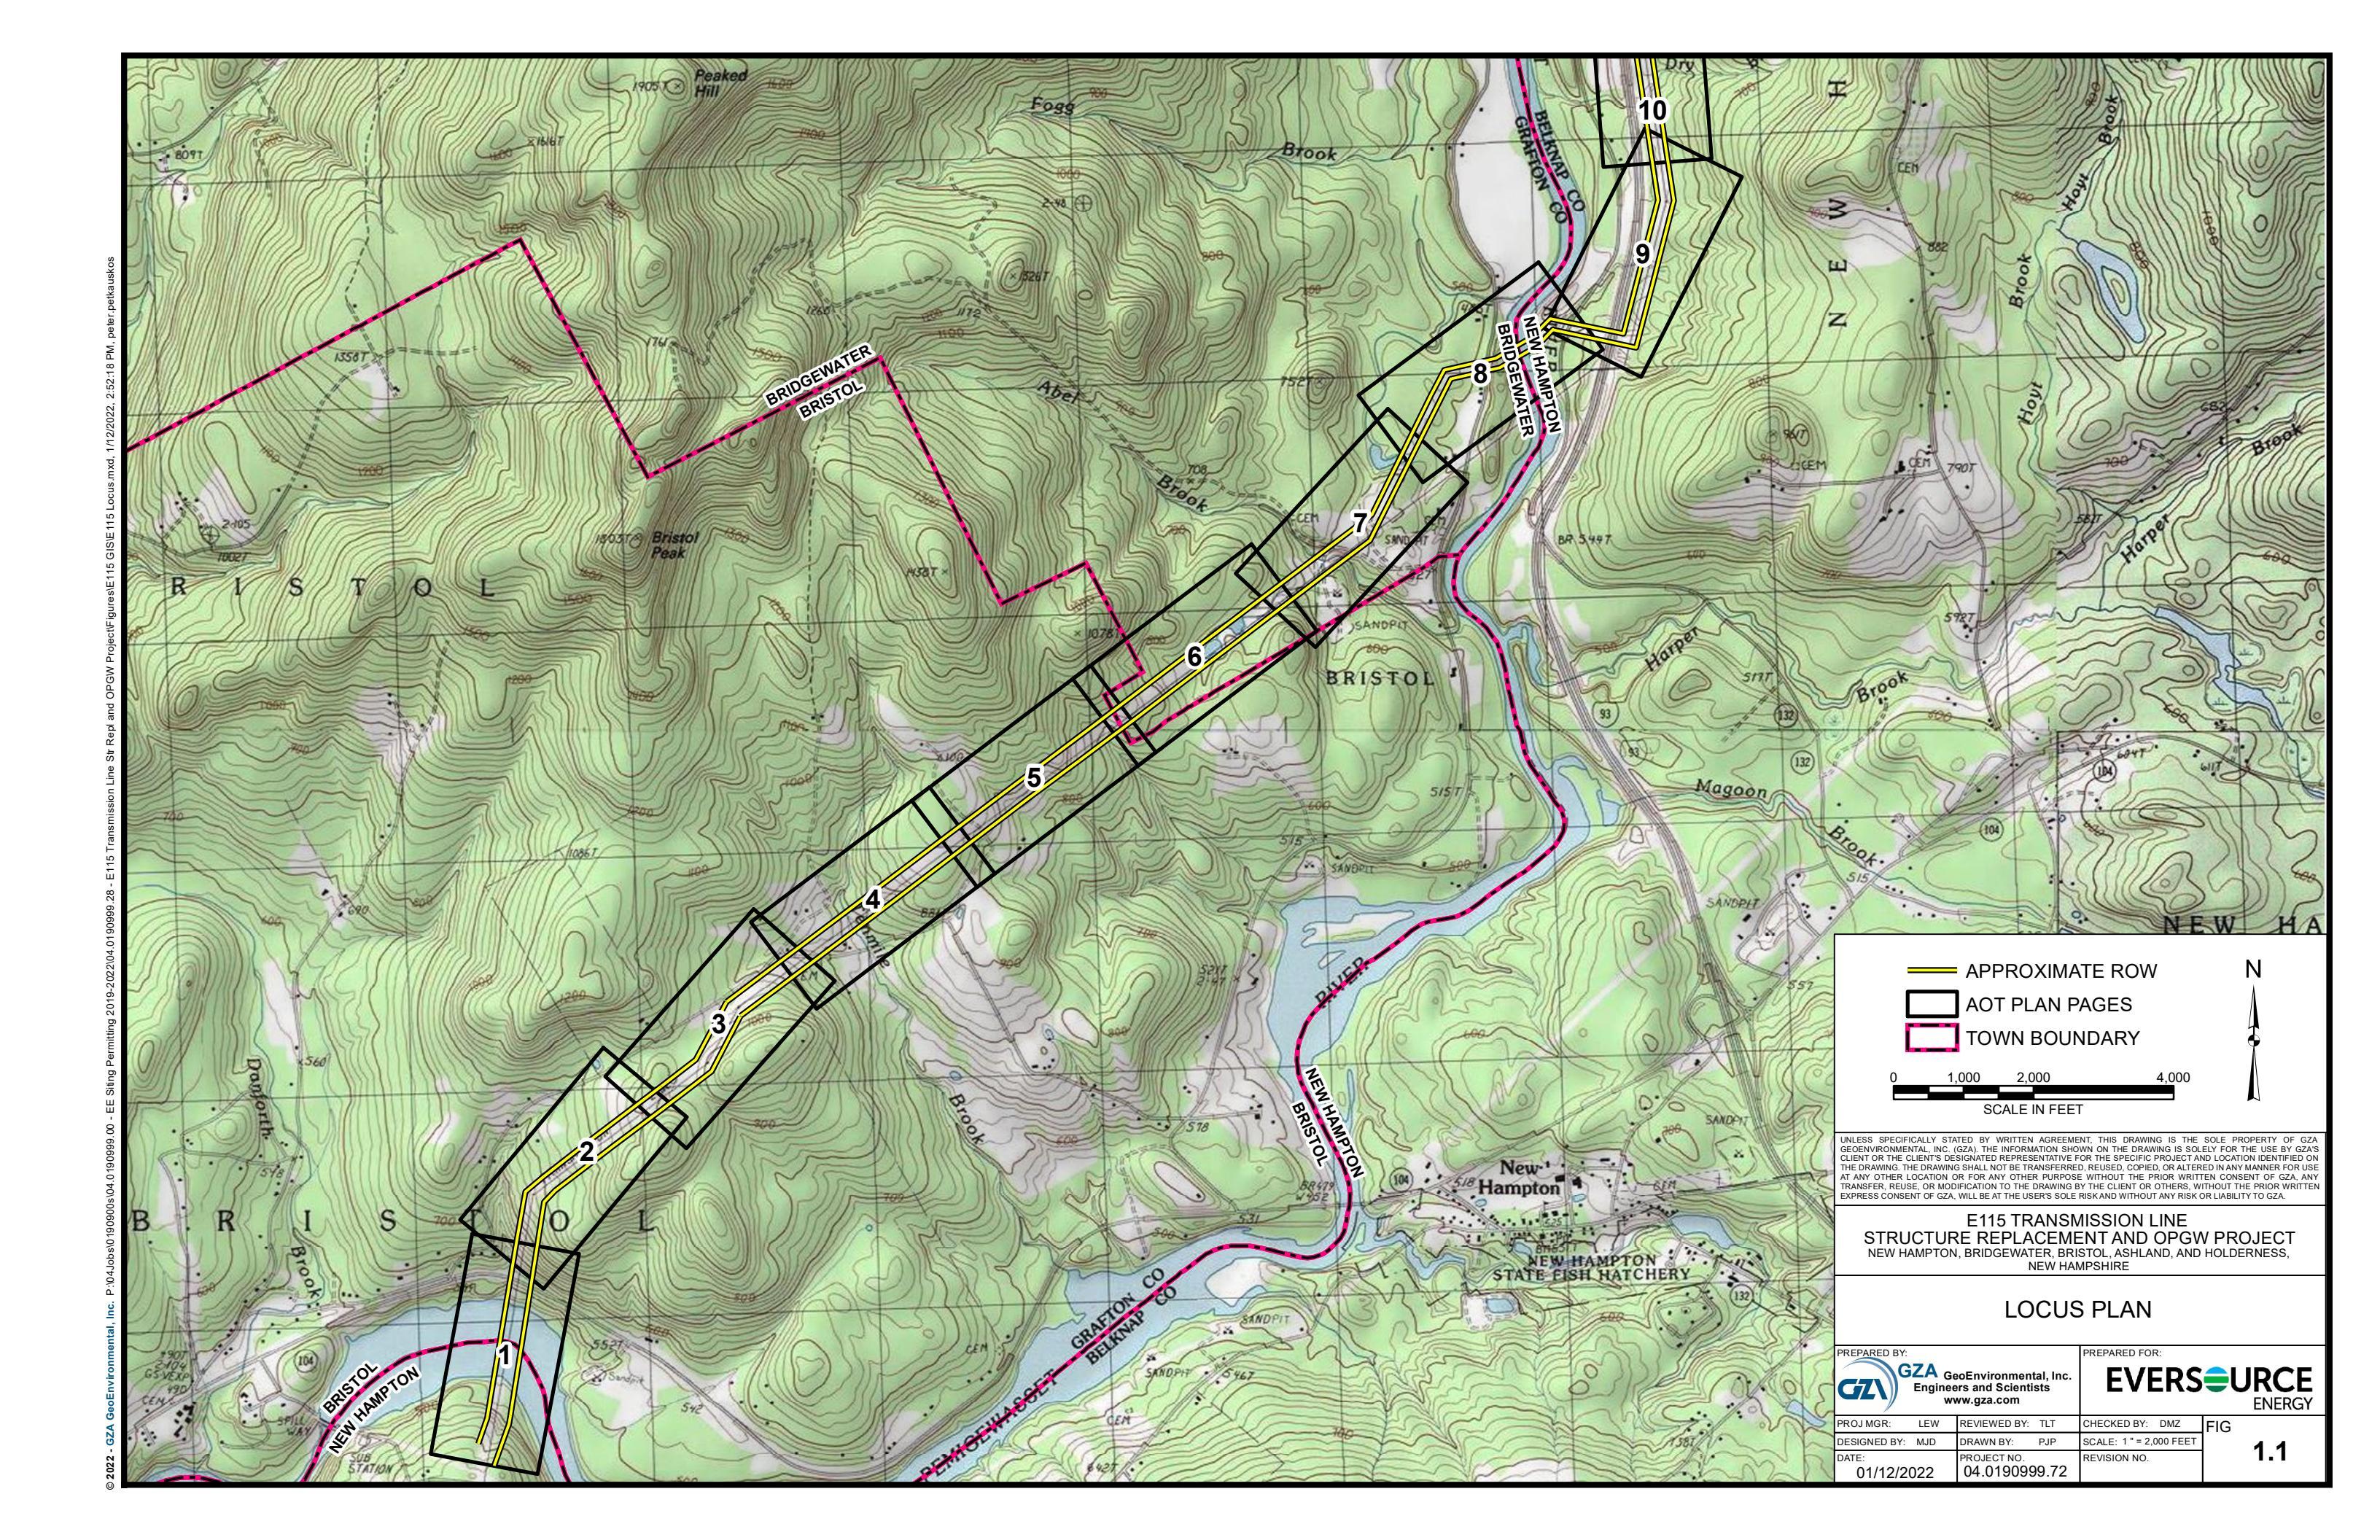
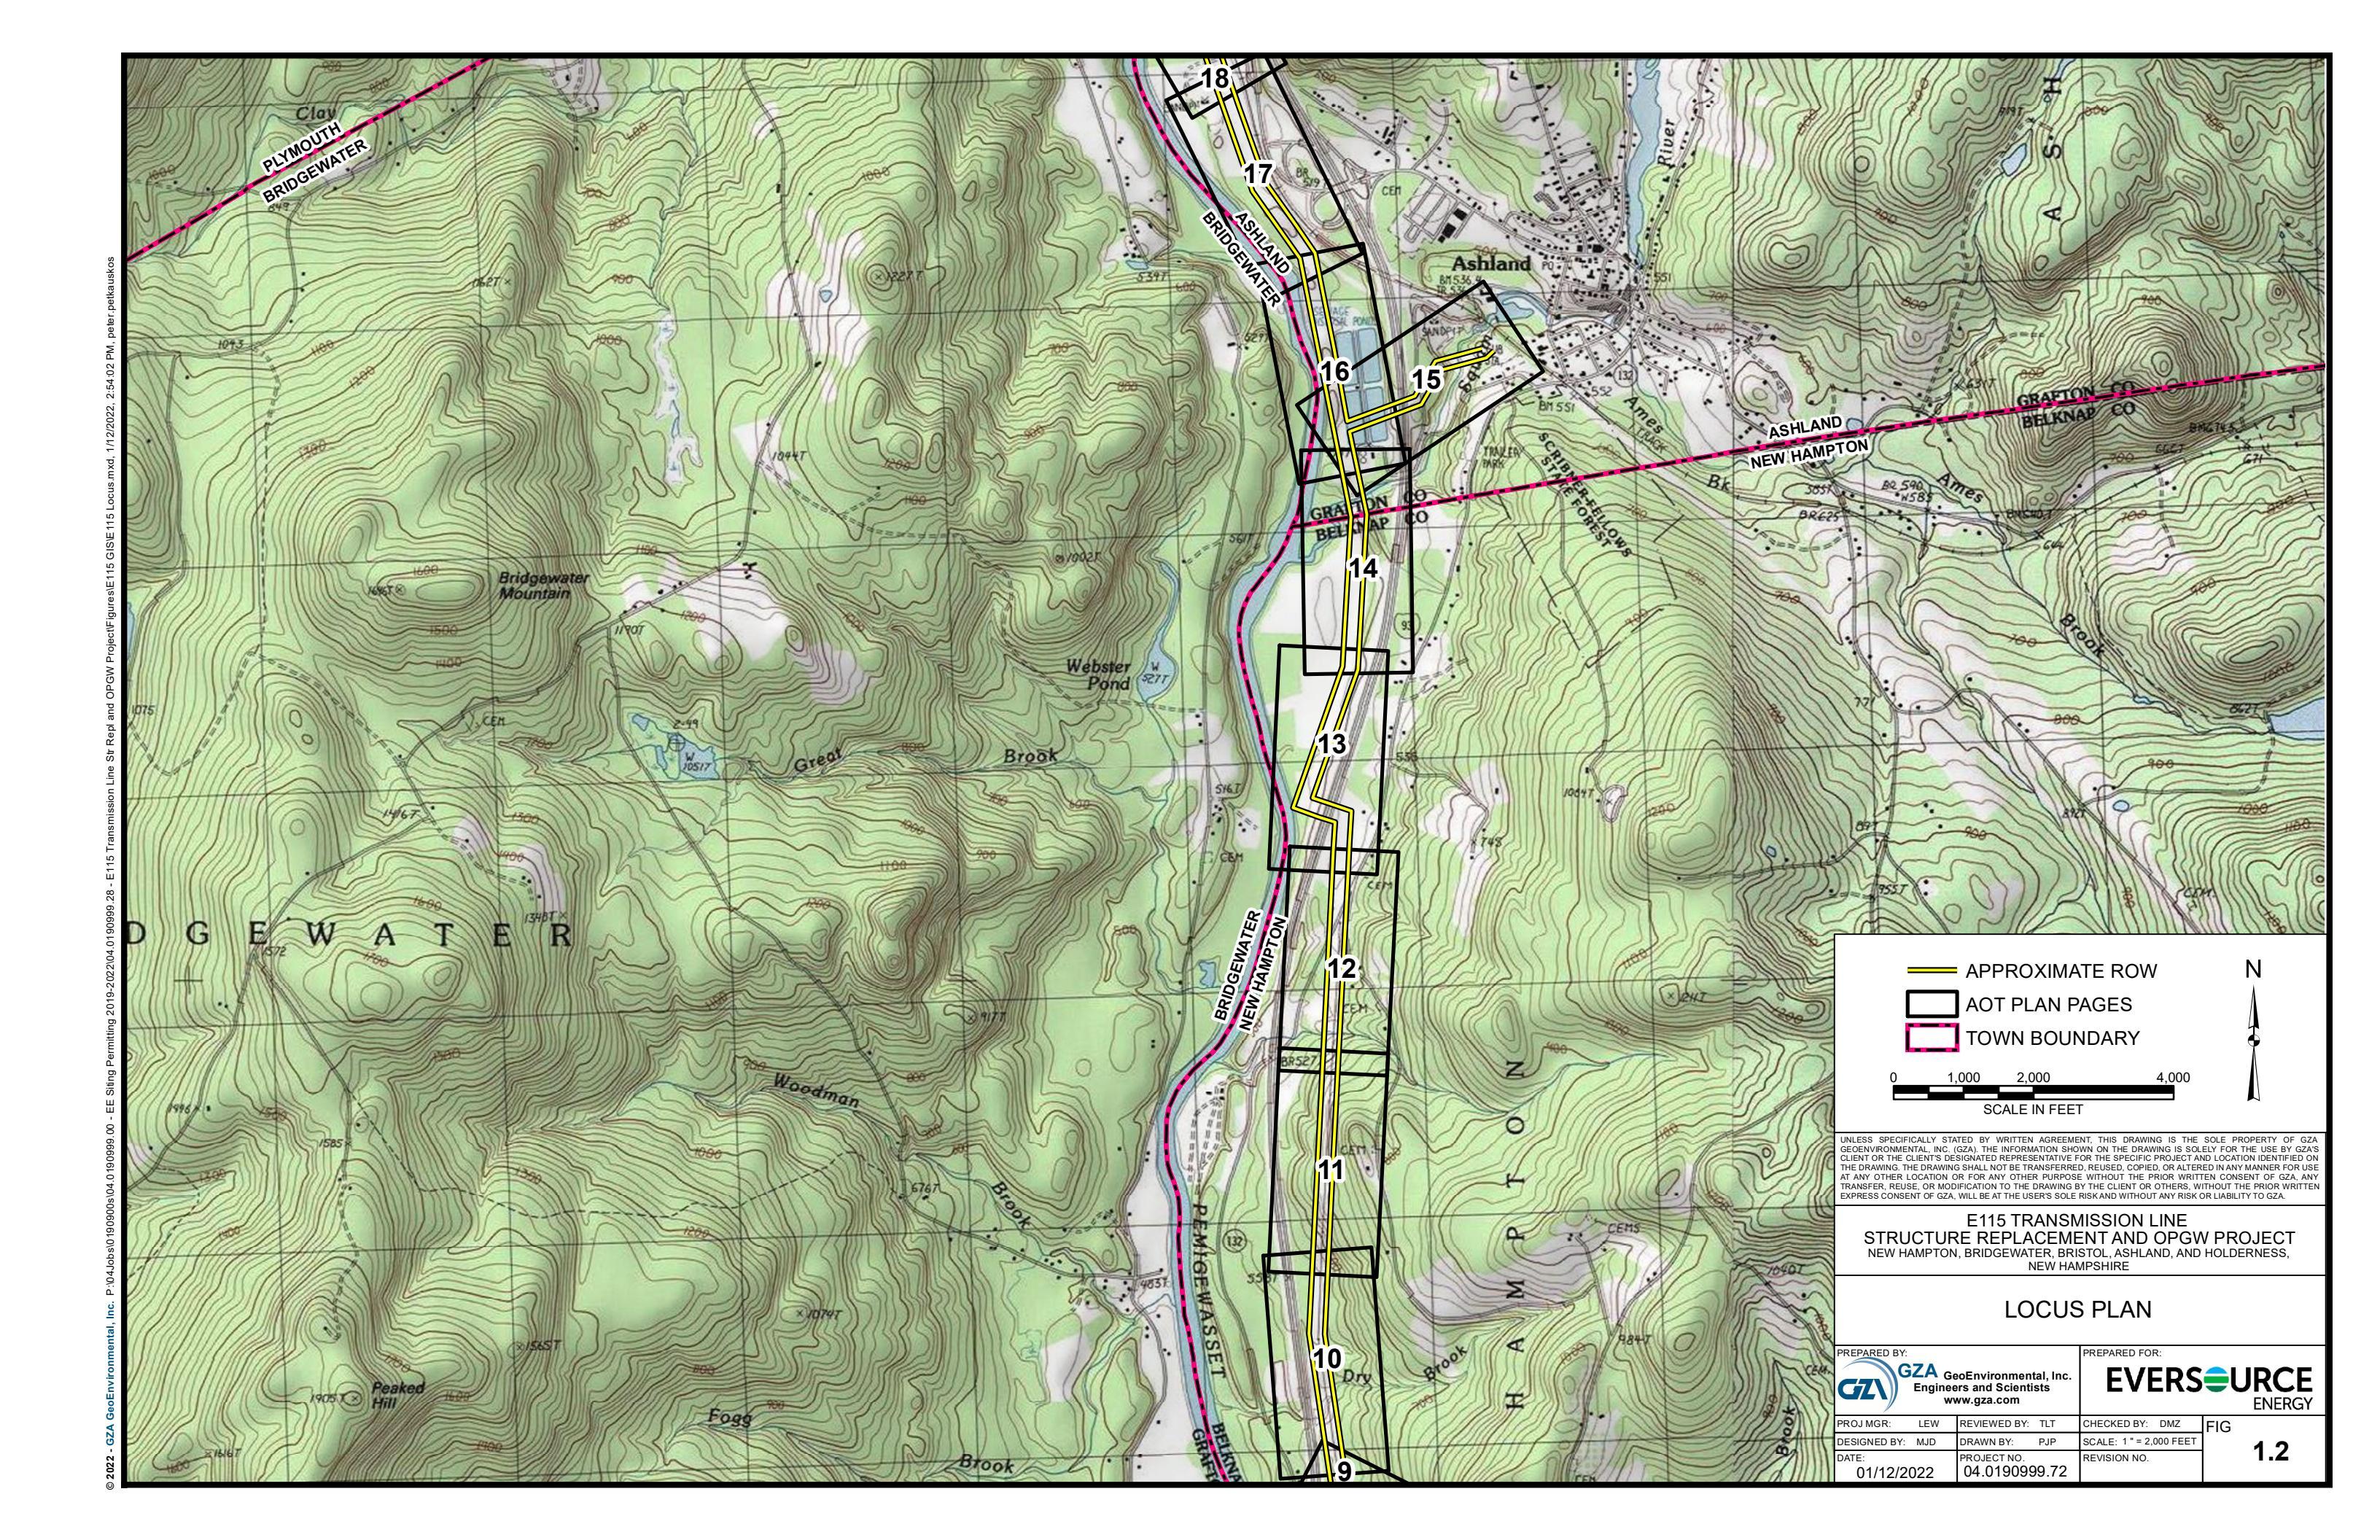
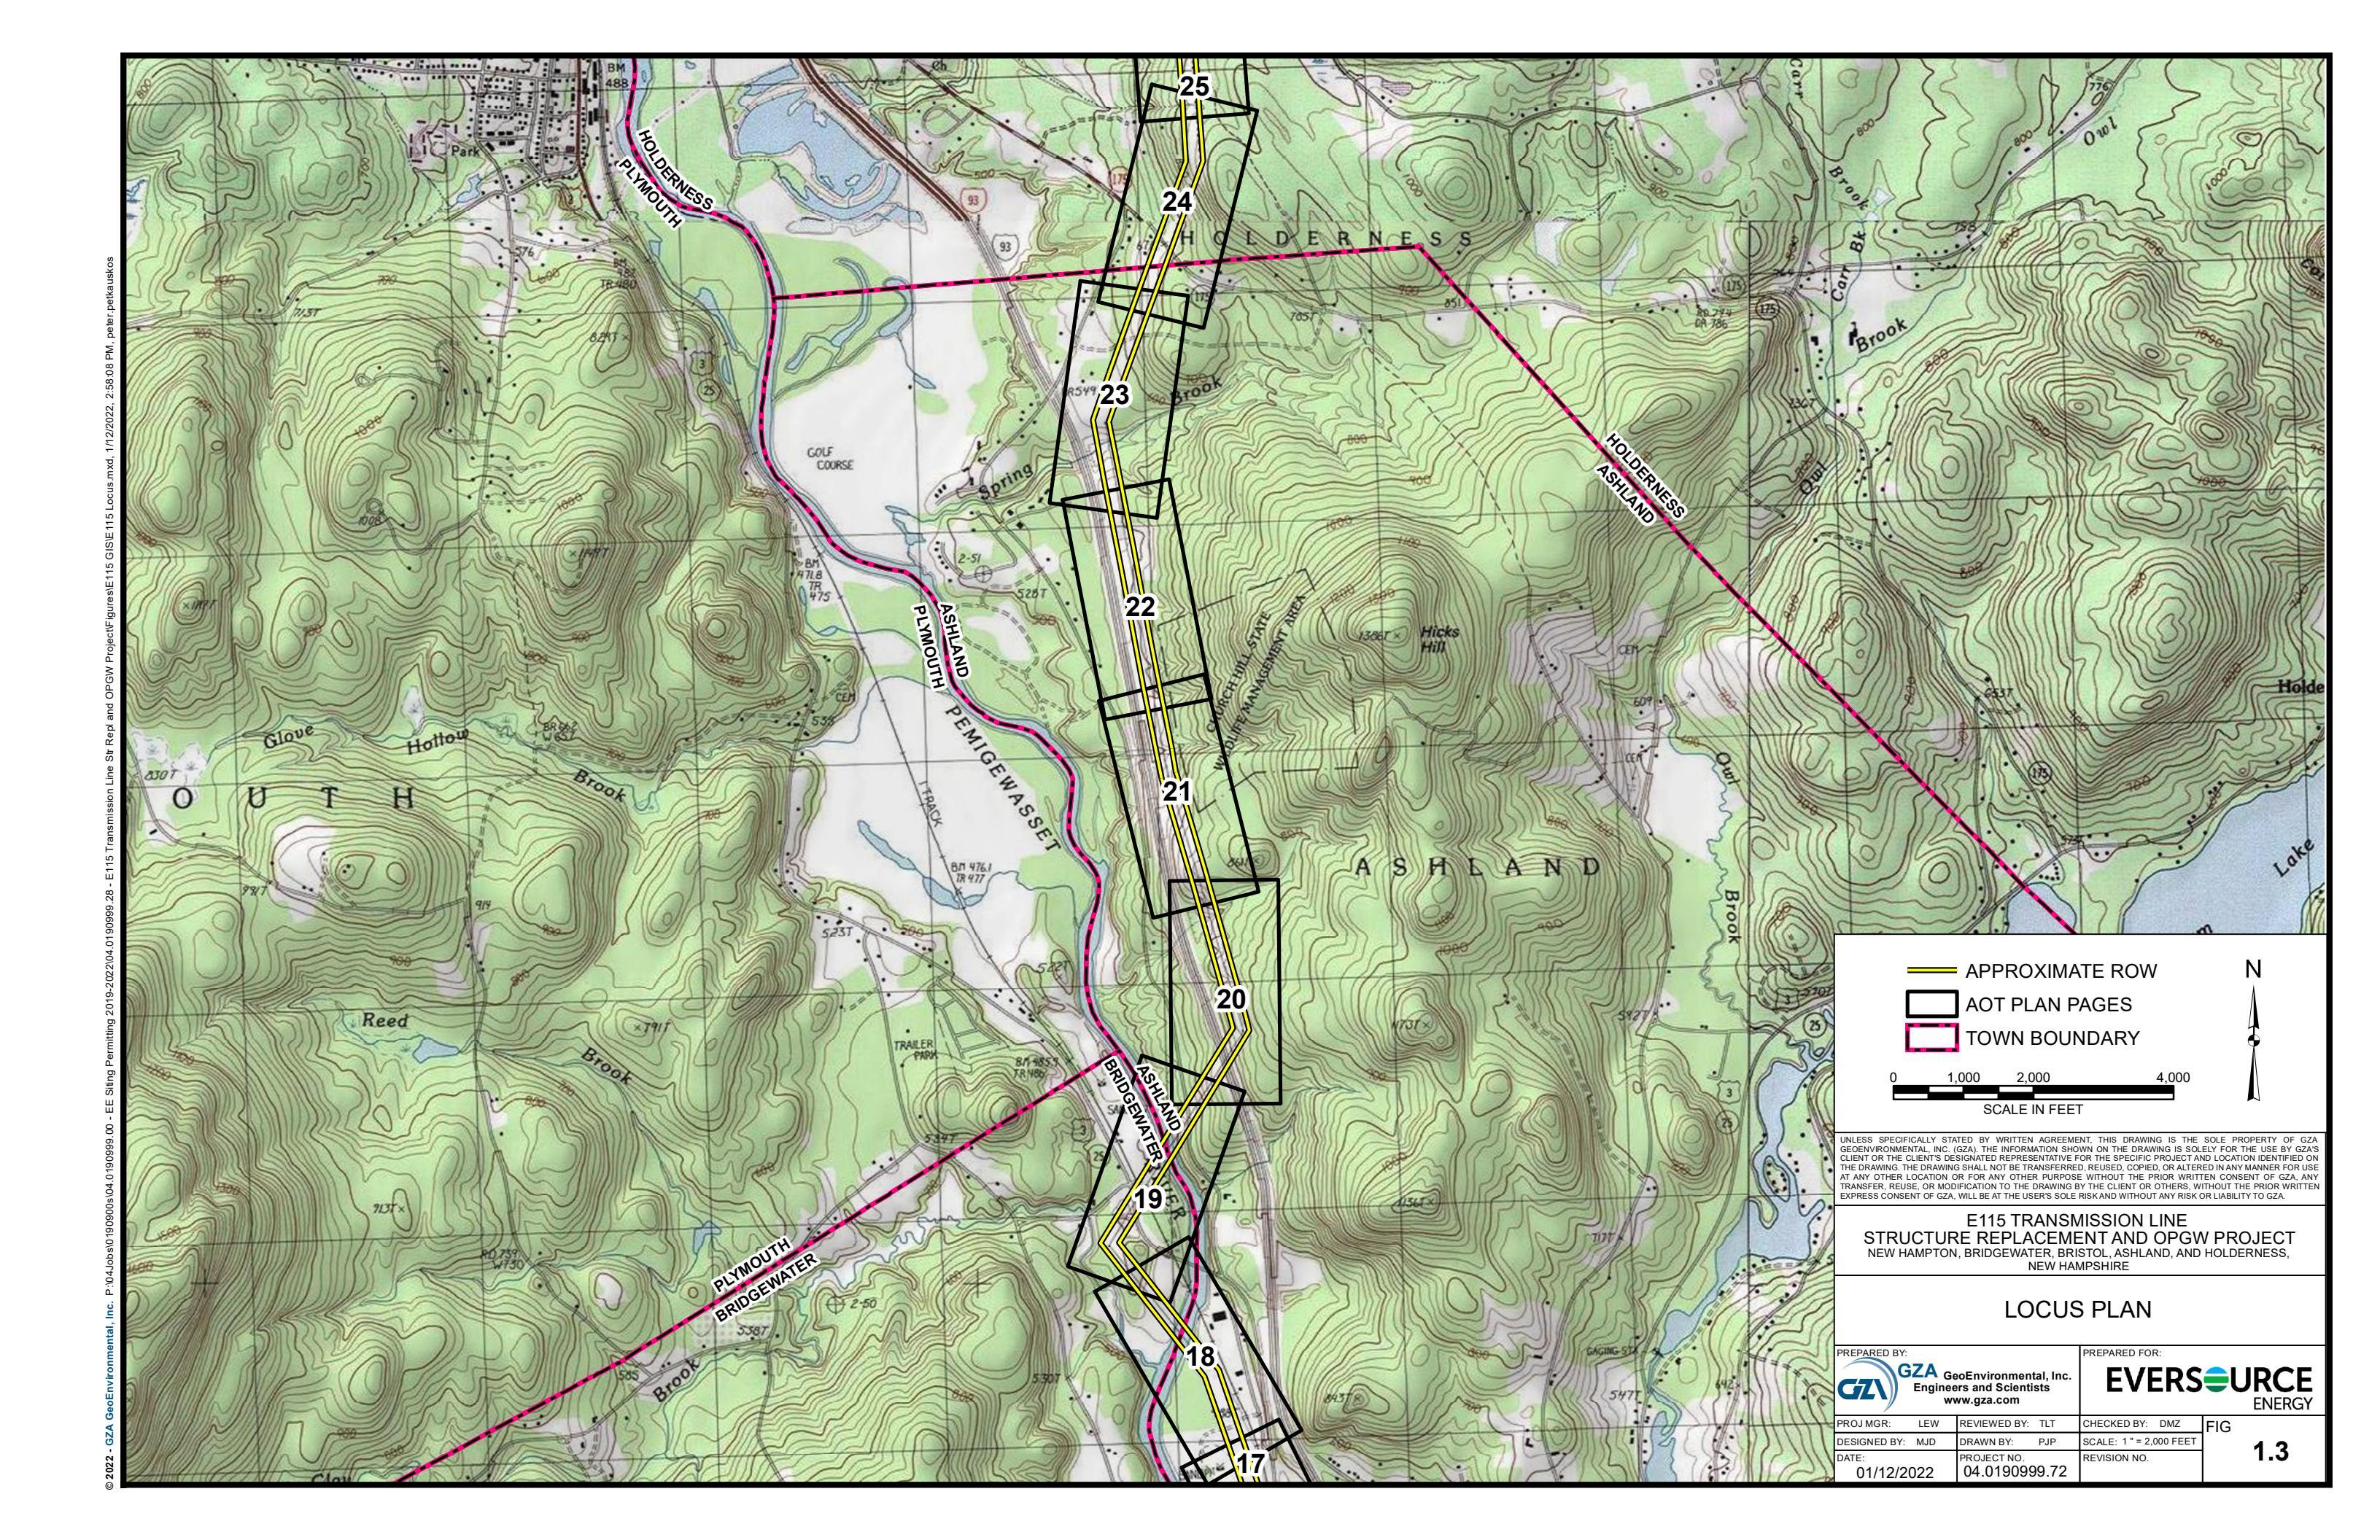
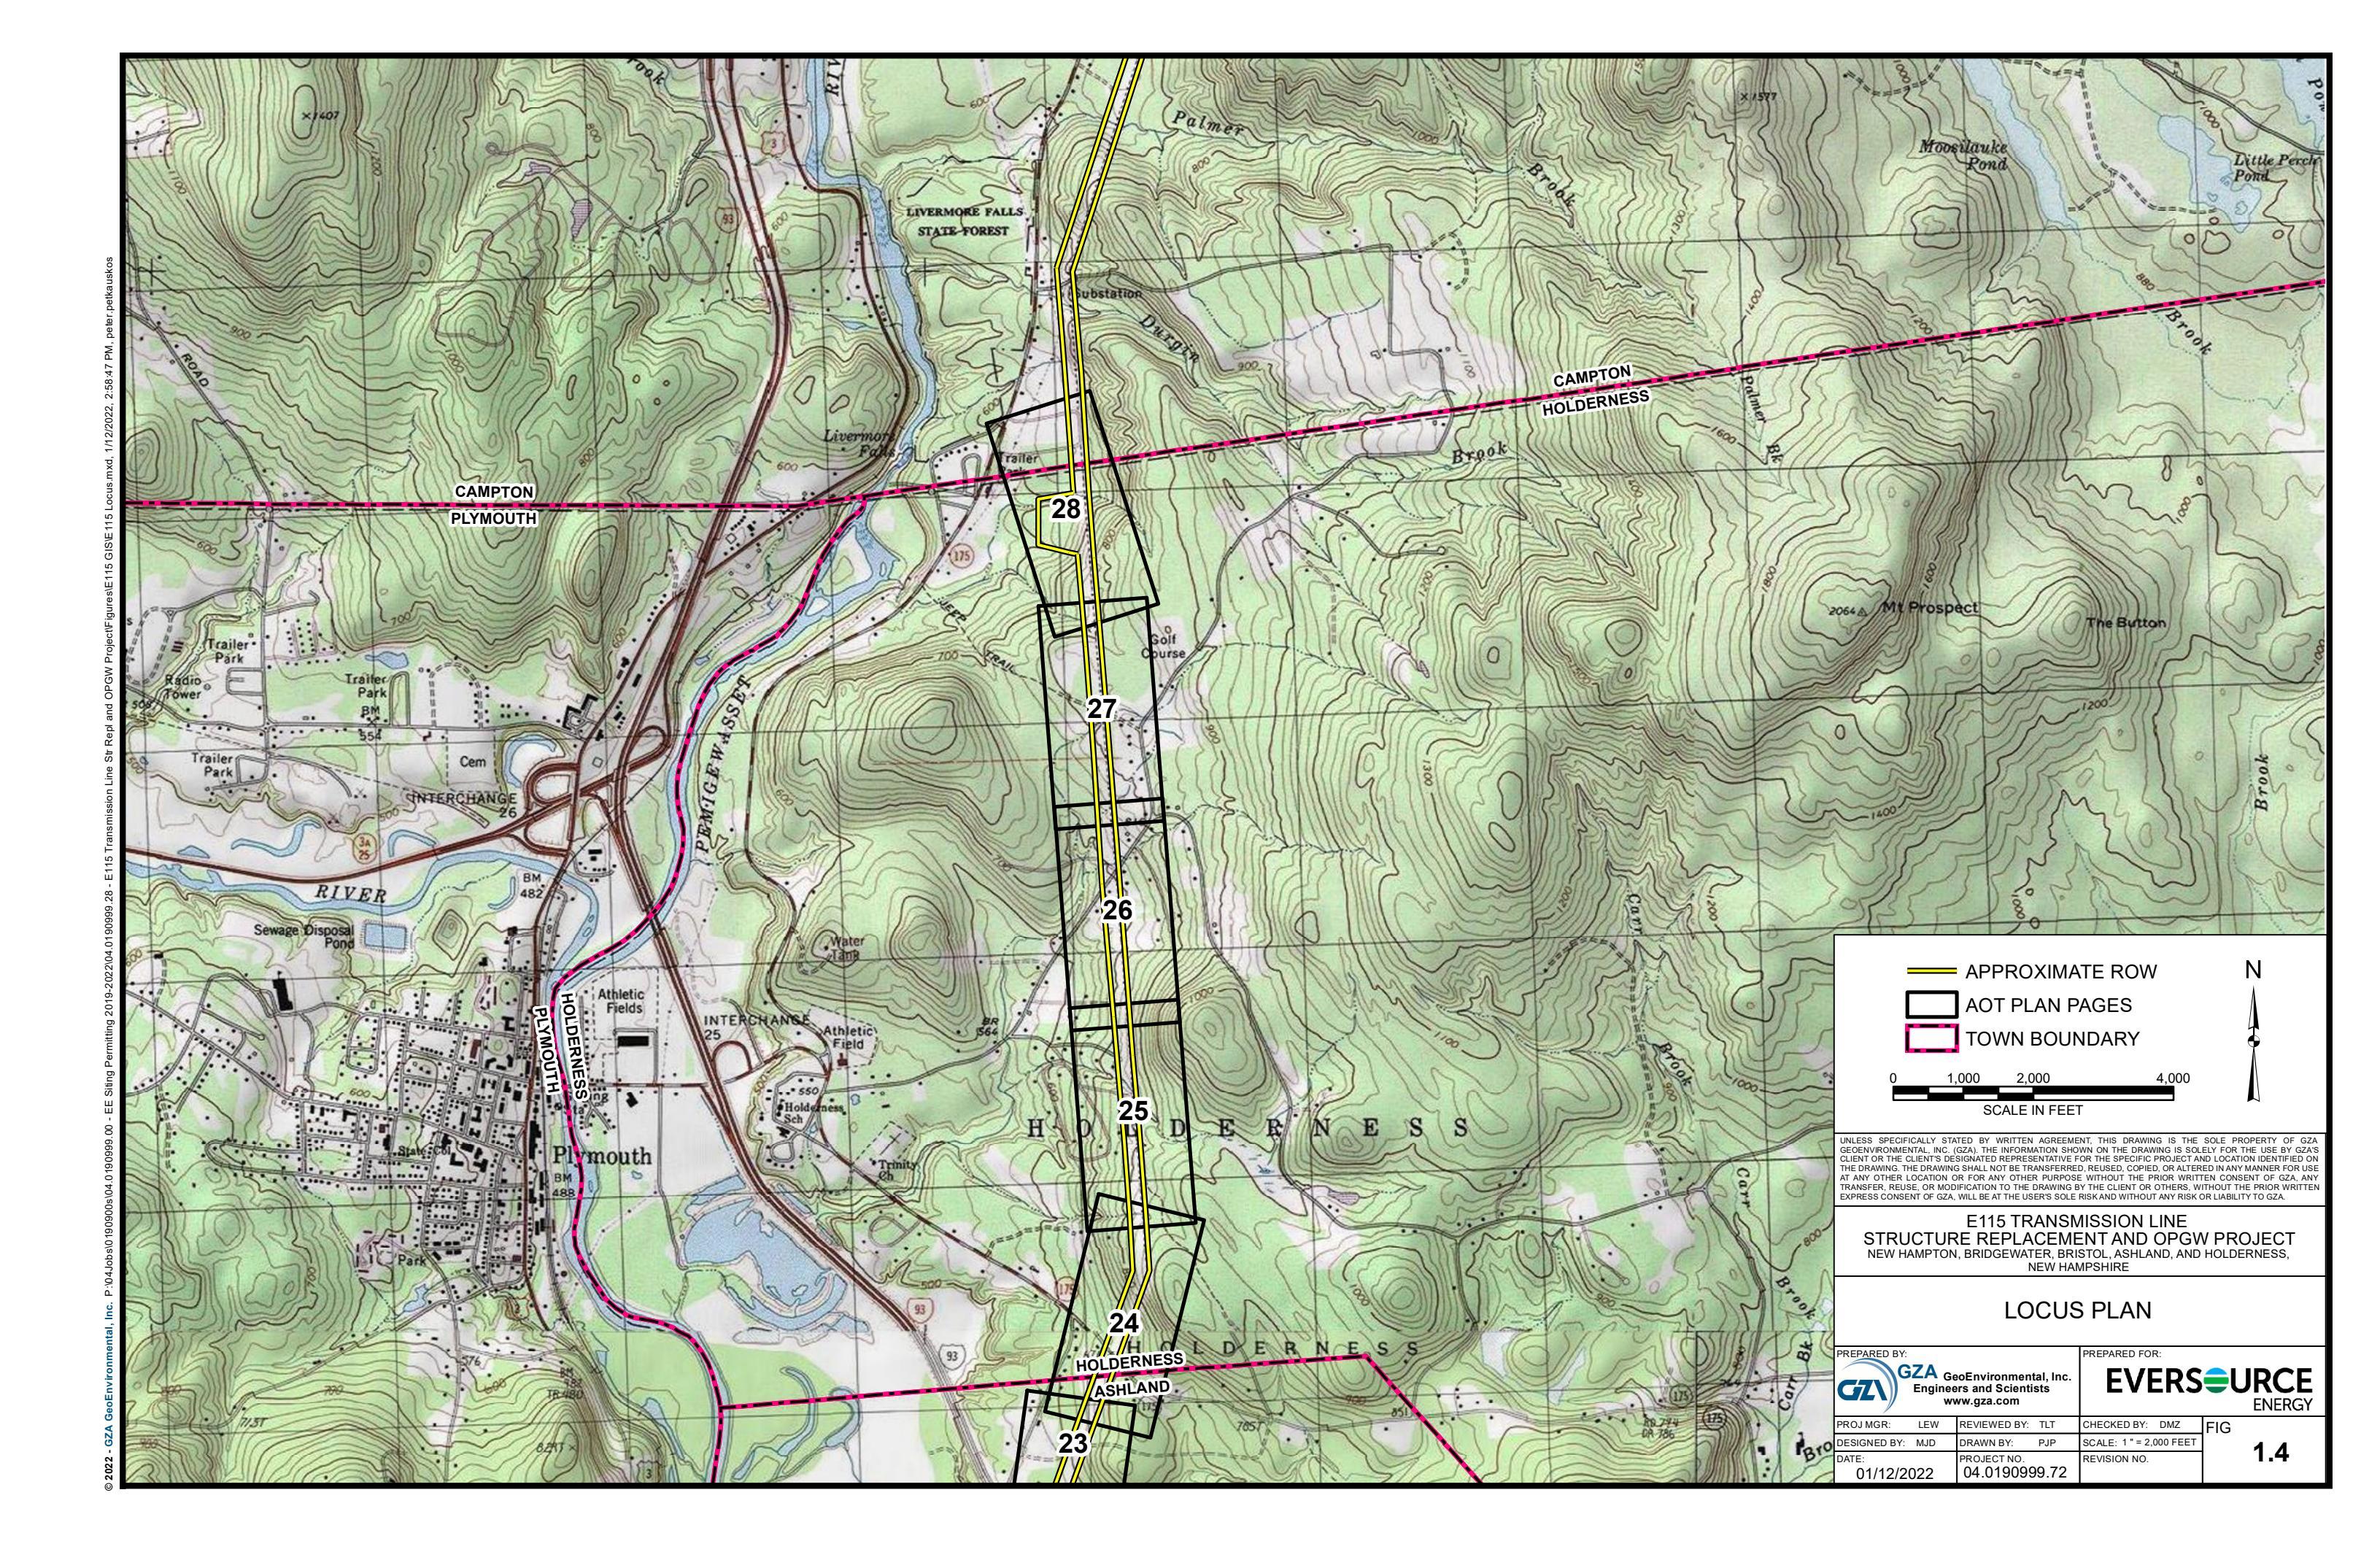
Figure 1 – USGS Topographic Map

The total project area is approximately 15 miles in length and includes the replacement of 183 utility structures in total. The project area primarily crosses privately owned rural/residential properties (see **Figure 1 – USGS Topographic Map**). There are approximately 126 wetlands along the project route located in the towns of New Hampton, Bristol, Bridgewater, Ashland and Holderness. The majority of ground disturbance resulting from the project will be related to access and work pad preparations.
