E115 Transmission Line Rebuild and Optical Ground Wire Replacement Project Eversource Energy

New Hampton, Bridgewater, Bristol, Ashland, and Holderness New Hampshire

NHDES Alteration of Terrain Permit Application

March 1, 2022 GZA File No. 04.0190999.72

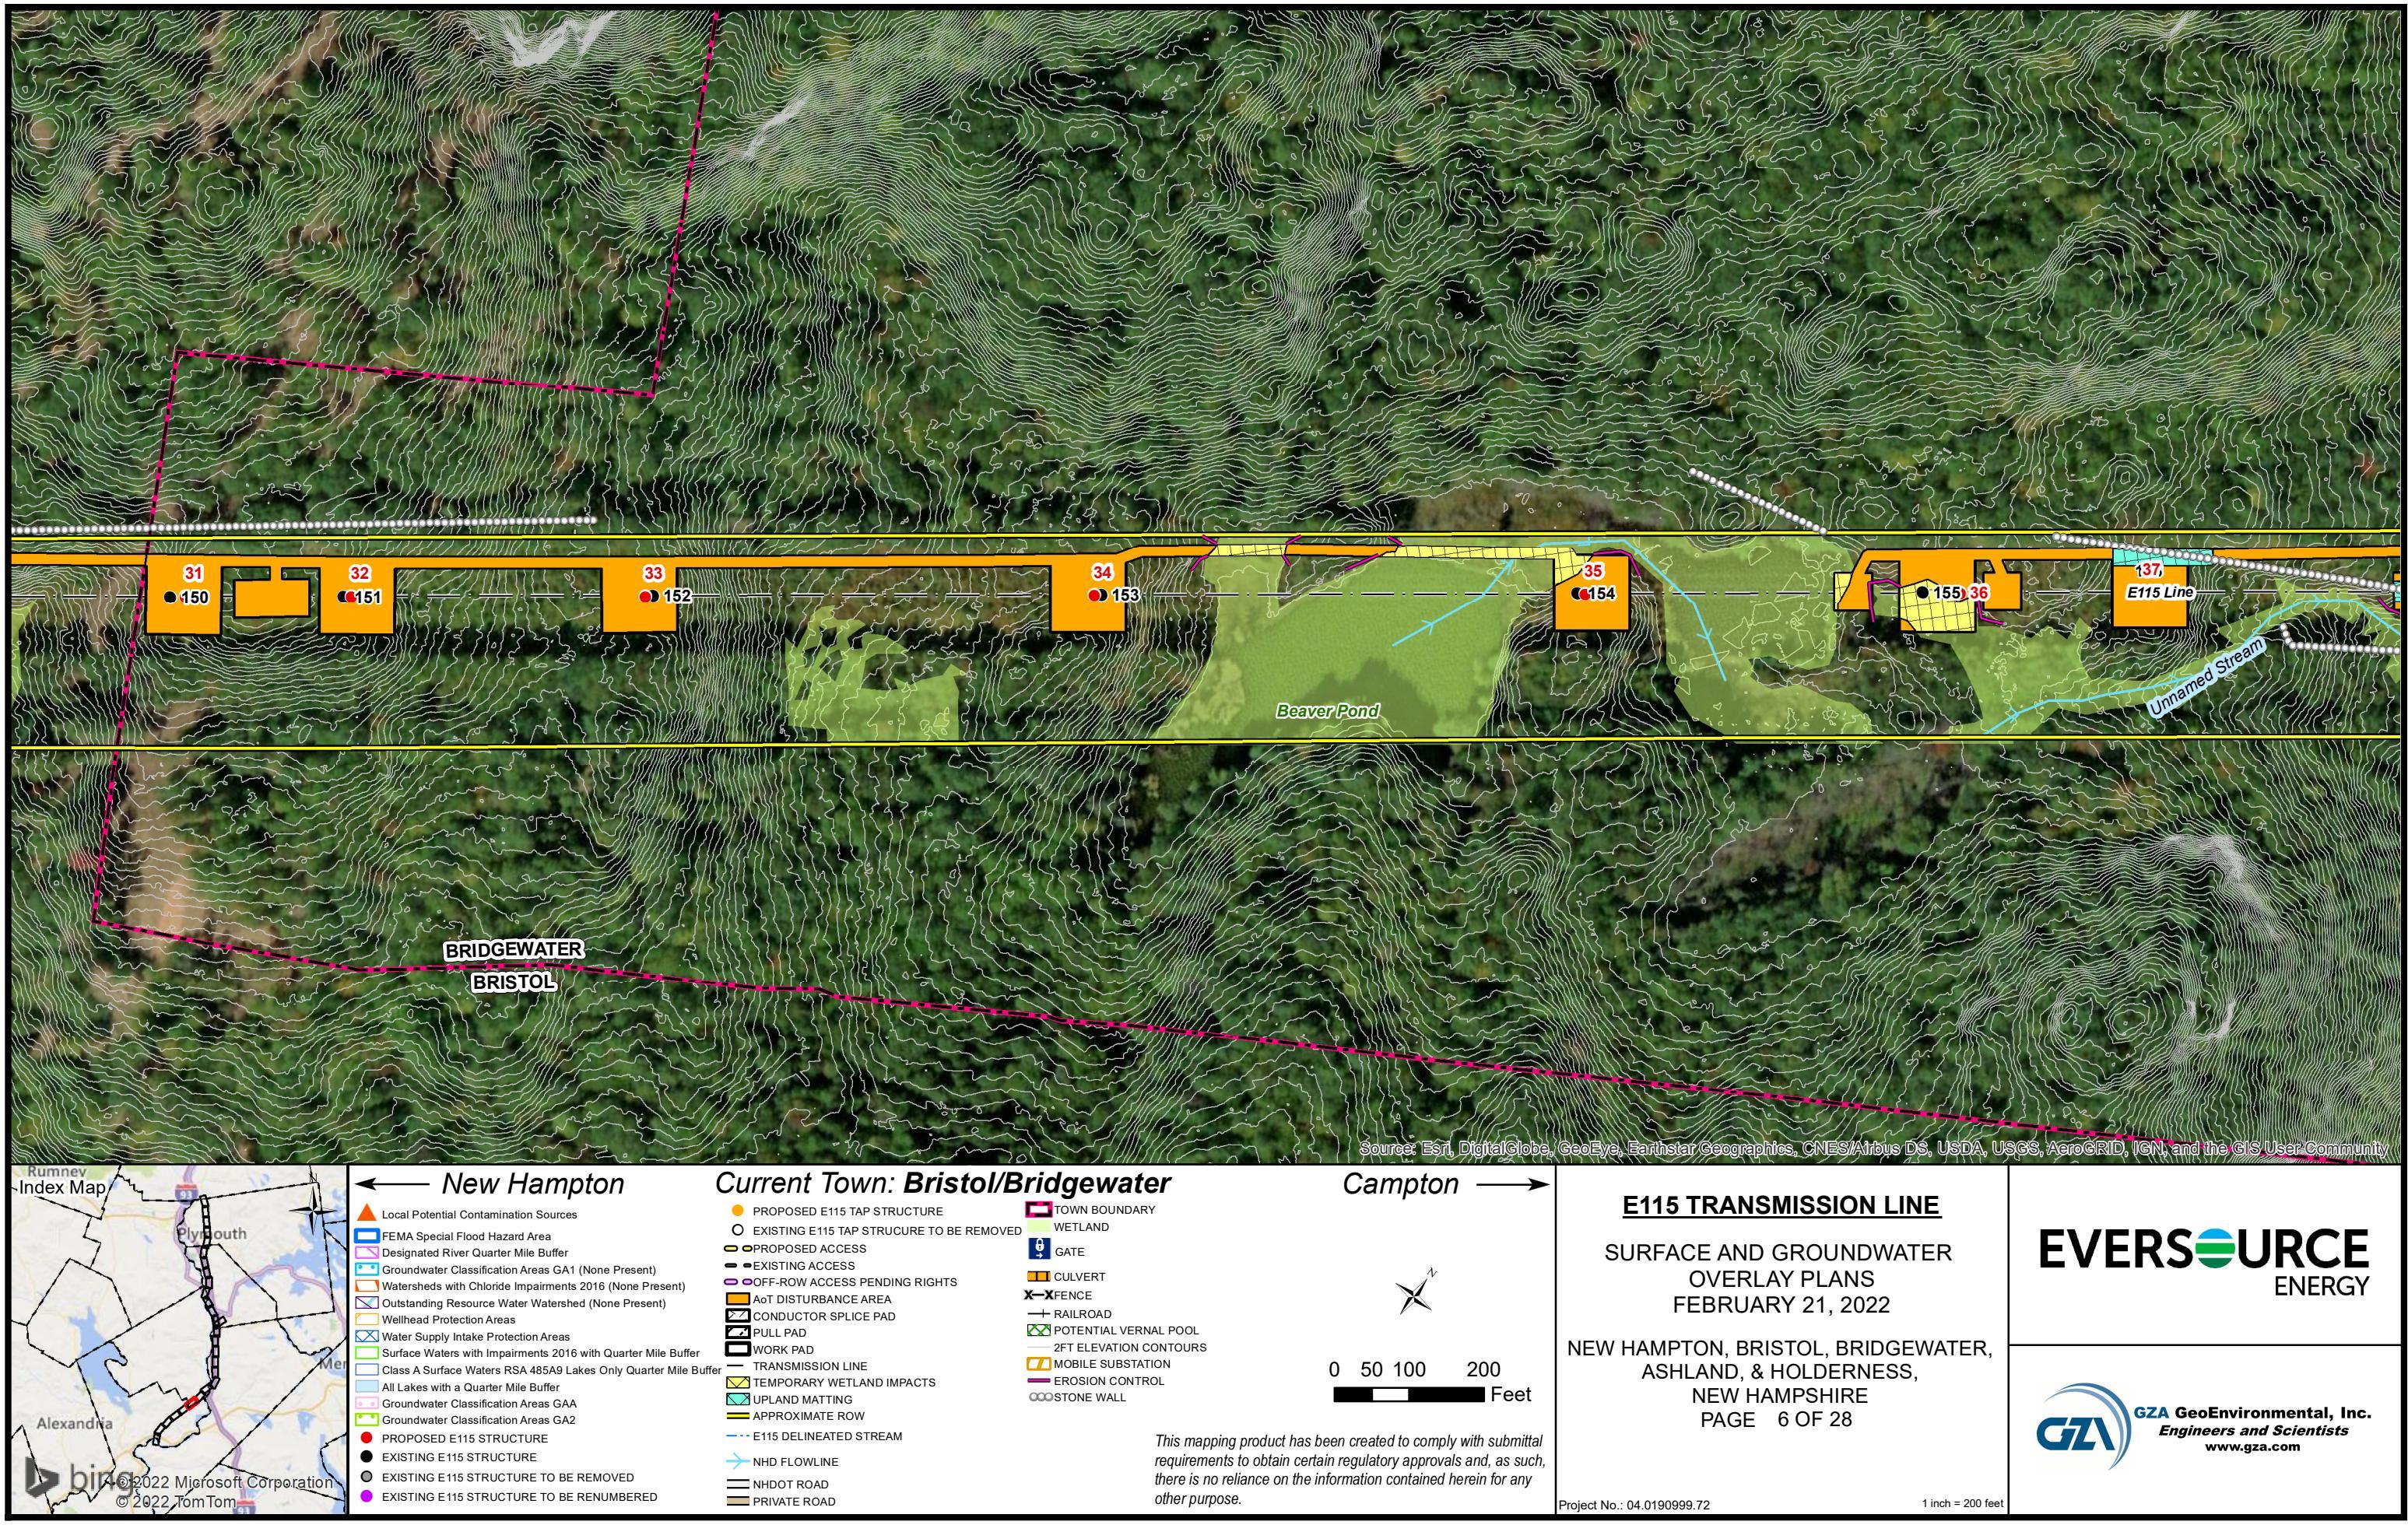
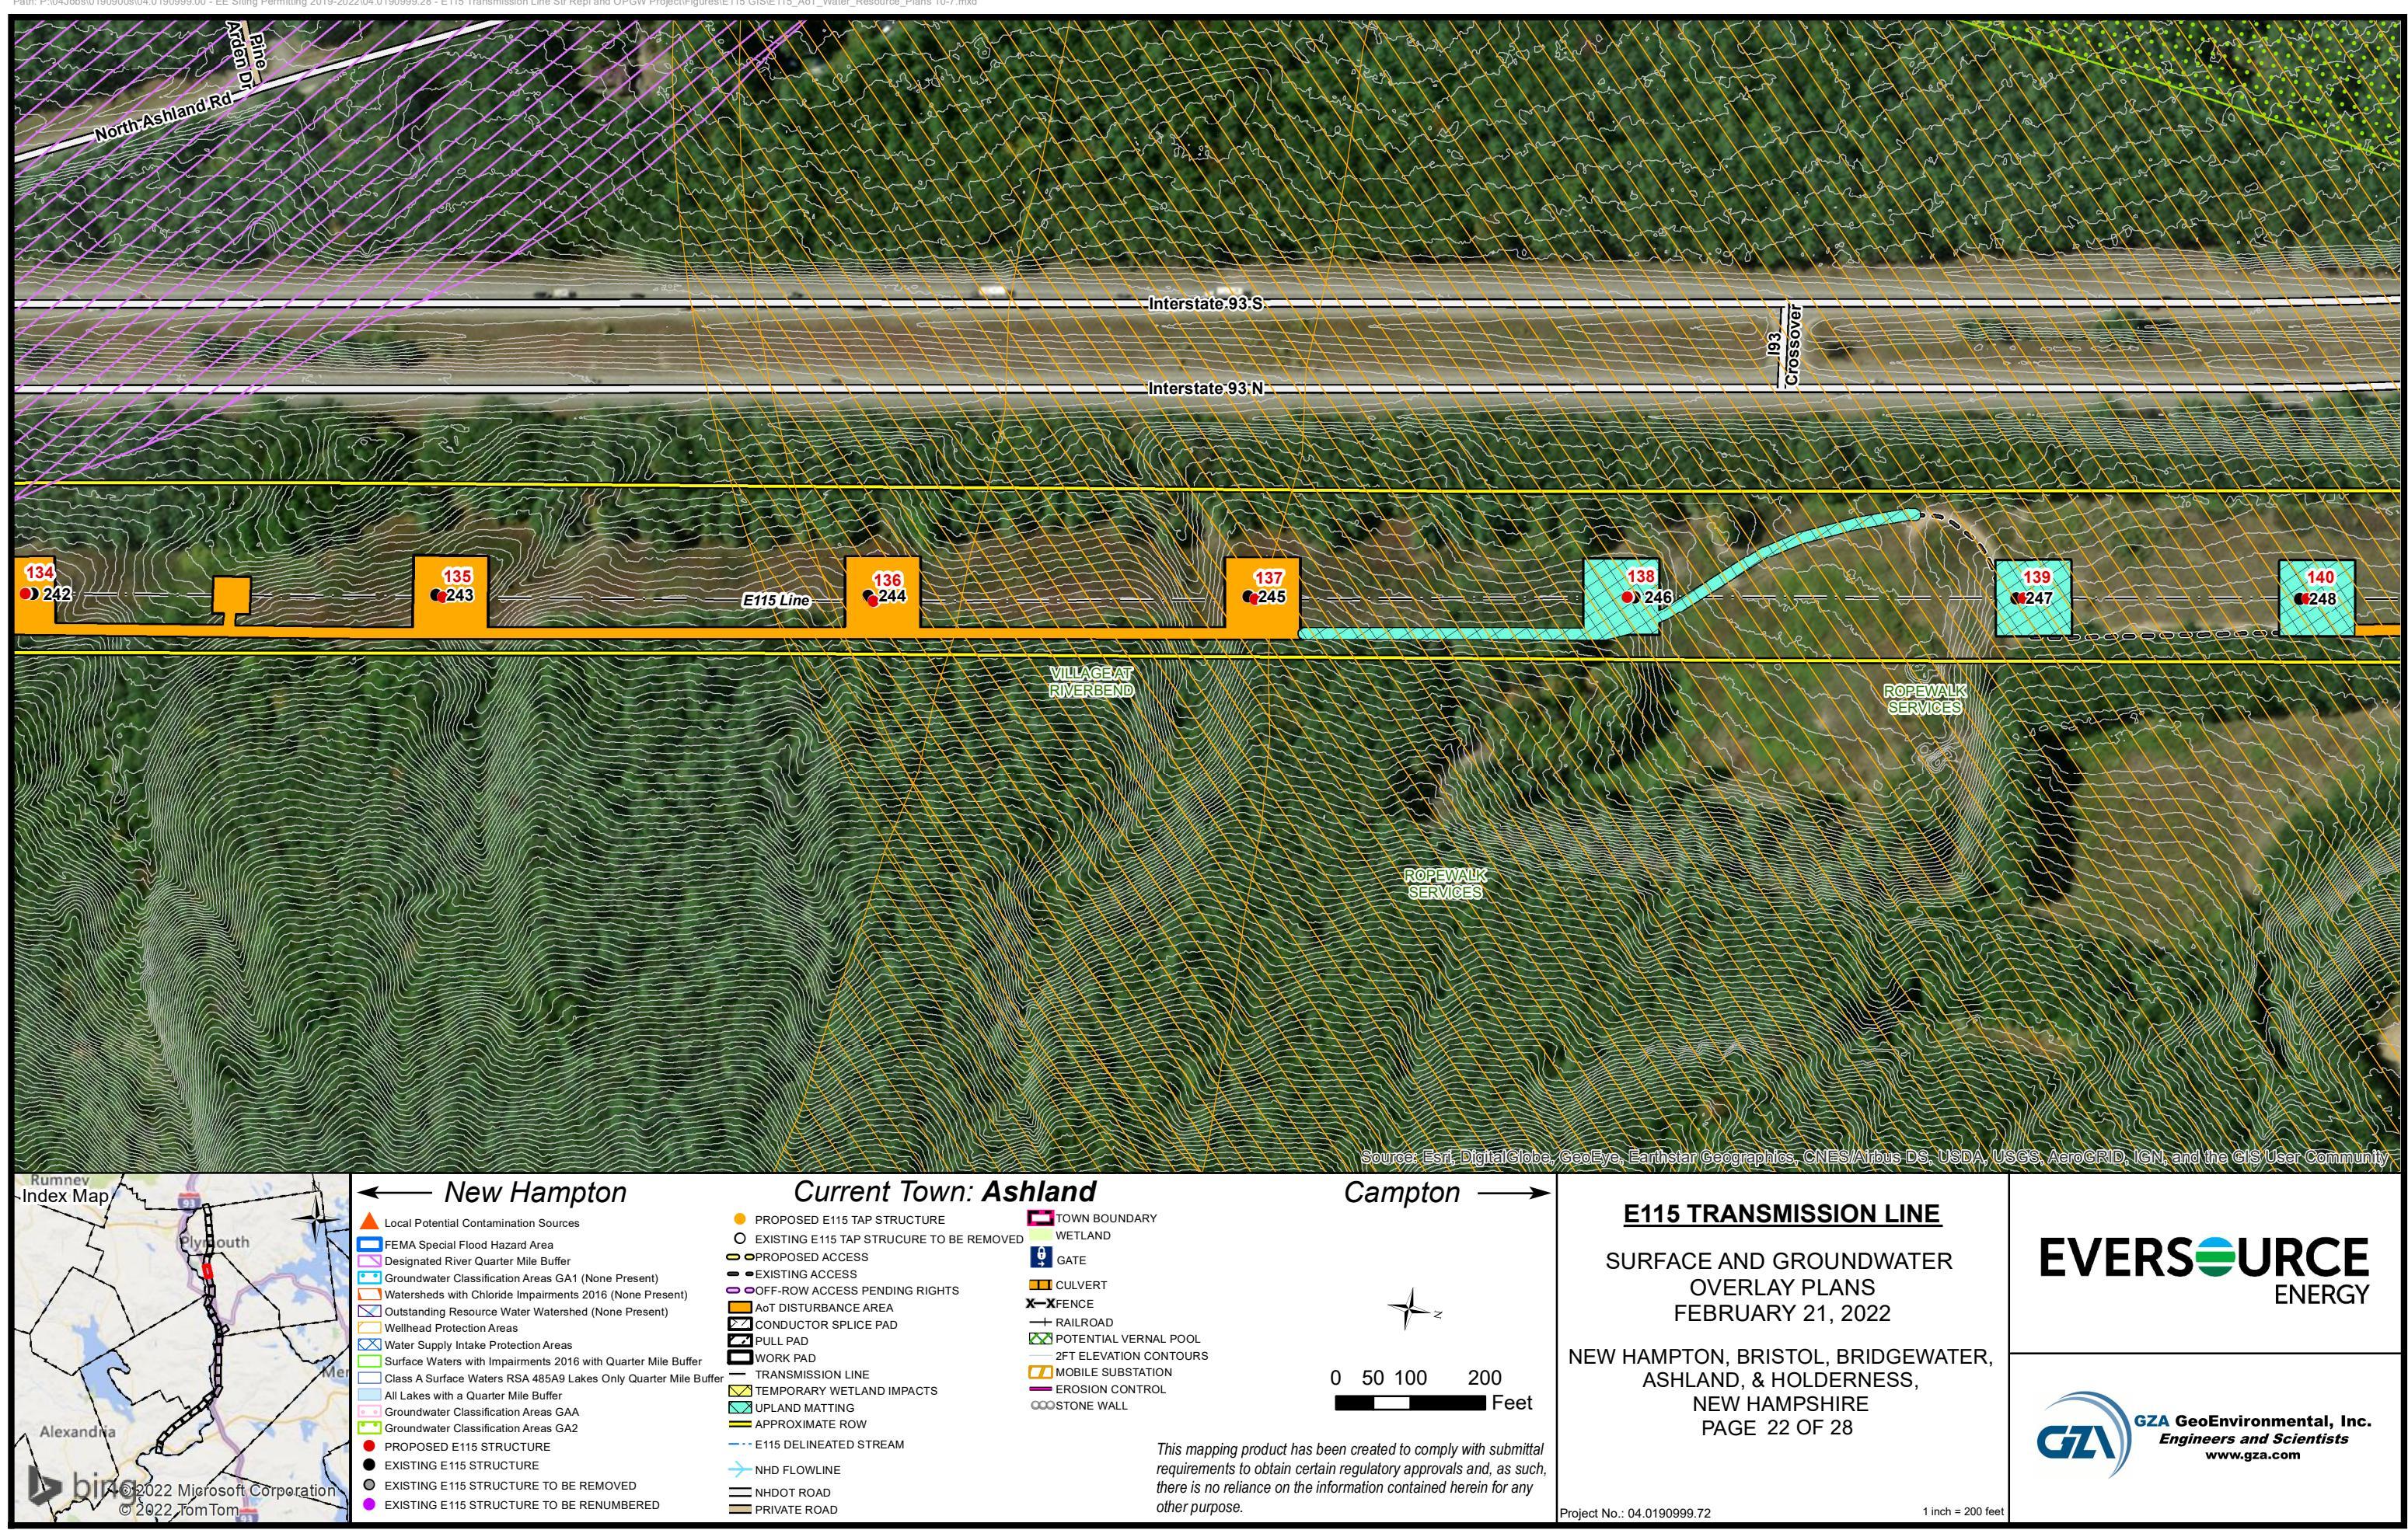
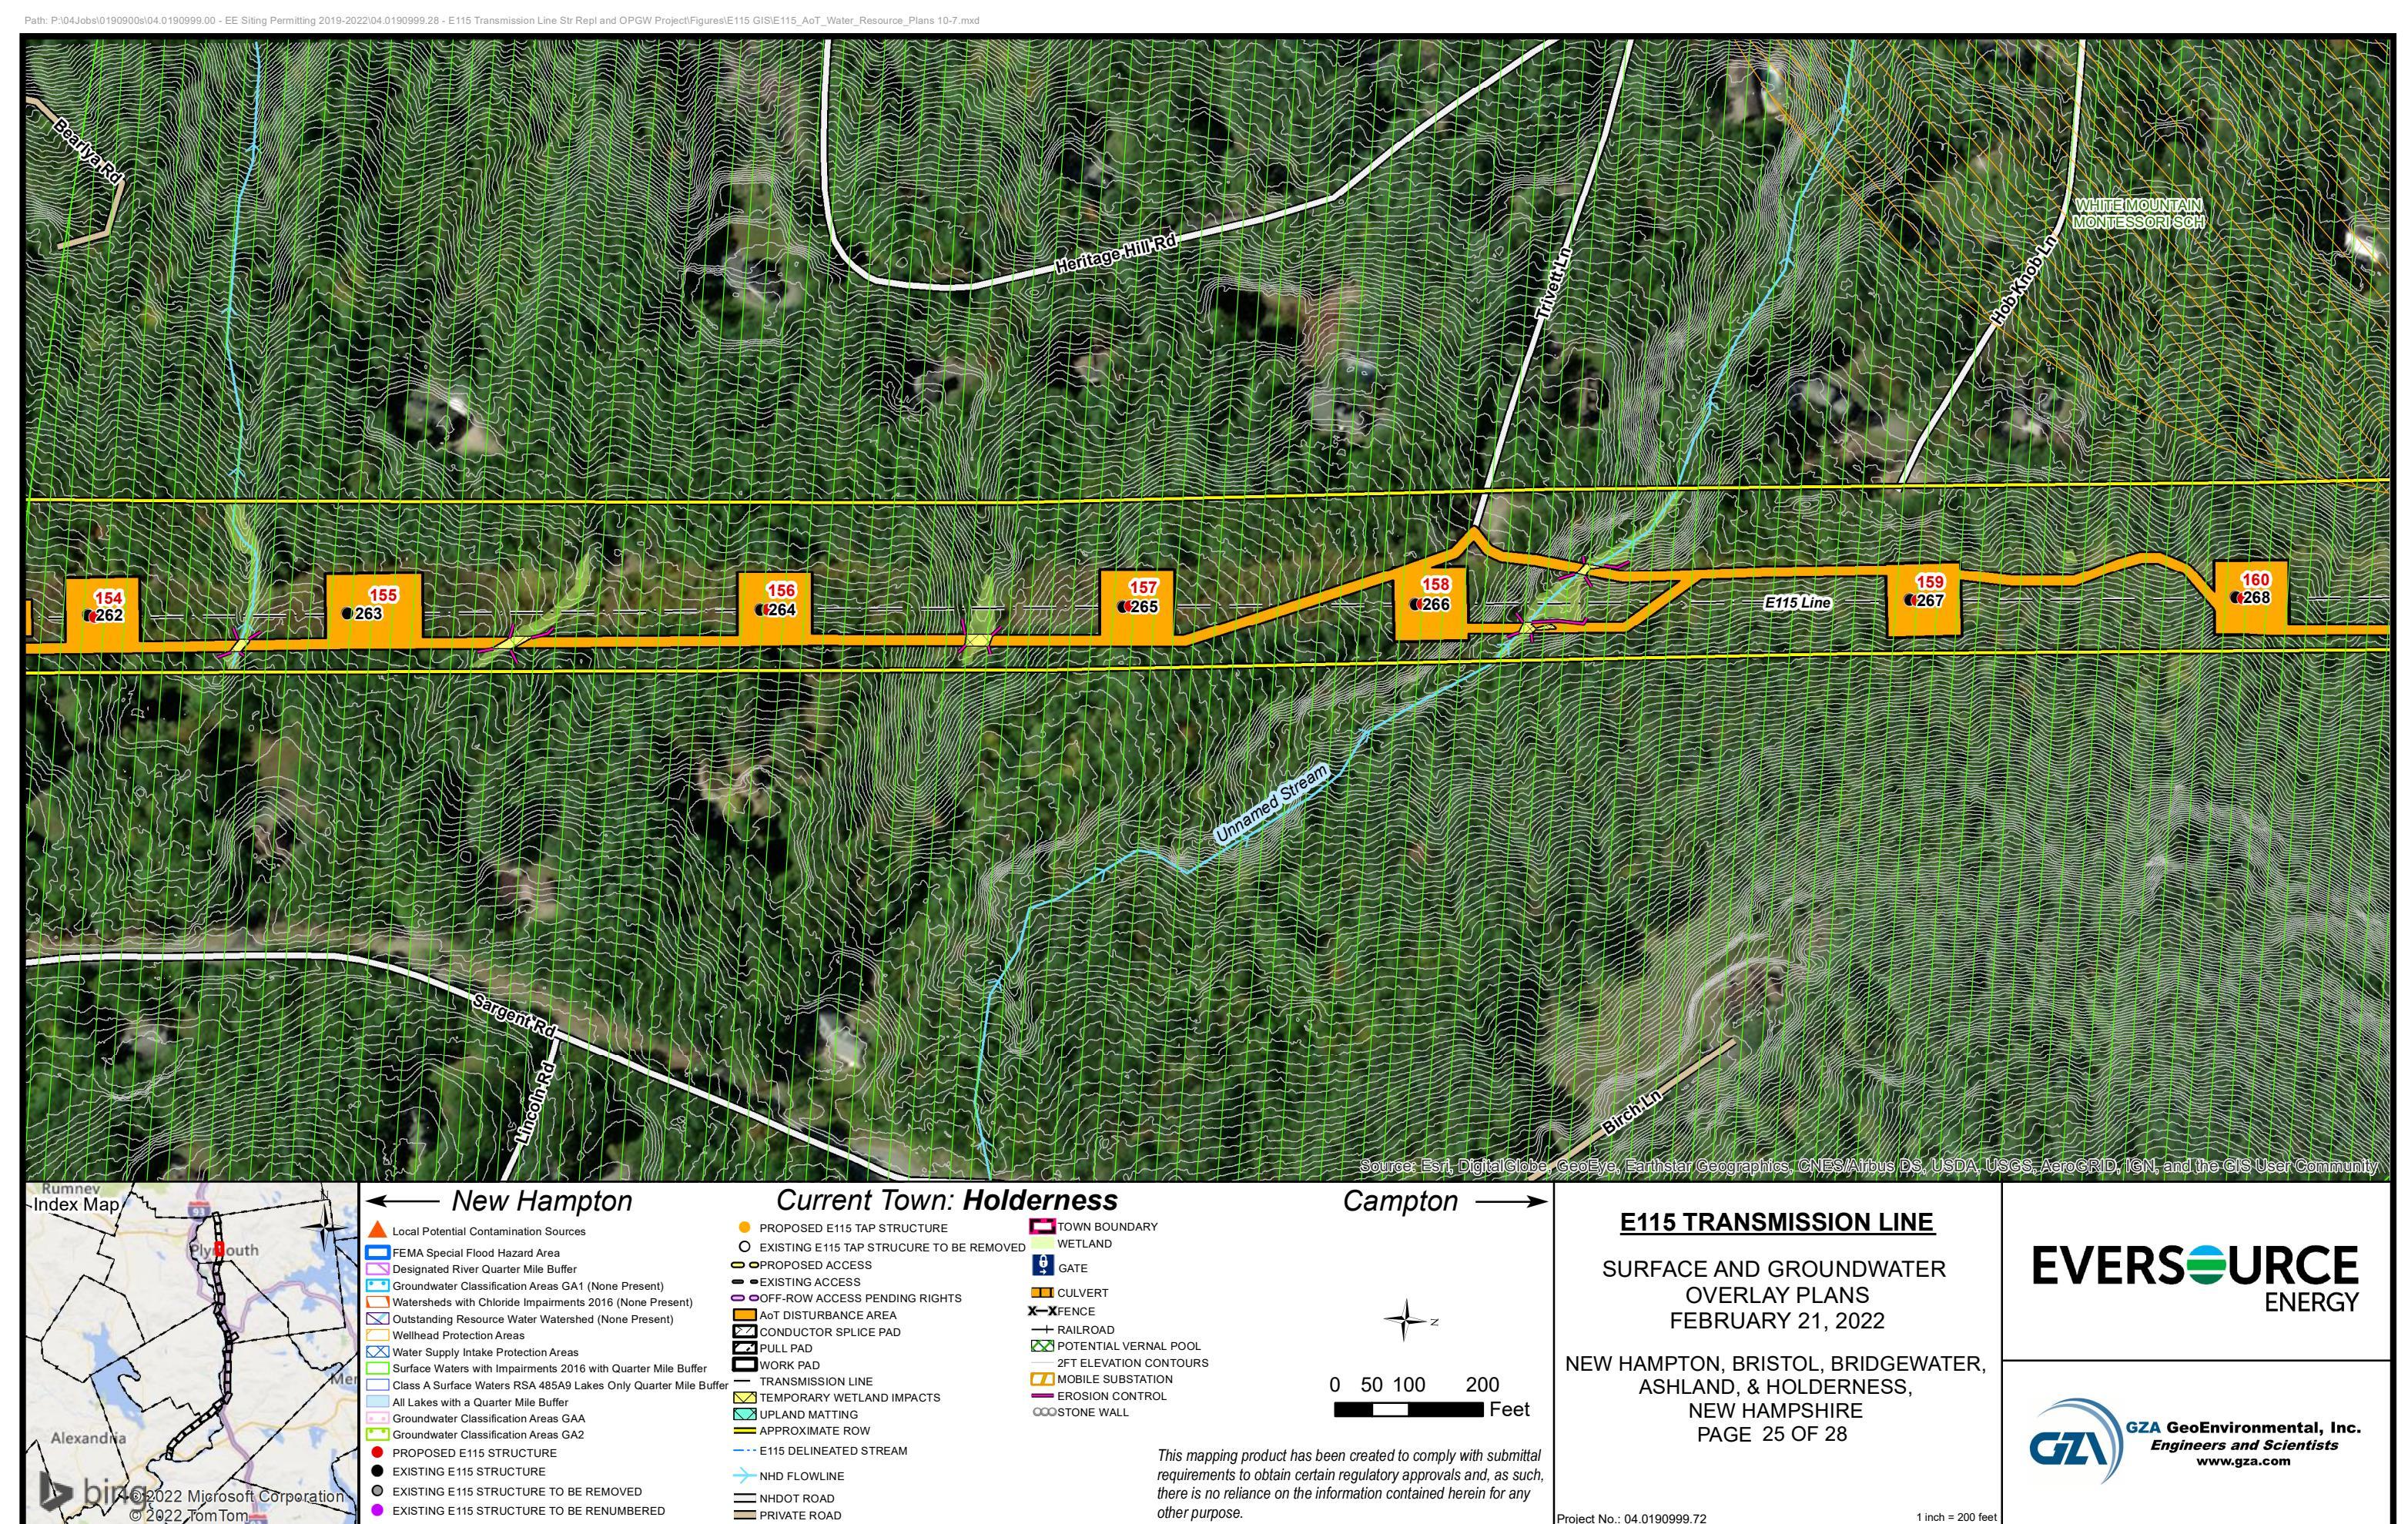
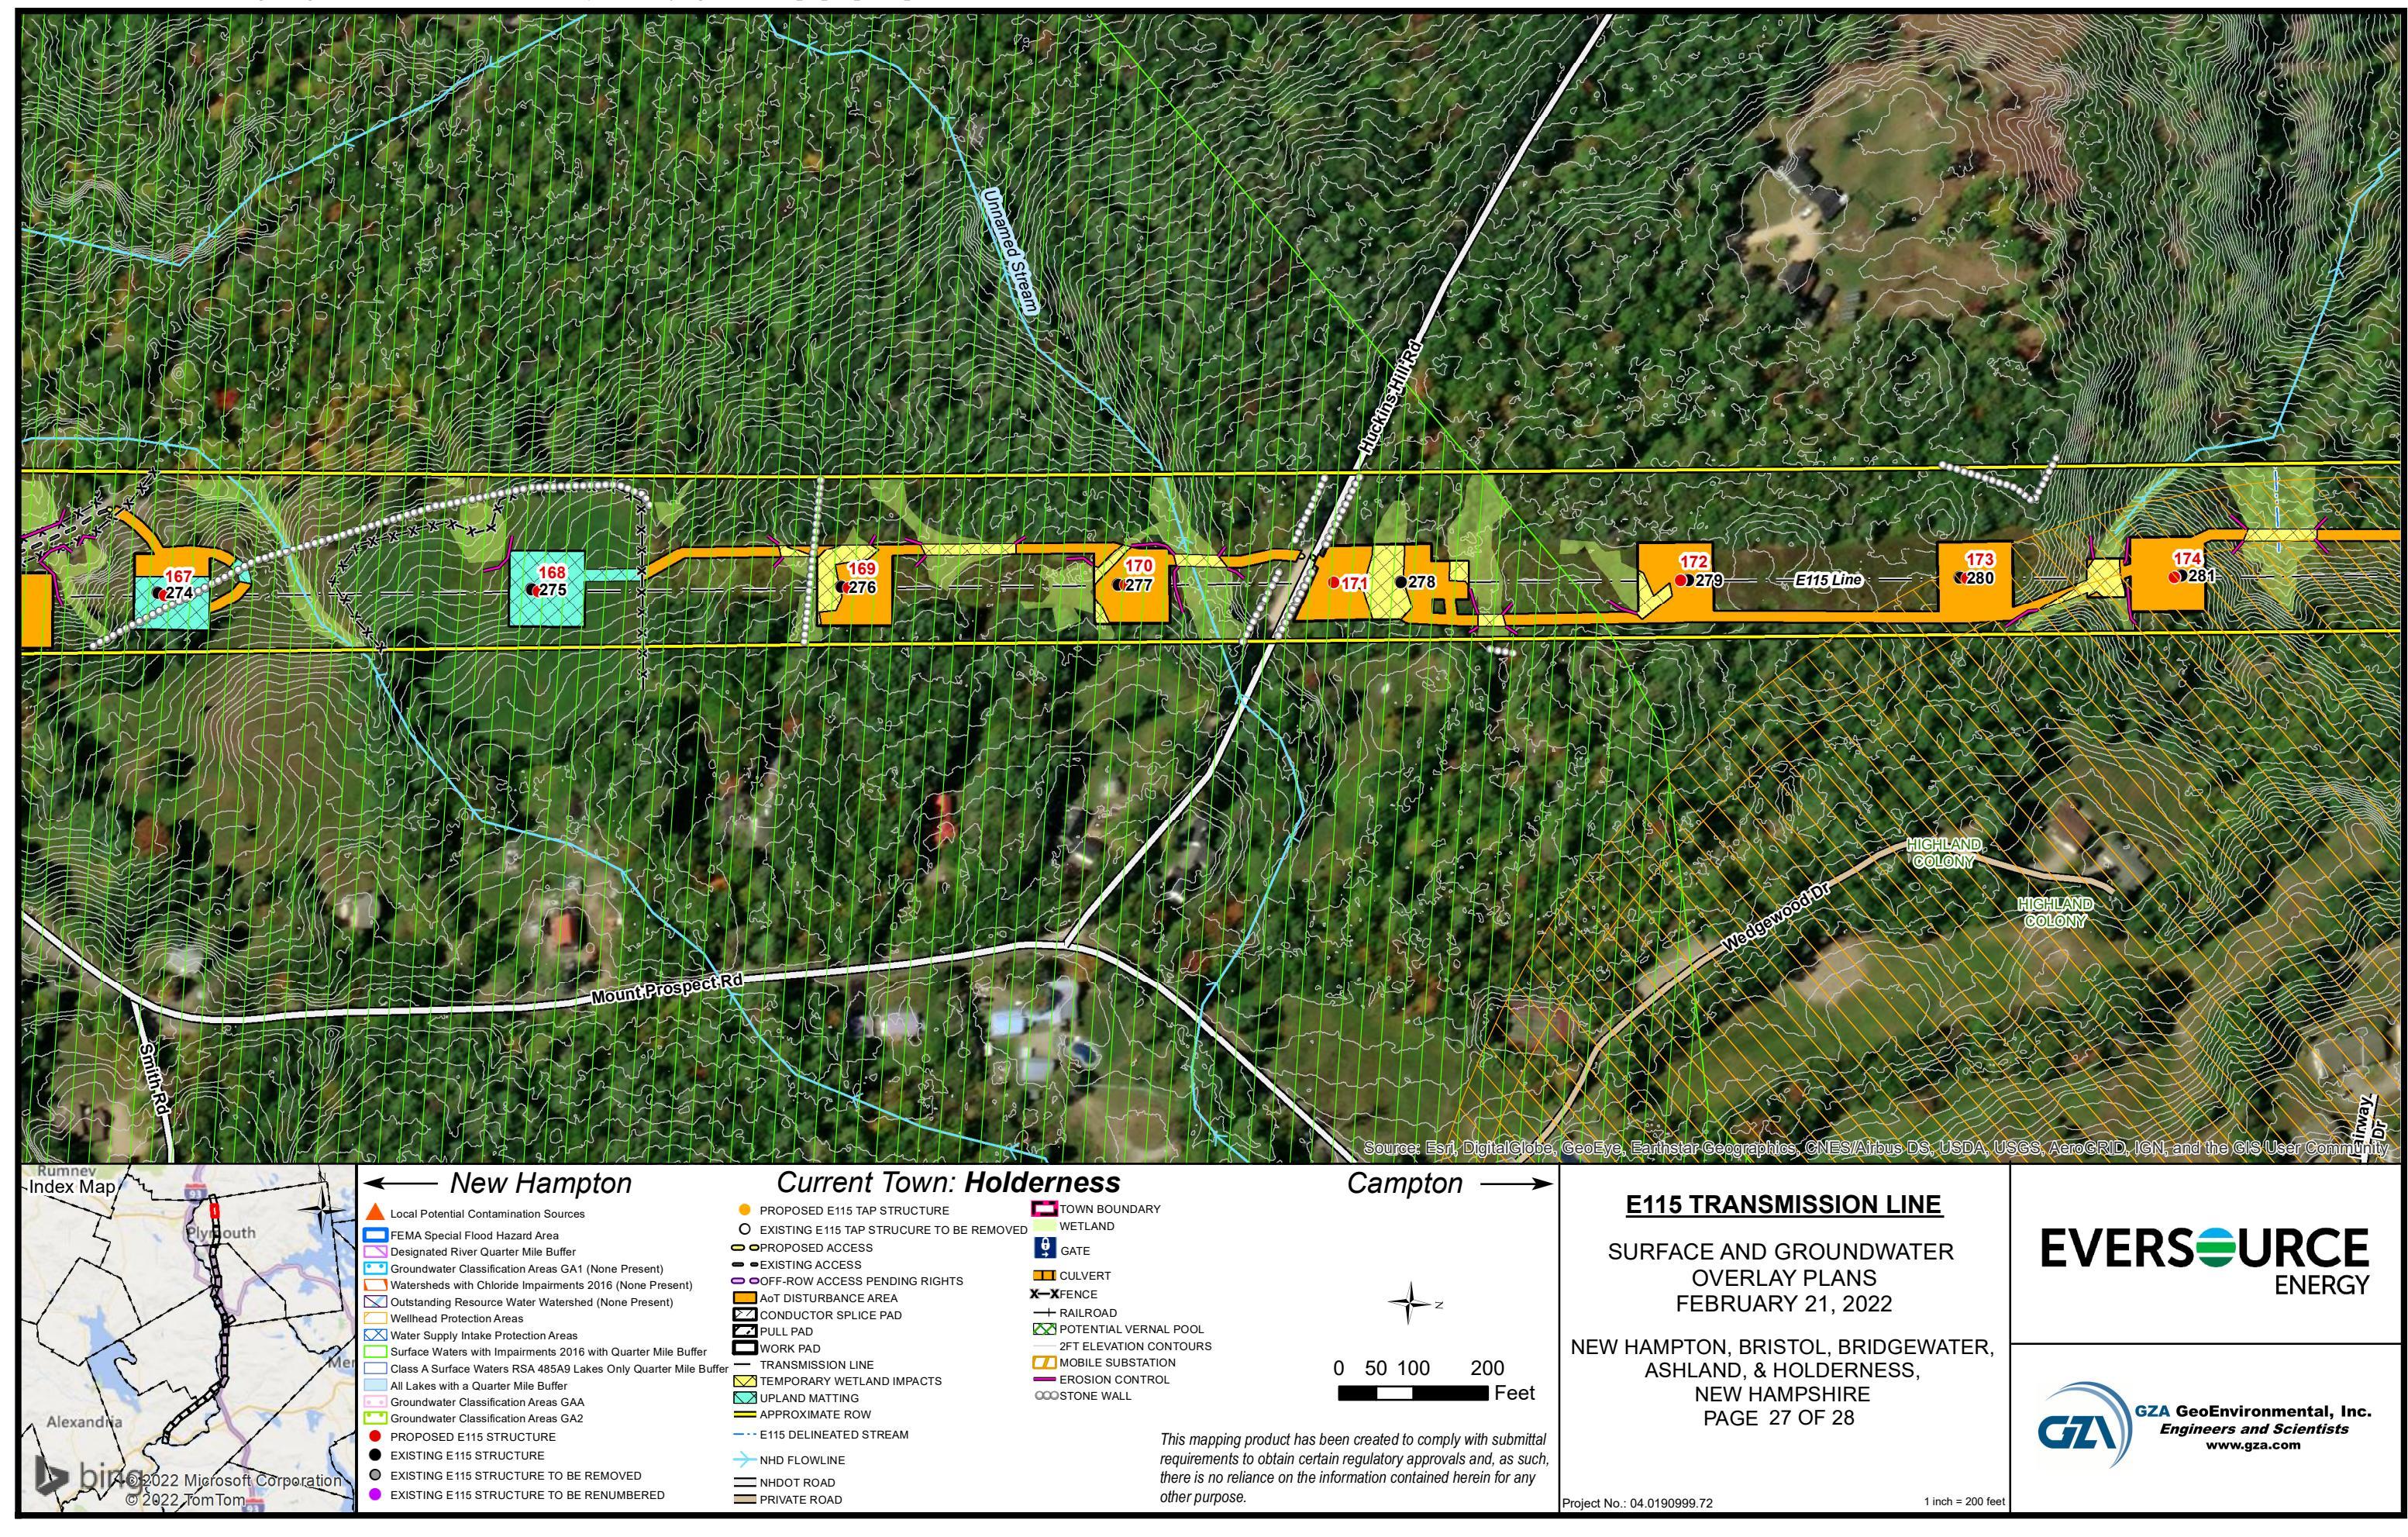
The proposed structure replacement project utilizes existing access routes within the existing E115 ROW to the greatest extent practicable. The majority of existing access routes are comprised of dirt or grassy areas and are proposed to be improved as part of this project. Proposed access routes are shown on the plans in both **Figures 3 and 4**. Access into the existing ROW will be obtained from various state and local roadways and private properties where permission has been obtained. Proposed access routes as shown on **Figures 3 and 4** were

Where necessary, perimeter protective measures consisting of a silt fence, straw wattle, mulch, and straw bales will be installed around the structures to minimize potential impacts to nearby resource areas. Water bars will be installed in areas of road improvements with steep slopes as identified by the Contractor. If necessary and based on localized site conditions, a silt fence may be used. Disturbed soil will be seeded and mulched with hay or straw for stabilization as needed following completion of work. No equipment or material will be stored within wetland areas. Erosion controls will be implemented during construction as detailed in Notesheets 1 through 3 of Figures 3 and 4 to minimize potential impacts during construction (see Figure 3 – Surface Water and Groundwater Overlay Plans and Figure 4 – Alteration of Terrain Permitting Plans).

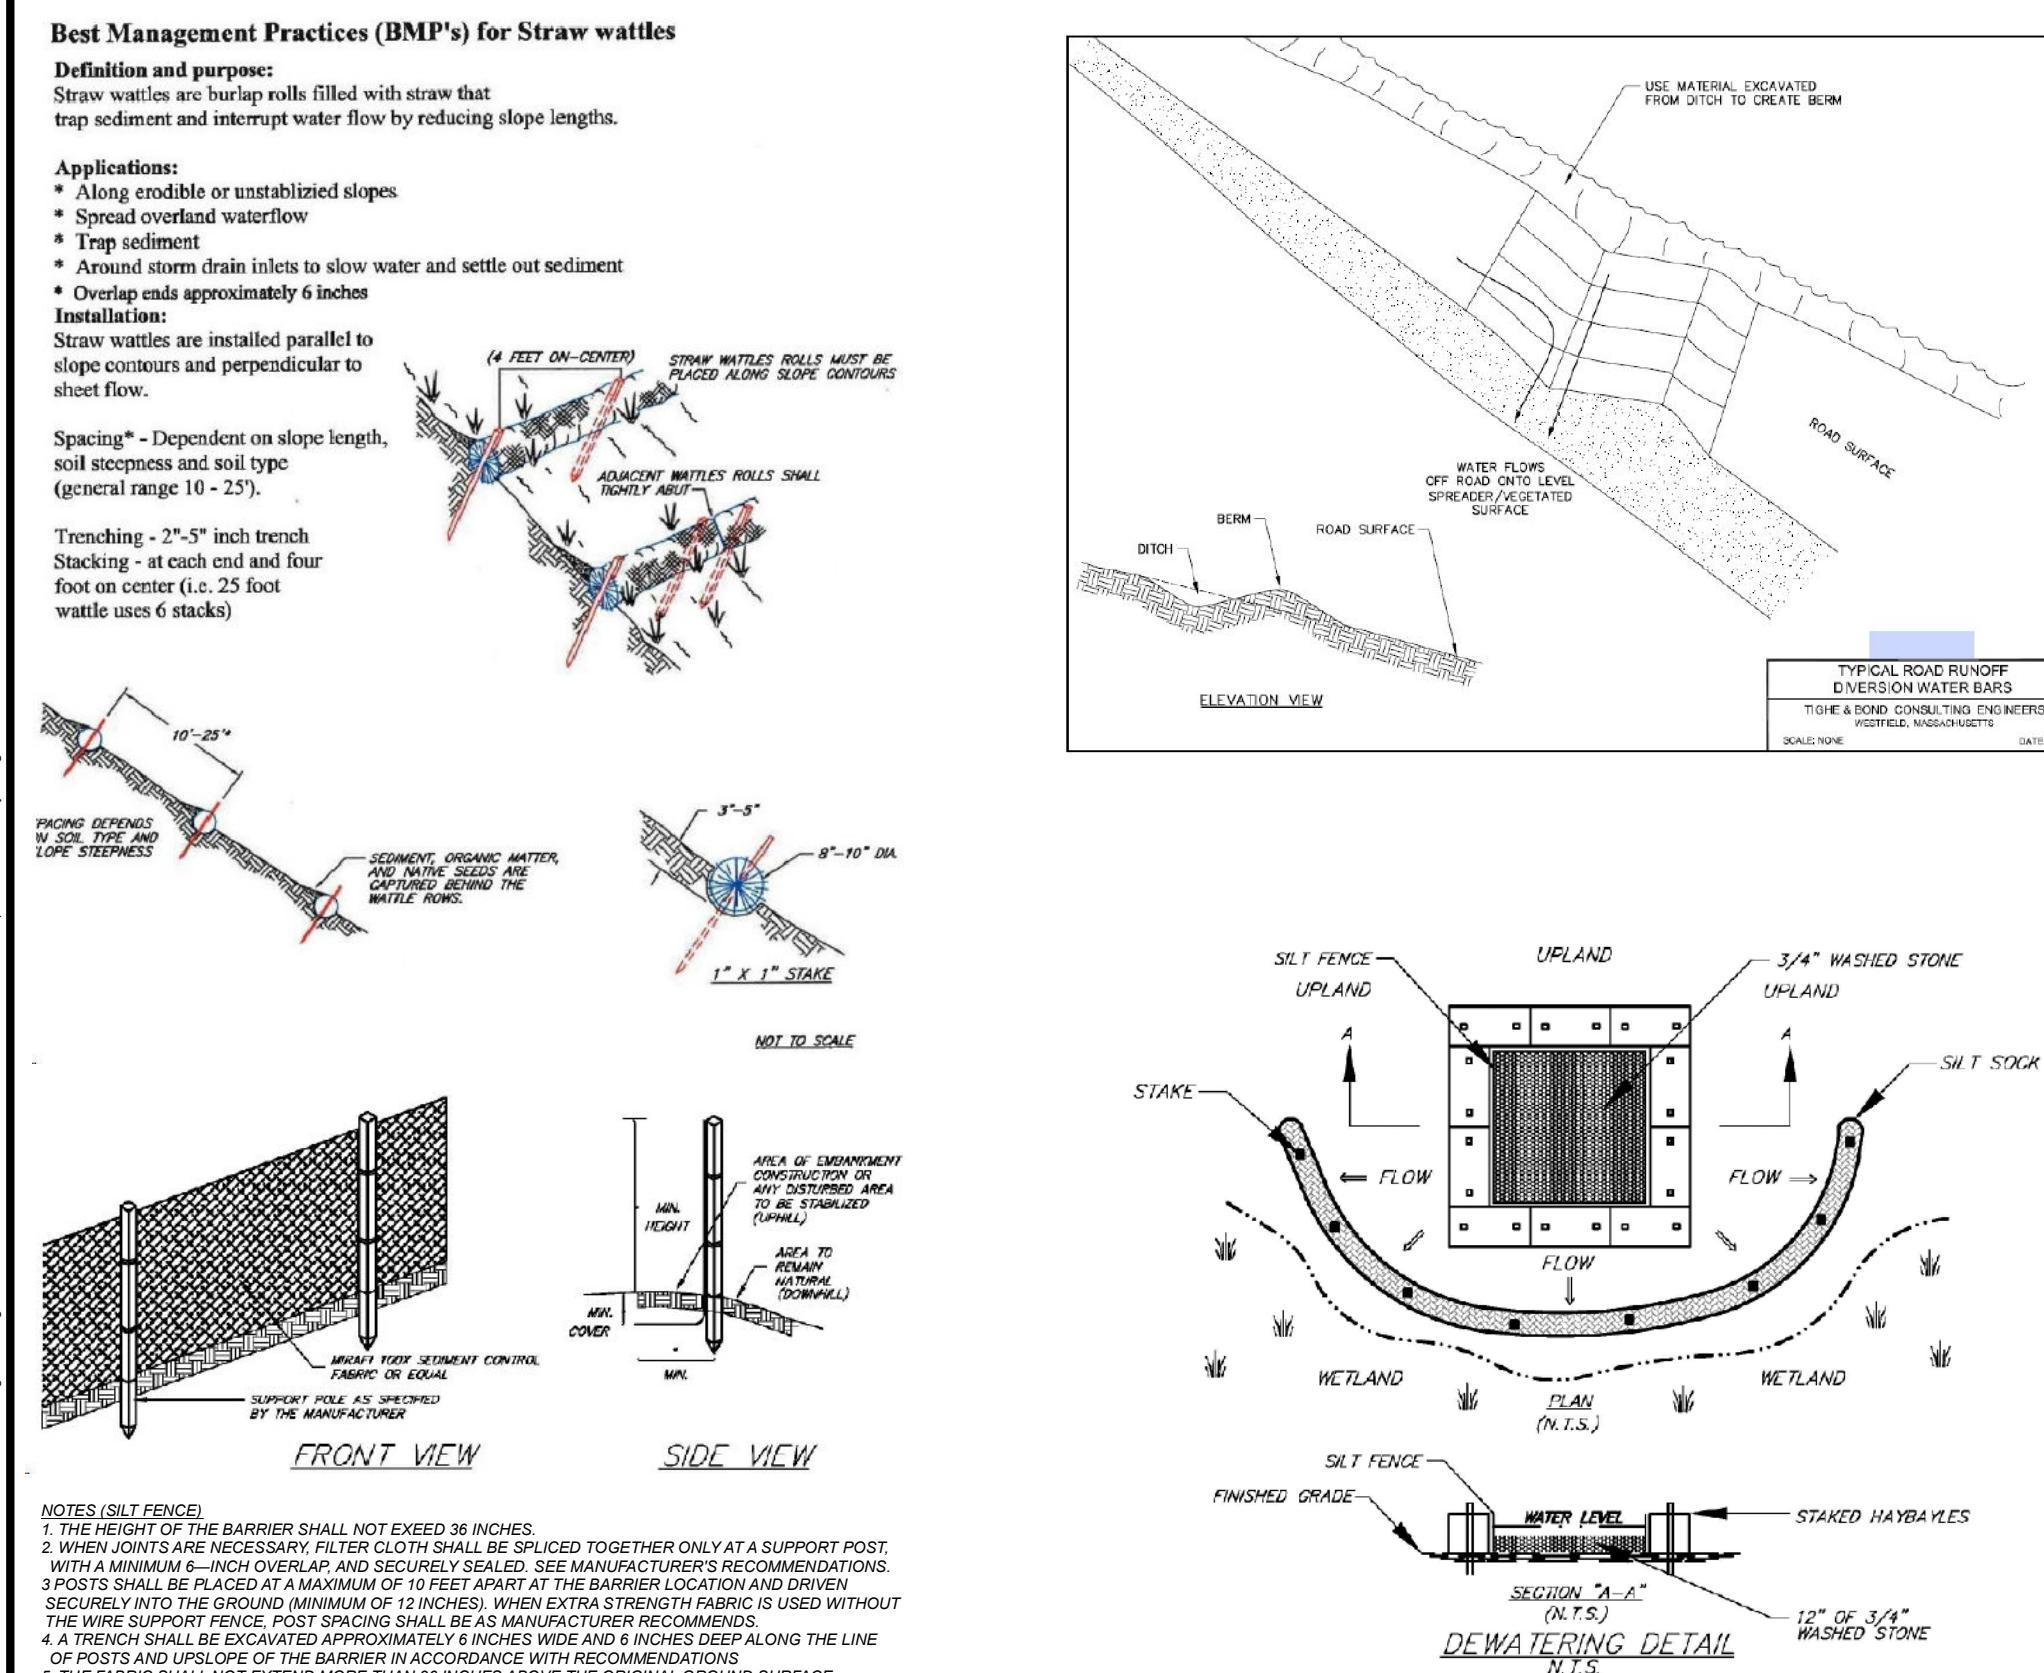
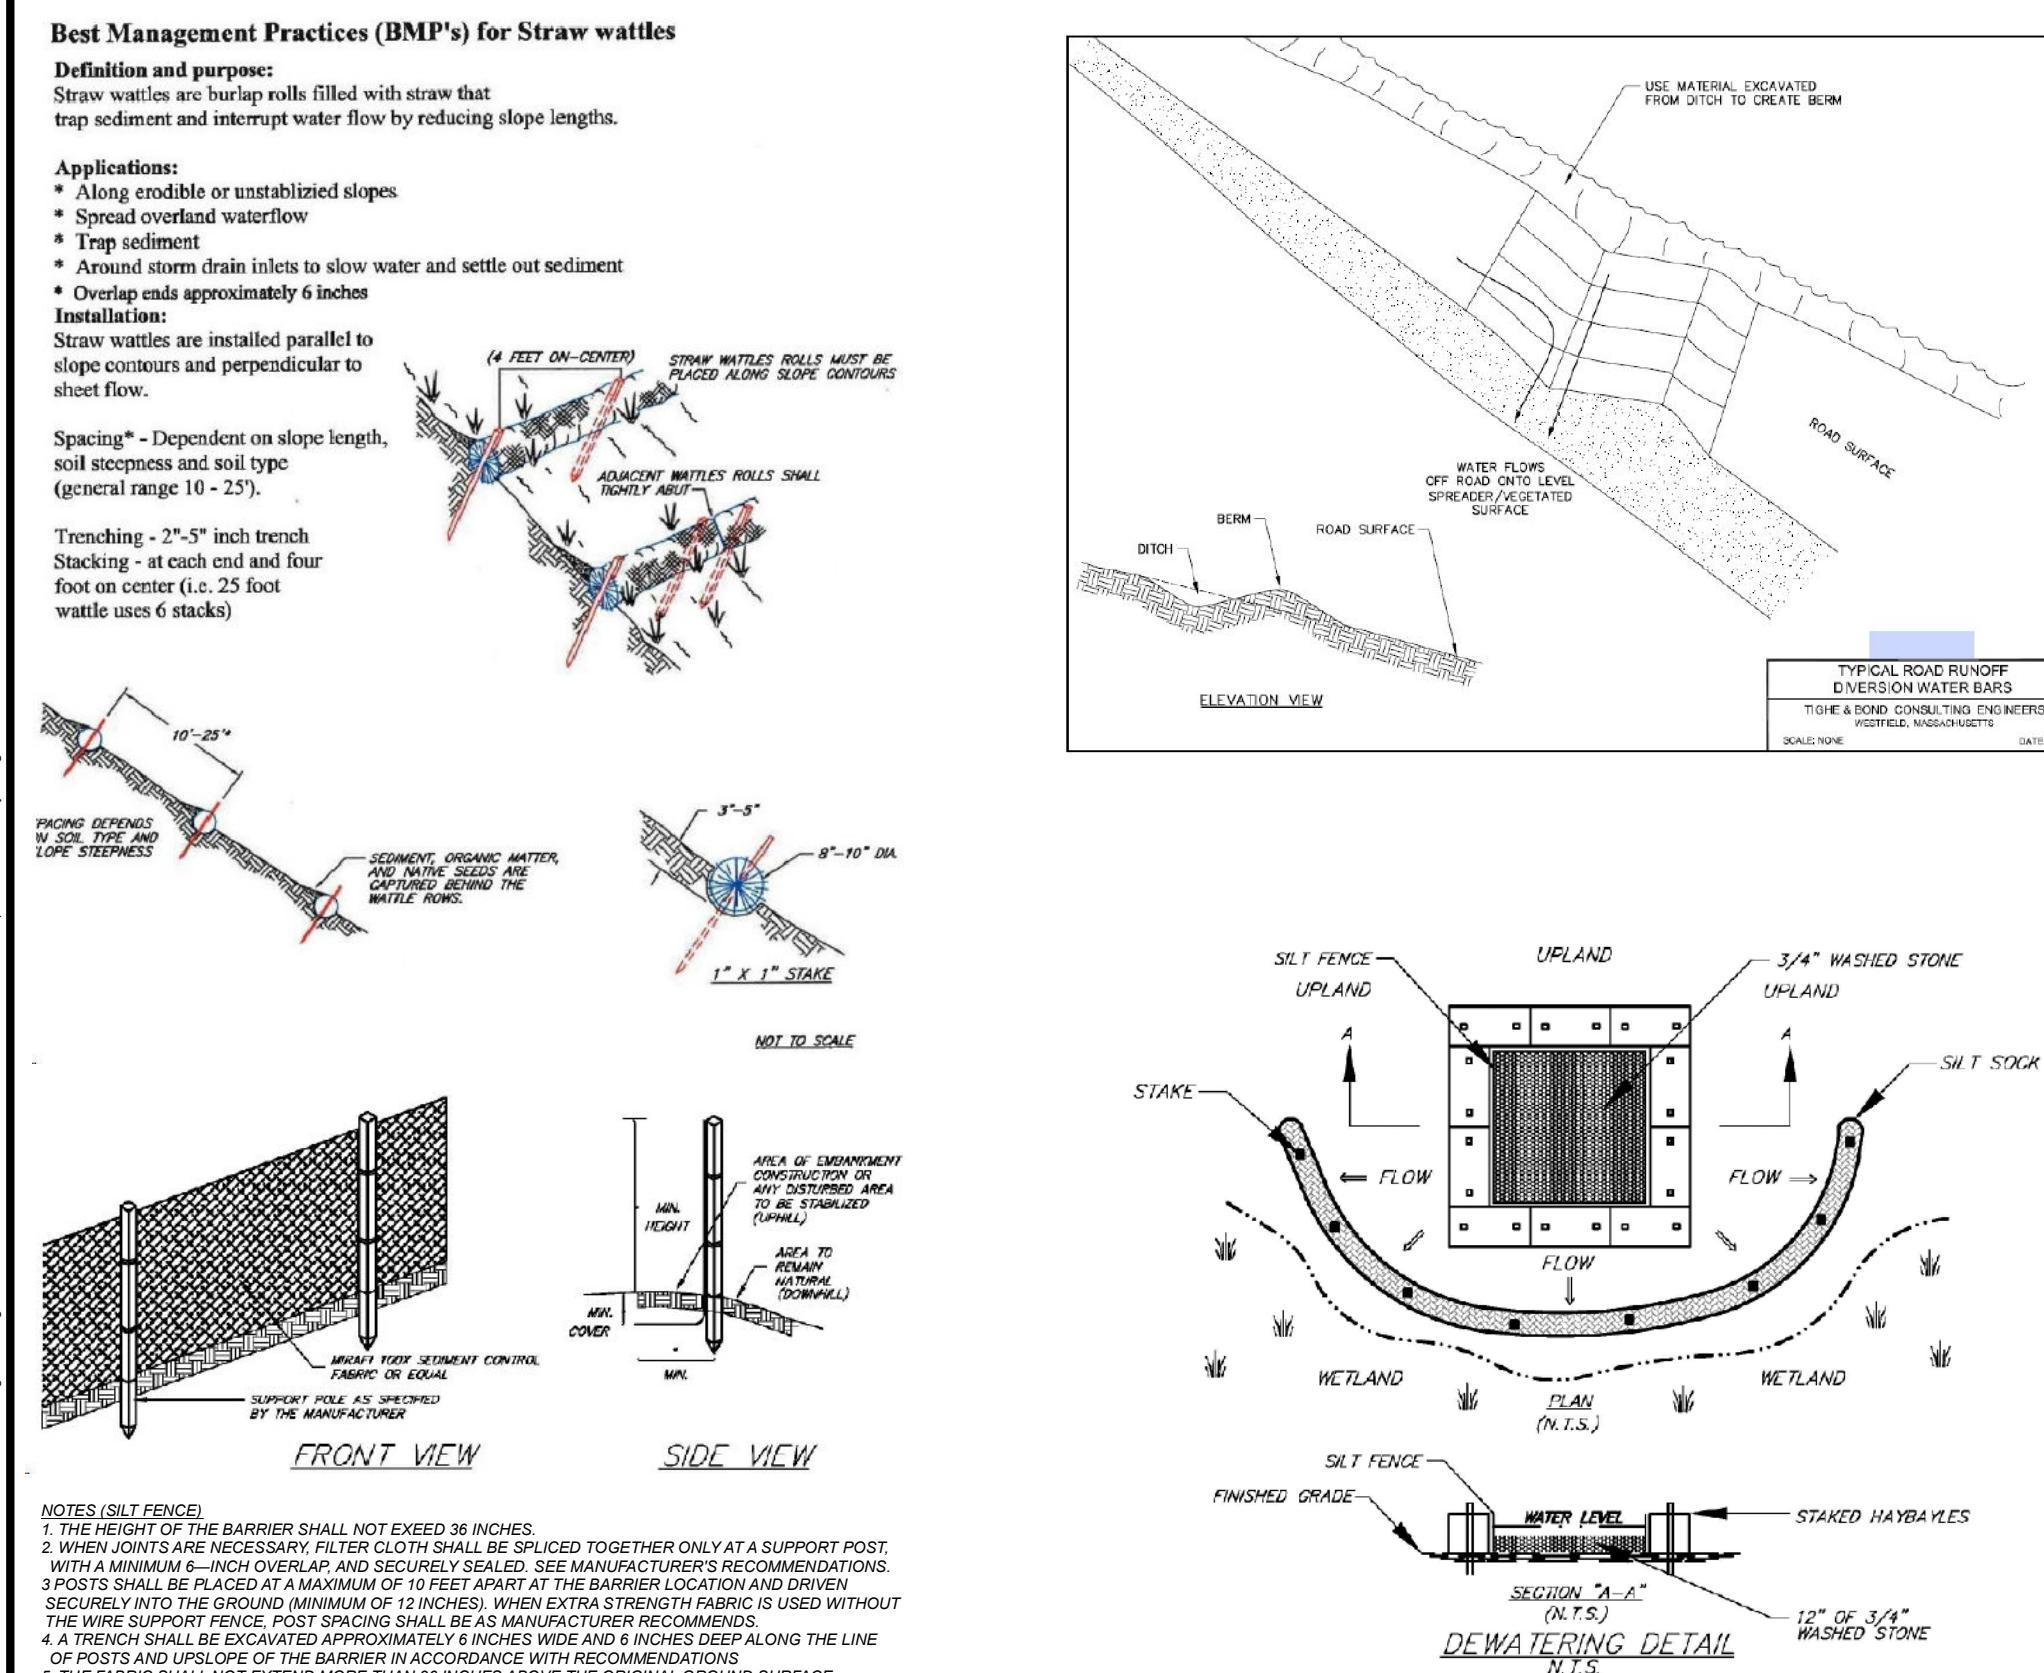
THE WIRE SUPPORT FENCE, POST SPACING SHALL BE AS MANUFACTURER RECOMMENDS. 4. A TRENCH SHALL BE EXCAVATED APPROXIMATELY 6 INCHES WIDE AND 6 INCHES DEEP ALONG THE LINE OF POSTS AND UPSLOPE OF THE BARRIER IN ACCORDANCE WITH RECOMMENDATIONS

5. THE FABRIC SHALL NOT EXTEND MORE THAN 36 INCHES ABOVE THE ORIGINAL GROUND SURFACE, AND WILL EXTEND A MINIMUM OF 8 INCHES INTO THE TRENCH. FILTER FABRIC SHALL NOT BE STAPLED TO EXISTING TREES.

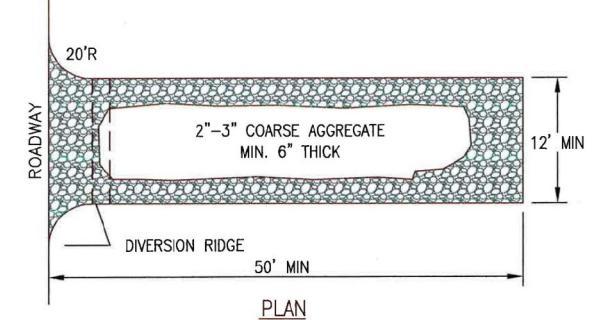
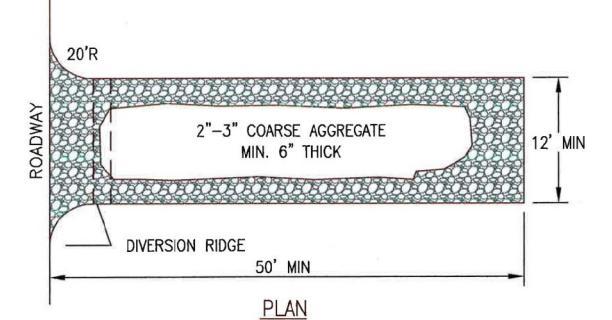
1. THE ENTRANCE SHALL BE MAINTAINED IN A CONDITION THAT WILL PREVENT TRACKING OR FLOWING OF SEDIMENT ONTO PUBLIC RIGHT-OF-WAYS. THIS MAY REQUIRE TOP DRESSING, REPAIR AND/OR CLEANOUT OF ANY MEASURES USED TO TRAP SEDIMENT
