то:		File				
FROM:		Mary F. Daun, P.E., Solid Waste Management Bureau, NHDES				
SUBJECT:		Pre-Application meeting, Campton/Thornton Municipal Landfill, Thornton, NH Permit No. DES-SW-TP-94-021				
DATE:		November 18, 2024				
ATTENDEES:						
	NHDES		Mary Daun, P.E., Jaime Colby, P.E.;			
	Town o	f Thornton:	Chris Boldt, Desiree Mahurin, Peter Laufenberg, Matthew Peltier;			
	Eversou	ırce:	Jennifer Codispoti, Almir Memic, Samuel Harris, Mary-Kate Daley, Samuel Eames, Jeremy Fennel, Erik Newman, Angus Strachan;			
	GZA:		David Lamothe, P.E., Jennifer Baron

### Beebe River to Whitefield (X178) Line Rebuild Project

### **Thornton Landfill Design Alternatives**

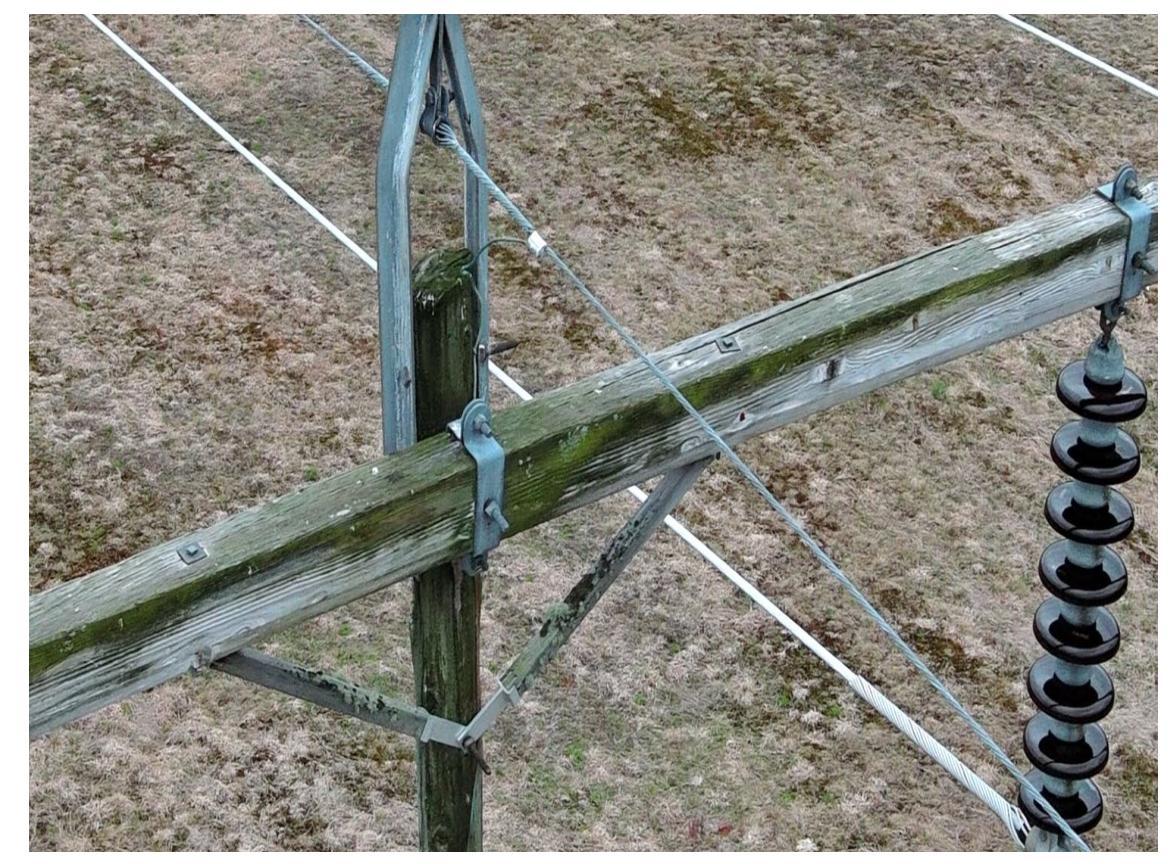
Structure 49

### **Structure Deterioration Identified on Landfill**

- Recent inspections of structures along the X178 identified additional deterioration of the three structures located on the landfill (cross arm cracking, pole-top rot)
- Emergency repairs may be required and immediate access to landfill if conditions change.
- Additional challenges to repair or replacement due to vehicular clearance.

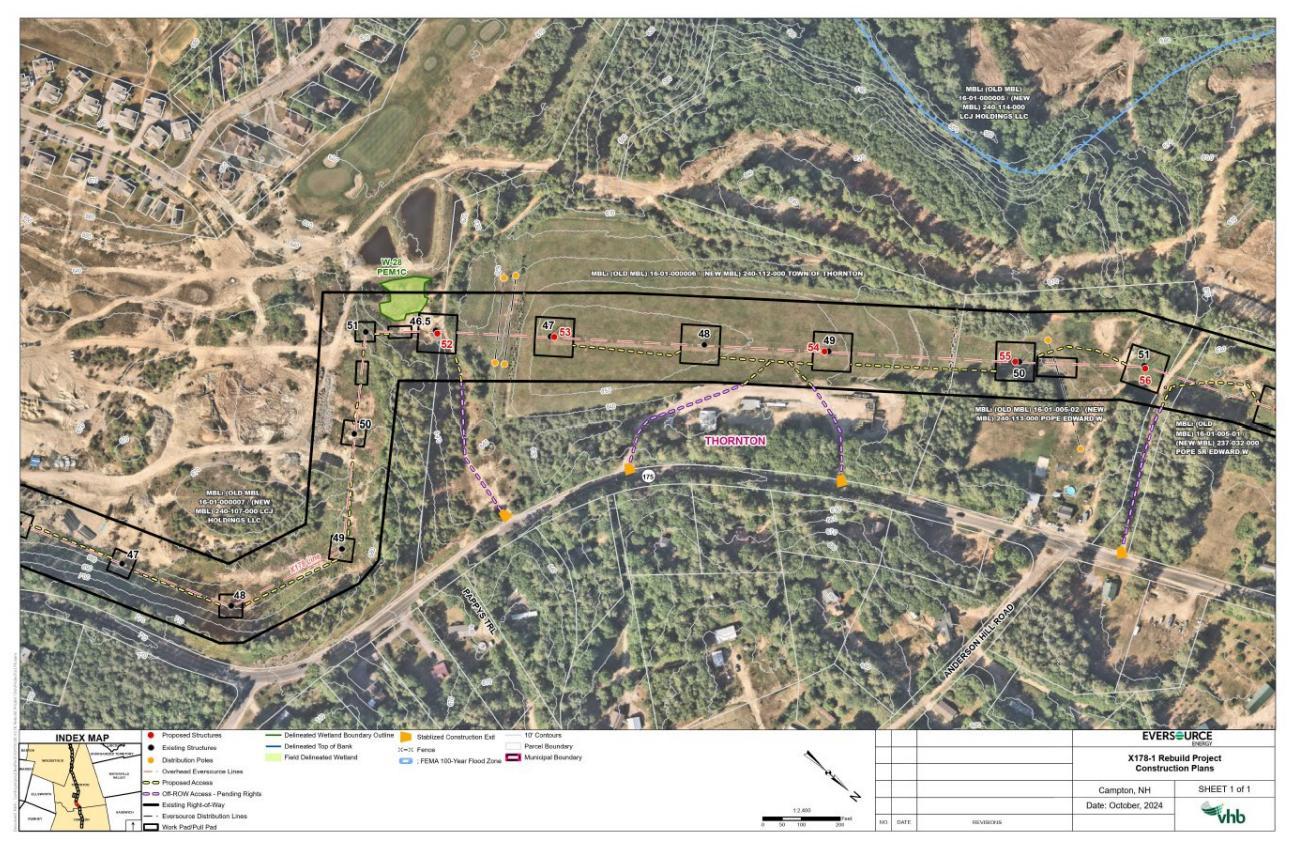
### **Overhead View of Landfill**

- Eversource will stay within our existing easement in replacing the existing wood structures with steel structures, with an approximate 10' offset from the current poles (subject to change based on result from Geotechnical borings).
- The project has been designed and will be executed using construction practices designed to prevent impacts to groundwater, which will be demonstrated through pre-and postconstruction monitoring.
- The project will obtain all necessary environmental permits and approval through NHDES and will be executed fully in compliance with all applicable environmental laws and permit conditions.
- Replacement of existing structures 47 & 49 will include the installation of concrete foundations with permanent casing to support the taller poles on the landfill needed to remove structure 48.

Landfill Structure Height Overview							
Structure	Existing	Proposed	Difference				
47	52.00	70.00	18.00				
48	Removed without replacement						
49	40.14	70.00	29.86

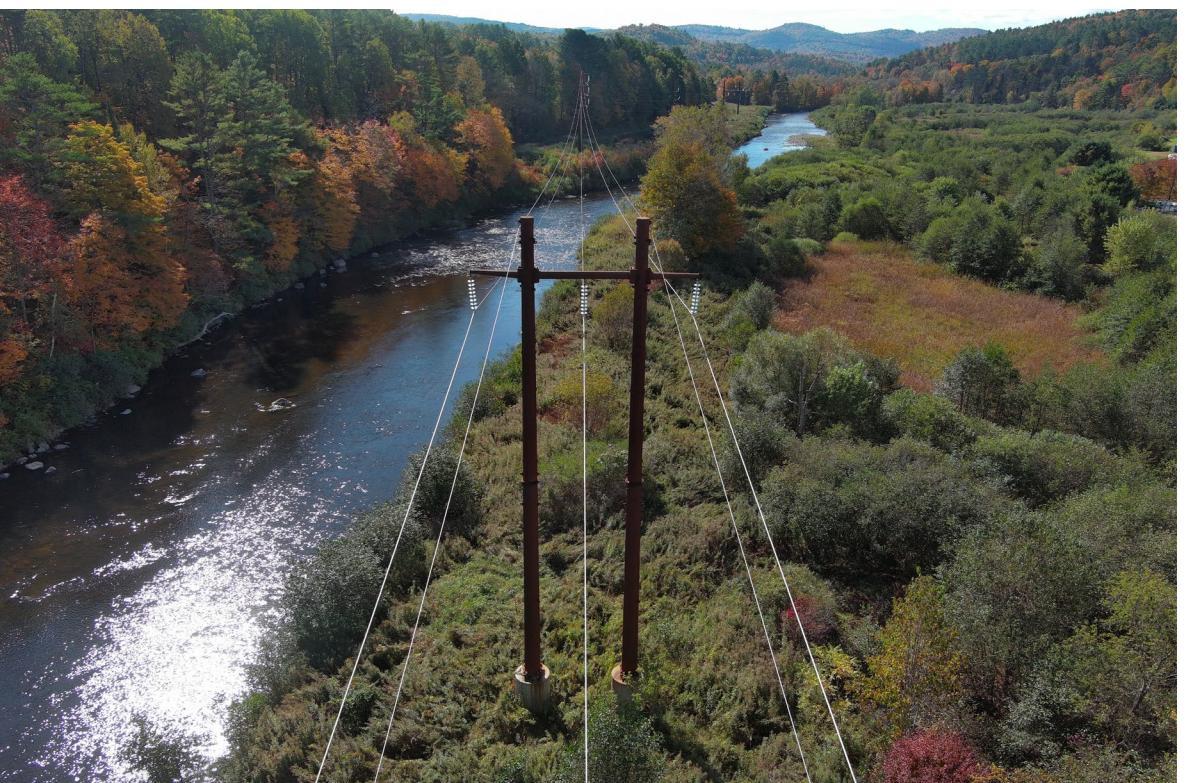
- 8 PSI limit recommendation for working on landfill
- Matting on top of landfill (timber or poly) required
- **Concrete Foundations**
- Two drilled shafts will be installed at each of the two proposed structure locations, Structure 47 and Structure 49
- Permanent casings will be advanced to maintain the integrity of each drilled shaft hole.
- Existing wooden poles will be cut below liner, and liner repaired.
