CONSTRUCTION MONITORING REPORT

B112 Transmission Line

**Campton, Sandwich,
and Tamworth, New
Hampshire**

AoT-2336

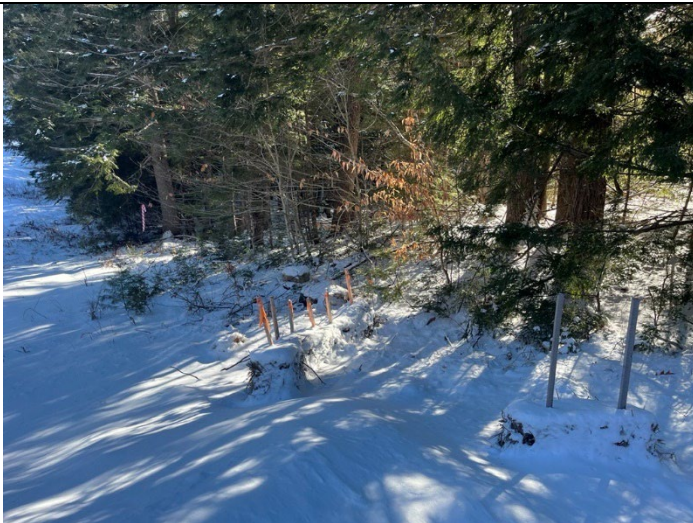
Looking southeast at the straw bales in place along the access road near Structure 8 off Page Road, Campton.

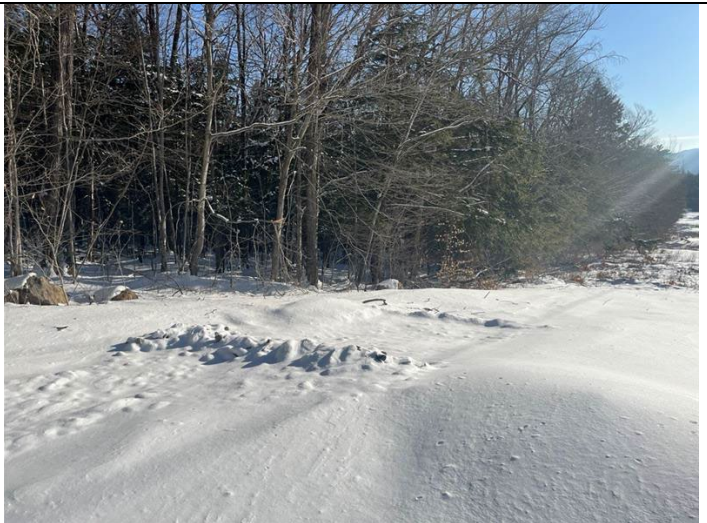
Looking east at the water bar and check dams in place along the access road near Structure 120 off Mount Israel Road, Sandwich.

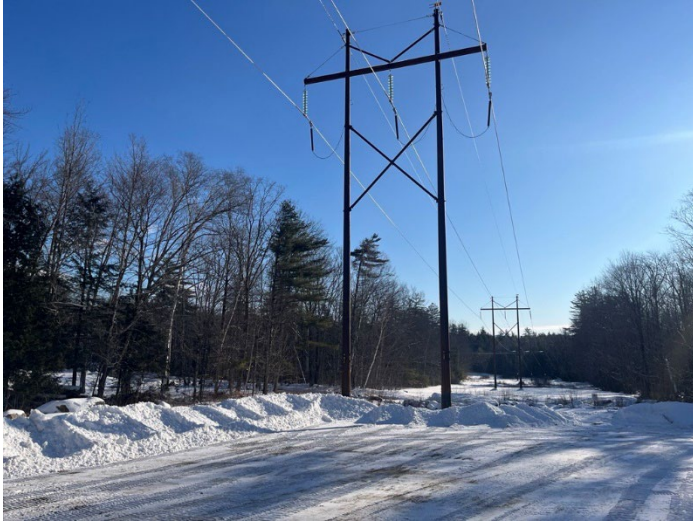
Looking east at the Structure 122 work pad off Mount Israel Road, Sandwich.

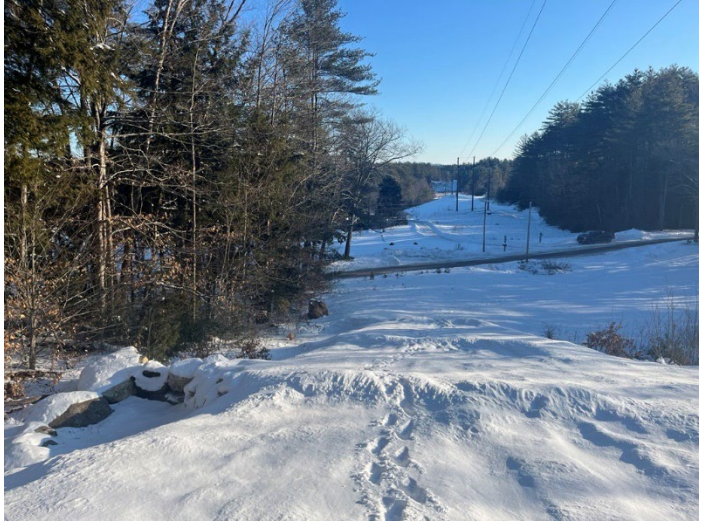
Looking northeast at the water bars and plunge pool in place along the access road near Structure 227 off Durrell Road, Tamworth.
