Original Alteration of Terrain Permit Application

C196 AND A253 TRANSMISSION LINE STRUCTURE REPLACEMENT PROJECT EVERSOURCE ENERGY Goffstown, Dunbarton, and Bow, New Hampshire

NHDES Alteration of Terrain Permit Application

November 28, 2022 GZA File No. 04.0191410.18

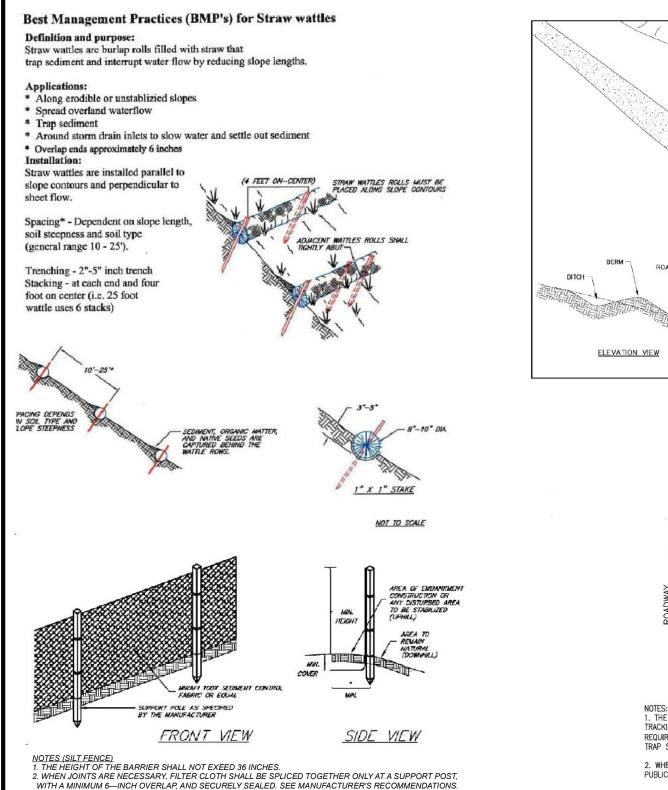
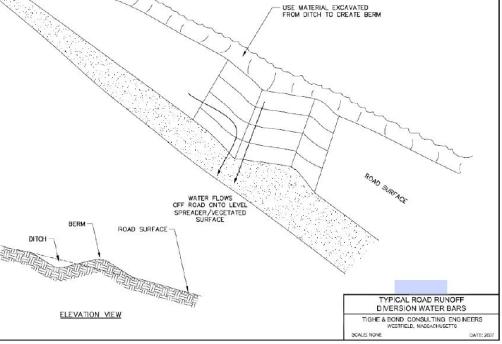
BMP DETAILS

1. THE ENTRANCE SHALL BE MAINTAINED IN A CONDITION THAT WILL PREVENT TRACKING OR FLOWING OF SEDIMENT ONTO PUBLIC RIGHT-OF-WAYS. THIS MAY REQUIRE TOP DRESSING, REPAIR AND/OR CLEANOUT OF ANY MEASURES USED TO TRAP SEDIMENT.

3 POSTS SHALL BE PLACED AT A MAXIMUM OF 10 FEET APART AT THE BARRIER LOCATION AND DRIVEN SECURELY INTO THE GROUND (MINIMUM OF 12 INCHES). WHEN EXTRA STRENGTH FABRIC IS USED WITHOUT THE WIRE SUPPORT FENCE, POST SPACING SHALL BE AS MANUFACTURER RECOMMENDS. 4. A TRENCH SHALL BE EXCAVATED APPROXIMATELY 6 INCHES WIDE AND 6 INCHES DEEP ALONG THE LINE OF POSTS AND UPSLOPE OF THE BARRIER IN ACCORDANCE WITH RECOMMENDATIONS

OF POSTS AND UPSLOPE OF THE BARRIER IN ACCORDANCE WITH RECOMMENDATIONS 5. THE FABRIC SHALL NOT EXTEND MORE THAN 36 INCHES ABOVE THE ORIGINAL GROUND SURFACE, AND WILL EXTEND A MINIMUM OF 8 INCHES INTO THE TRENCH. FILTER FABRIC SHALL NOT BE STAPLED TO EXISTING TREES. 6. THE TRENCH SHALL BE BACKFILLED AND THE SOIL COMPACTED OVER THE FILTER FABRIC.

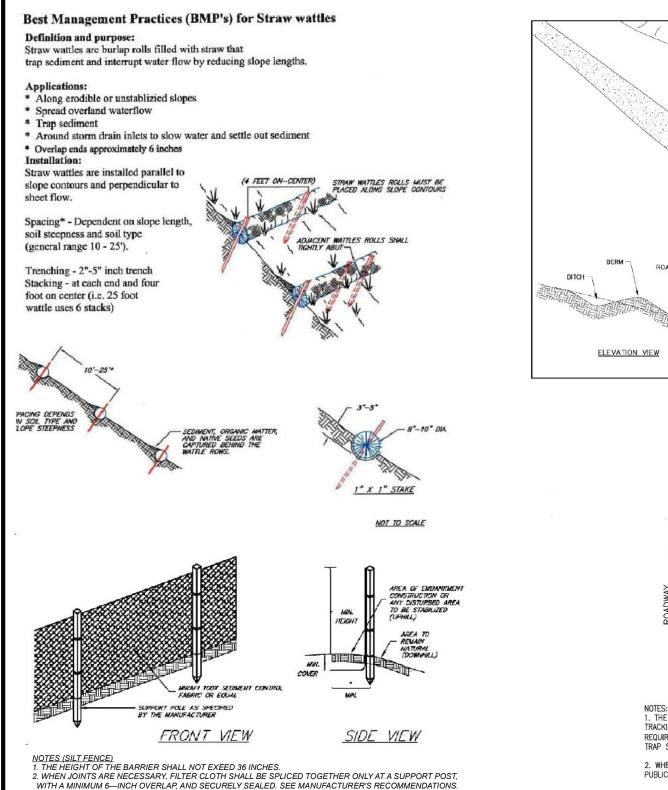
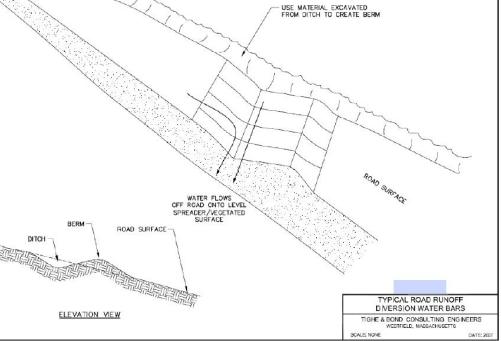
3 POSTS SHALL BE PLACED AT A MAXIMUM OF 10 FEET APART AT THE BARRIER LOCATION AND DRIVEN SECURELY INTO THE GROUND (MINIMUM OF 12 INCHES). WHEN EXTRA STRENGTH FABRIC IS USED WITHOUT

THE WIRE SUPPORT FENCE, POST SPACING SHALL BE AS MANUFACTURER RECOMMENDS. 4. A TRENCH SHALL BE EXCAVATED APPROXIMATELY 6 INCHES WIDE AND 6 INCHES DEEP ALONG THE LINE

1. THE ENTRANCE SHALL BE MAINTAINED IN A CONDITION THAT WILL PREVENT TRACKING OR FLOWING OF SEDIMENT ONTO PUBLIC RIGHT-OF-WAYS. THIS MAY REQUIRE TOP DRESSING, REPAIR AND/OR CLEANOUT OF ANY MEASURES USED TO TRAP SEDIMENT.

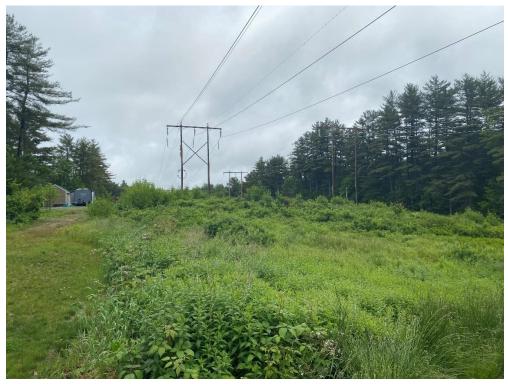
Photograph No. 1: Looking at proposed access and work pad location for C196 Structure 116 (left).

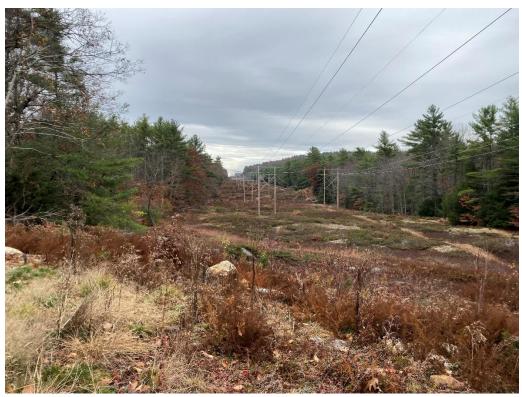
Photograph No. 5: Looking at proposed access and work pad location for C196 Structure 103 (left).

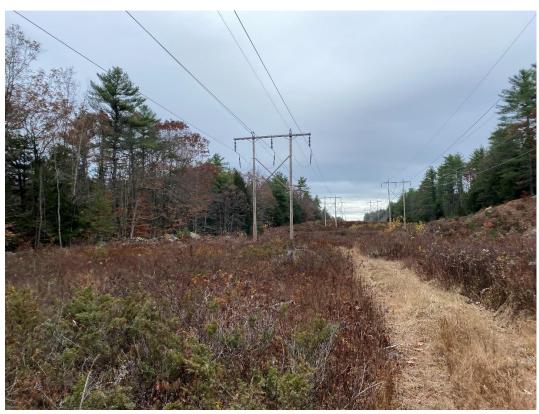
Photograph No. 6: Looking at proposed access and work pad location for C196 Structure 102.

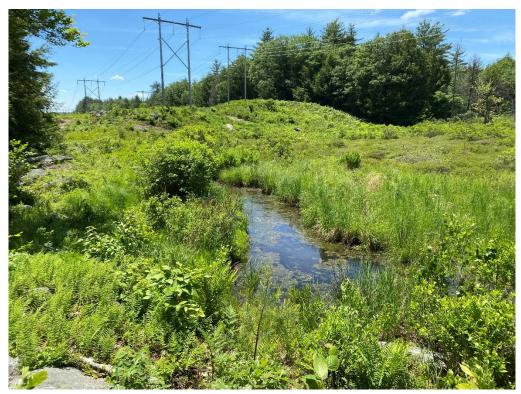
Photograph No. 8: Looking at proposed access and work pad location for C196 Structure 87.

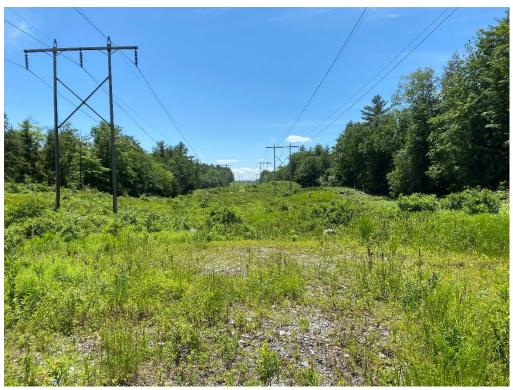
Photograph No. 9: Looking at proposed access and work pad location for C196 Structure 86 (right).

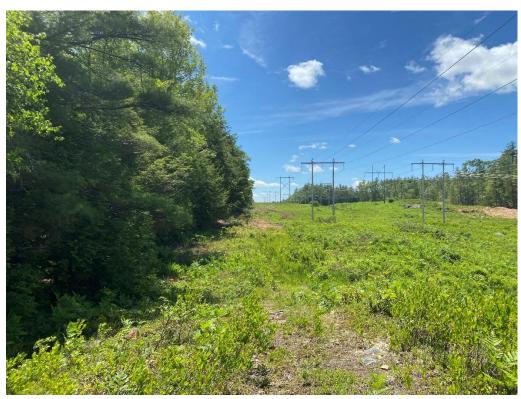
Photograph No. 10: Looking at proposed access and work pad for A253 Structure 81 (center).

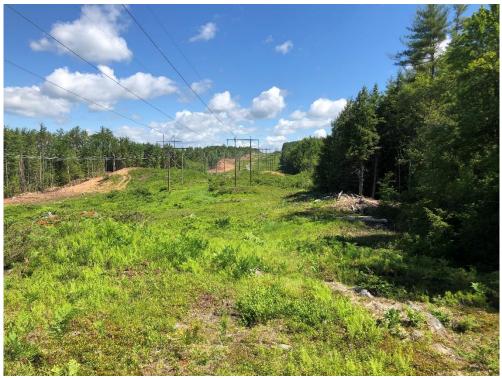
Photograph No. 11: Looking at proposed access and work pad location for A253 Structure 82 (left).

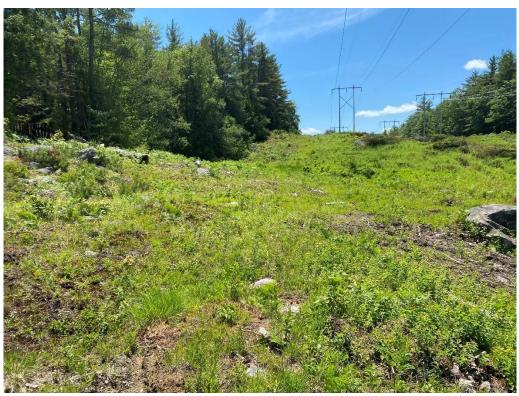
Photograph No. 13: Looking at proposed access and work pad location for C196 Structure 83 (right).

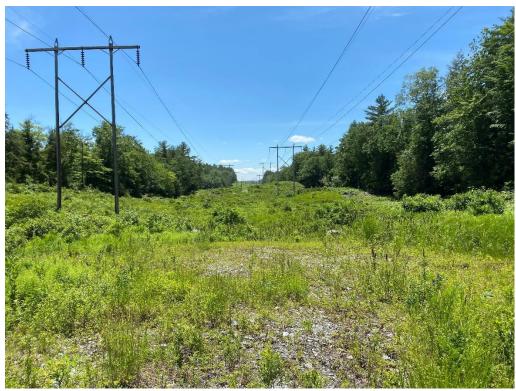
Photograph No. 15: Looking at proposed access and work pad location for C196 Structure 86 (right).

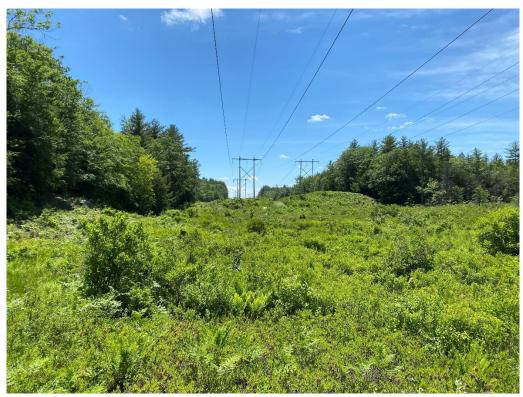
Photograph No. 16: Looking at proposed access and work pad location for C196 Structure 87 (right).

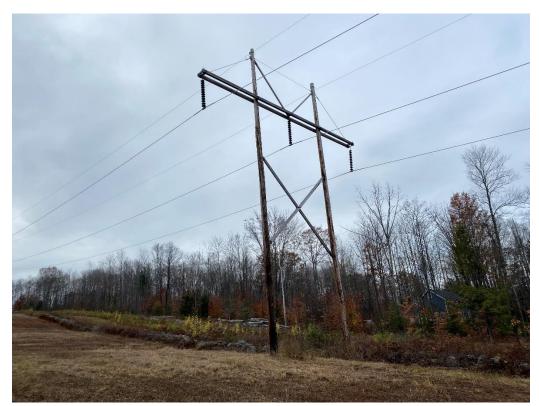
Photograph No. 18: Looking at proposed access and work pad location for A253 Structure 52.

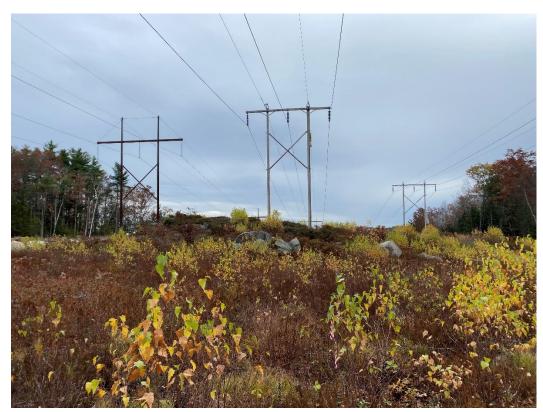
Photograph No. 20: Looking at proposed work pad location for C196 Structure 45 (center).

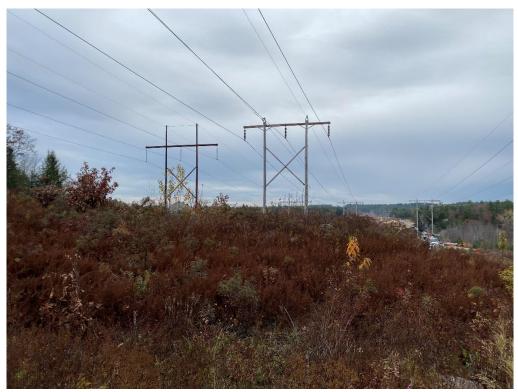
Photograph No. 21: Looking at proposed access and work pad location for C196 Structure 44 (center).

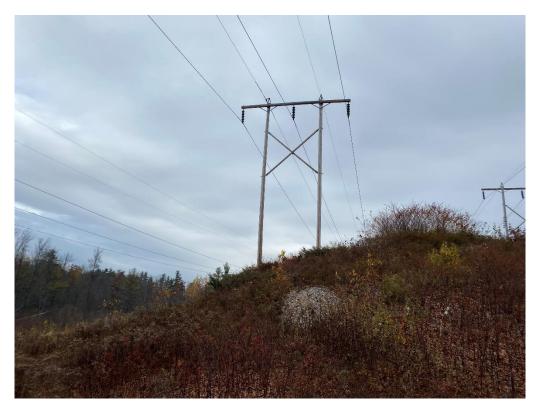
Photograph No. 24: Looking at proposed access and work pad location for C196 Structure 41.

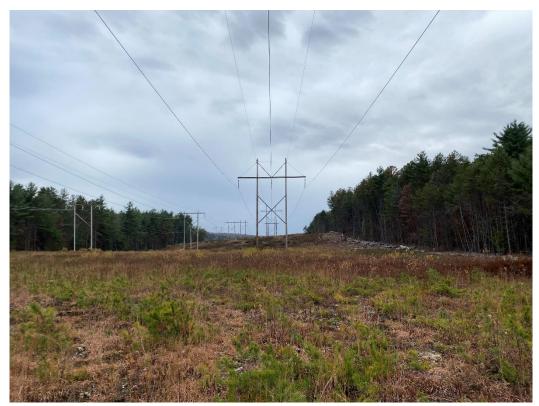
Photograph No. 26: Looking at proposed access and work pad location for A253 Structure 37.

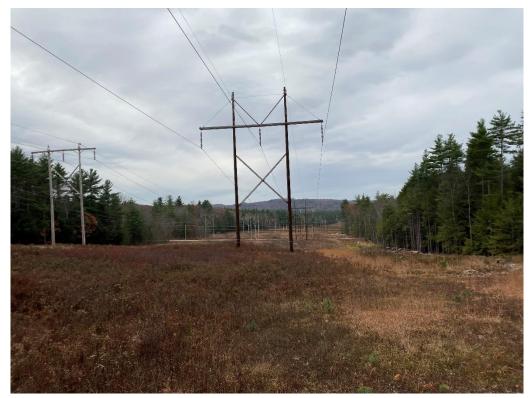
Photograph No. 28: Looking at proposed access and work pad location for A253 Structure 30.

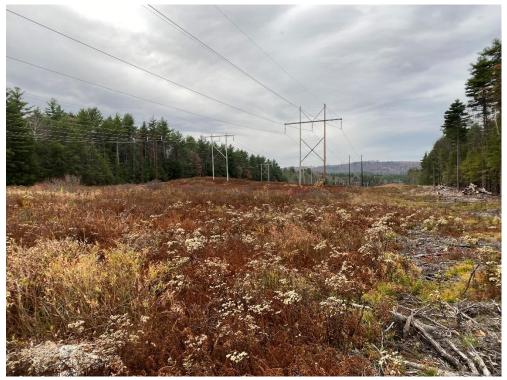
Photograph No. 29: Looking at proposed access and work pad location for A253 Structure 29.

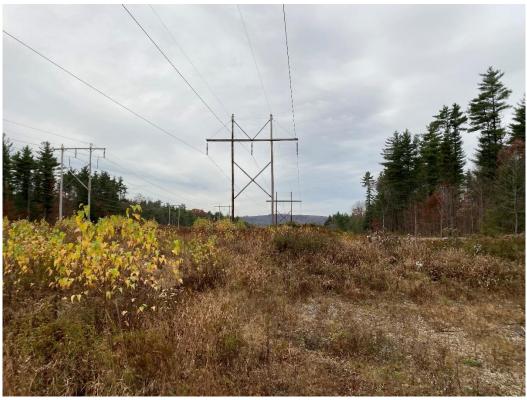
Photograph No. 31: Looking at proposed access and work pad location for A253 Structure 26.

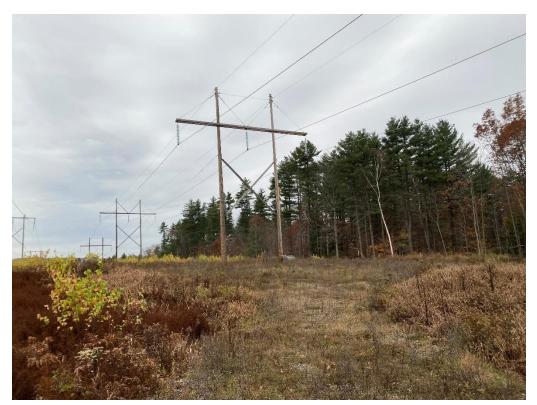
Photograph No. 32: Looking at proposed access and work pad location for A253 Structure 25.

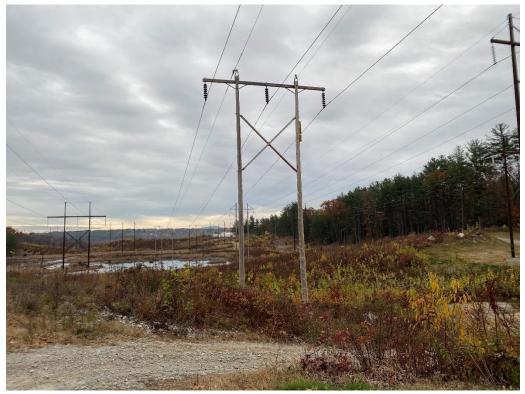
Photograph No. 33: Looking at proposed access and work pad location for C196 Structure 14.

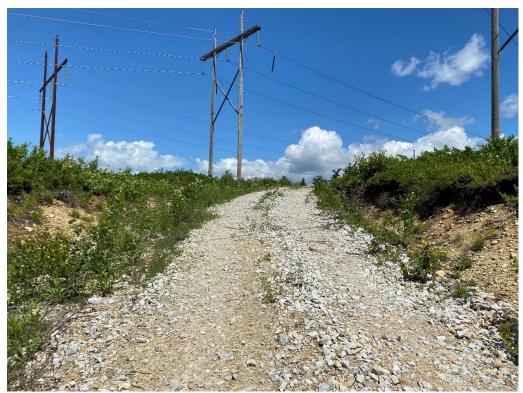
Photograph No. 35: Looking at proposed access and work pad location for C196 Structure 6.
