Comment on SEC 2024-02

Eversource's SEC Exhibit 1 part [2/3](#) contains errors.

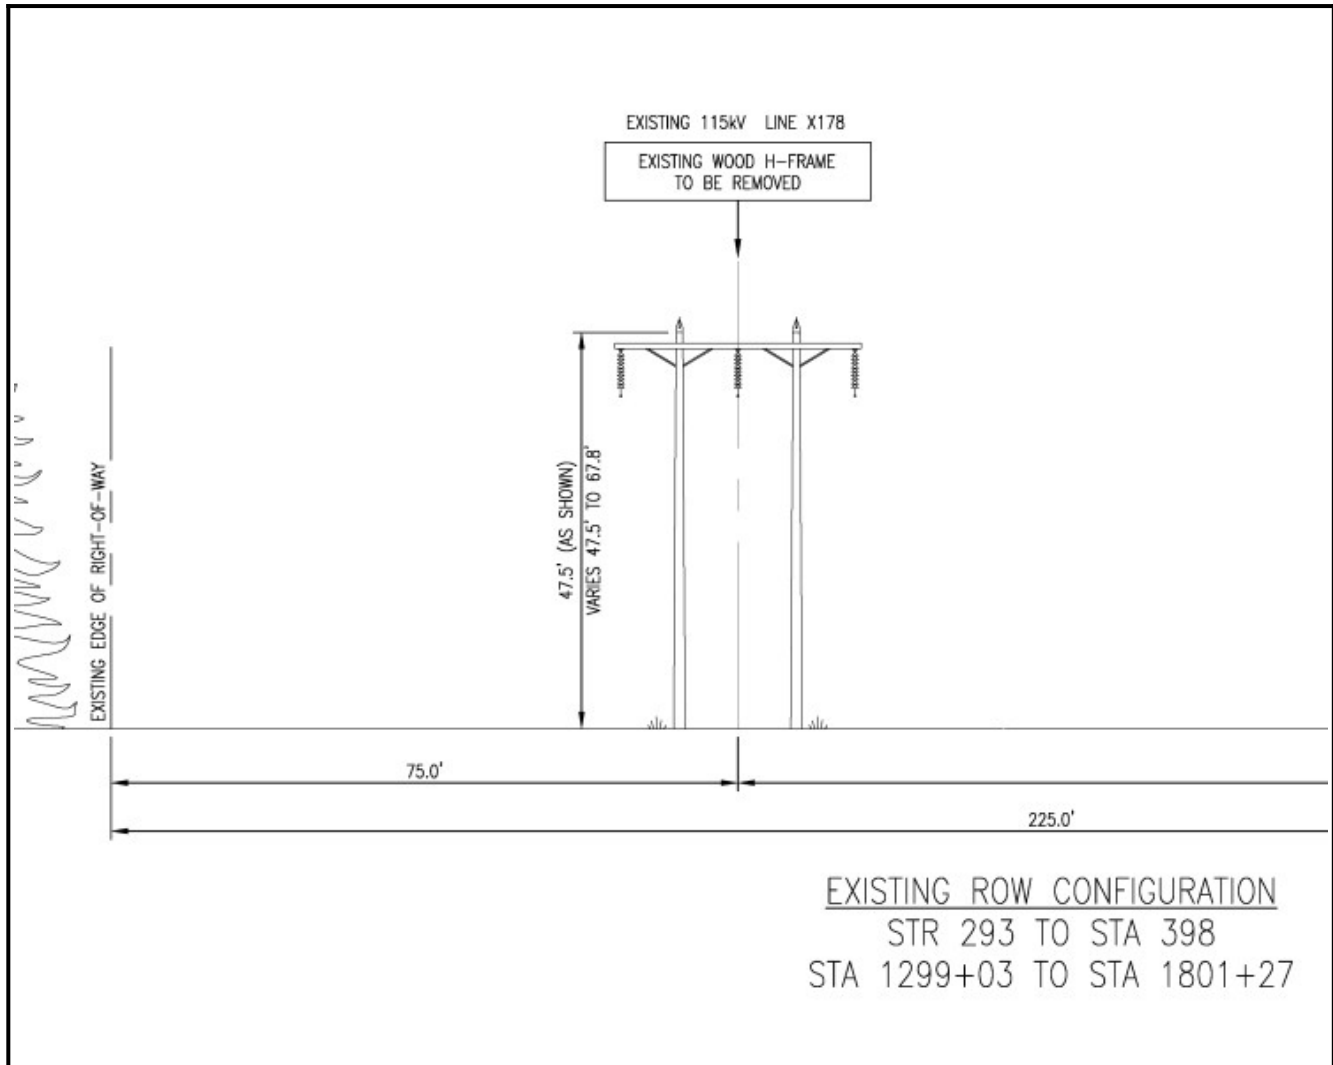
Eversource's Exhibit shows structures 1 through 407, which comprise the X-178 (1 & 2), as the 1948/1969 type structure shown below:

The actual X-178 (1 & 2) structures have larger poles, cross-bracing on most of the structures, different bracing above the cross-bar and different ground/static wire carriers.

Third party ground-proofing and collection of information, including structure inspections, is necessary for the SEC to make informed decisions in this docket.

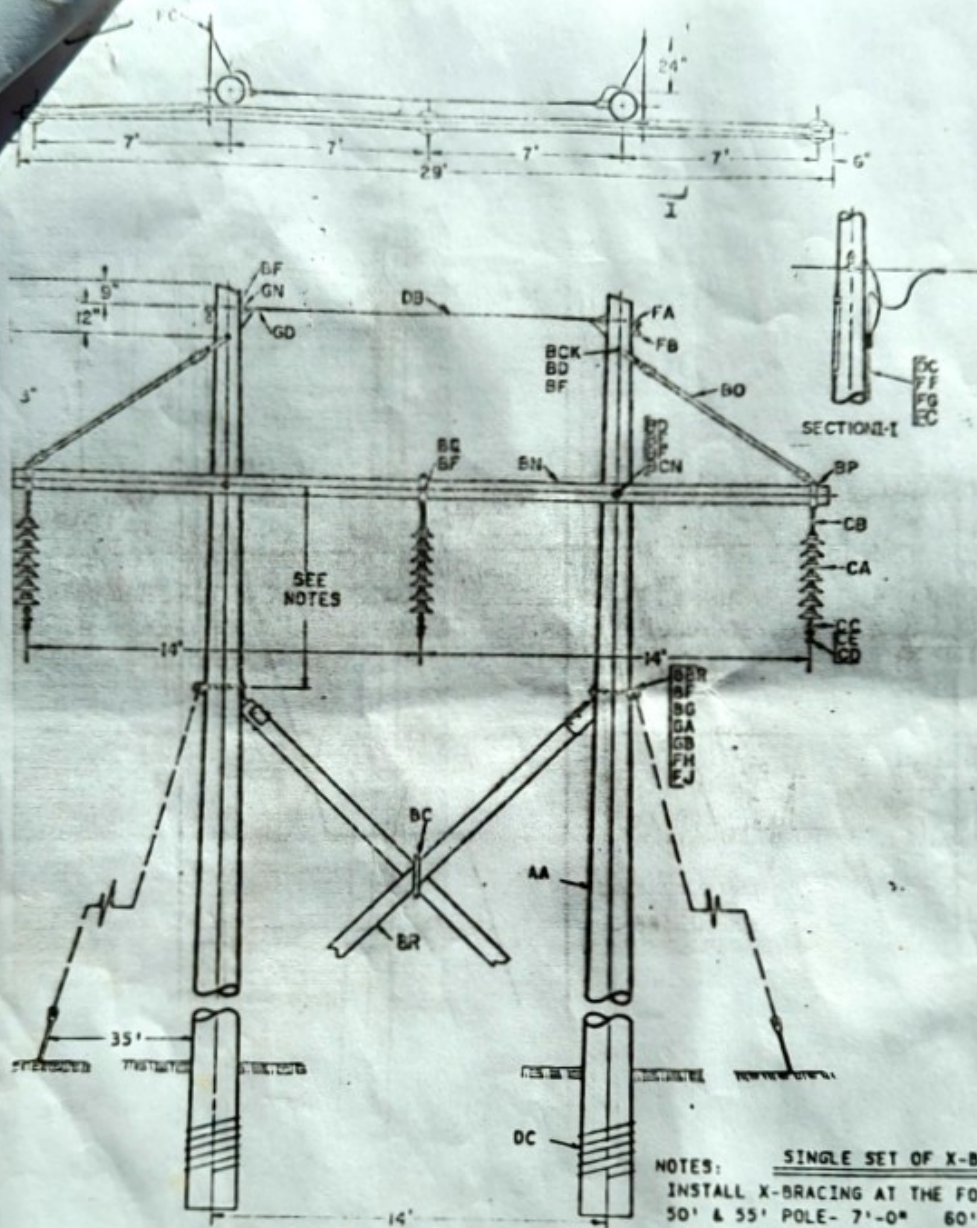
Below: 1985 X-178 (1 & 2) structure:

NOTES: SINGLE SET OF X-BRACING
 INSTALL X-BRACING AT THE FOLLOWING DISTANCES BEL
 50' & 55' POLE- 7'-0" 60' POLE - 9'-0"
DOUBLE SET OF X-BRACING
 ALL TANGENT STRUCTURES 65 FEET AND ABOVE SHALL R
 2 SETS OF X-BRACING. INSTALL TOP SET OF X-BRACIN
 AT 7'-0" BELOW THE CROSSARM, AND INSTALL BOTTOM
 OF X-BRACING 3'-0" BELOW UPPER SET.

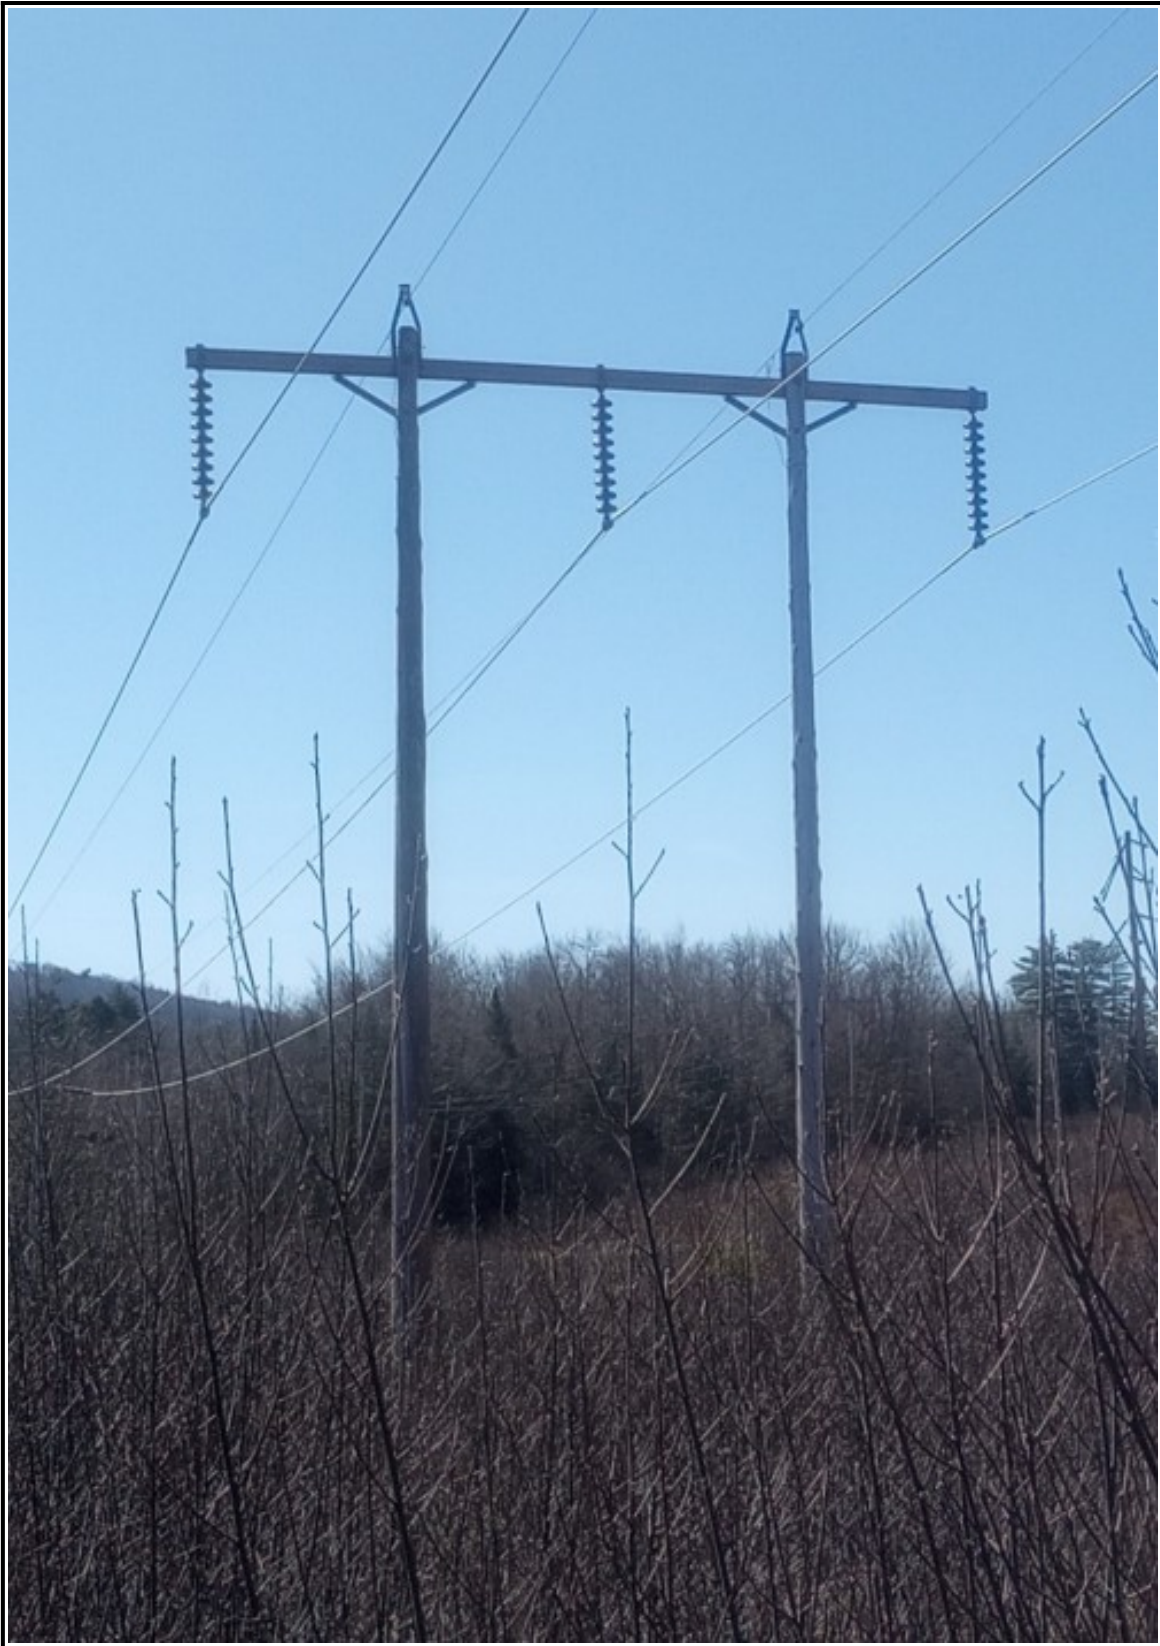
1969 structure, X-178 (3), between the Rocks Estate and Profile School Bethlehem, NH:

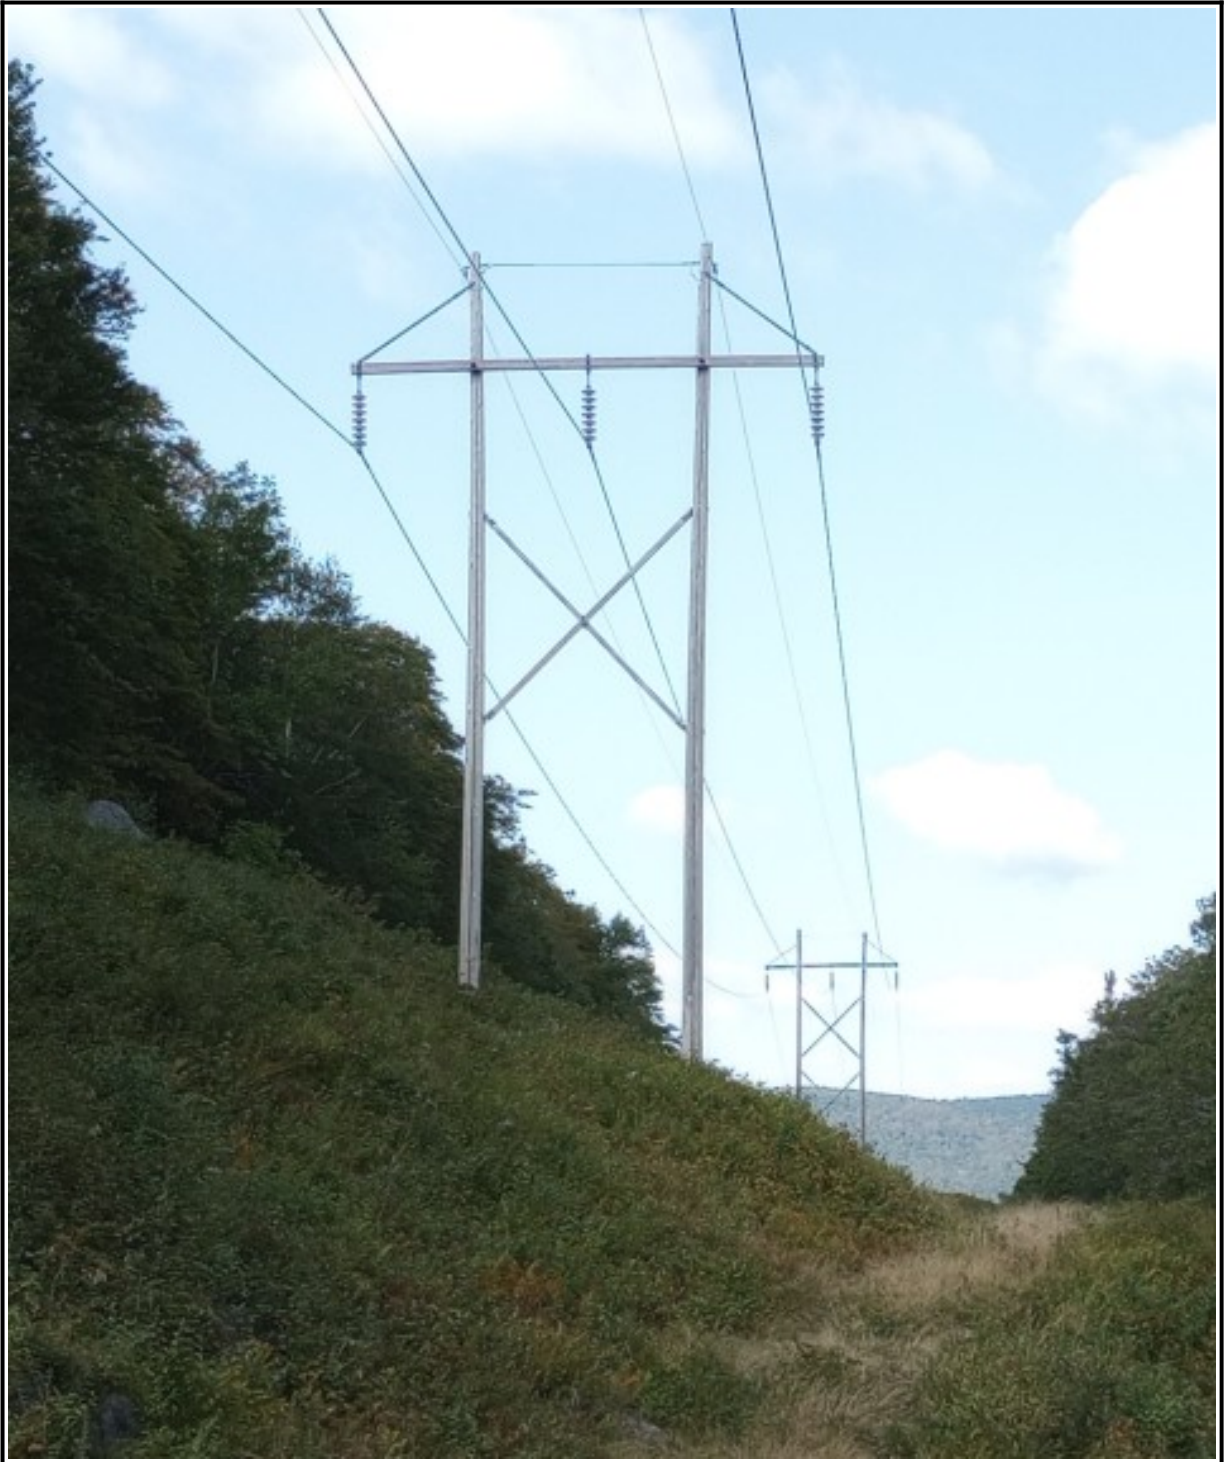
1985 structures 280 and 281 on the X-178 (2), White Mountain National Forest, Reel Brook watershed, Easton:
